# School Assessment Report

District: Arriba-Flagler C-20

School: Flagler ES/MS/HS

Date: Mar 18, 2013

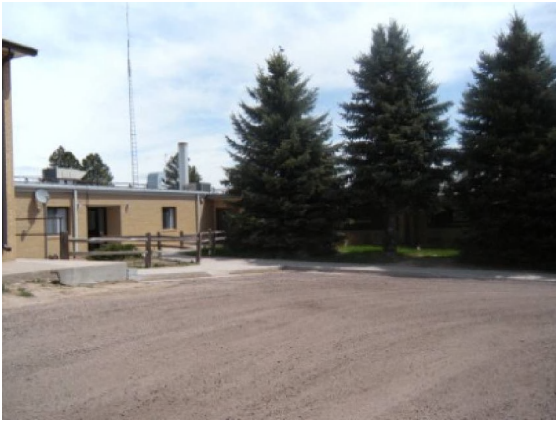
**System:** G2010 - Roadways

**Analysis:** The system age is either beyond expected life or does not meet its intended performance under the Guidelines. The system may be in service and functioning but it is recommended to be replaced due to probable increased condition budget needs, the potential failure of its components, or in order to meet the performance Guidelines for this system. The system was installed in 1954. It has a 50-year service life which expired in 2004.

**Recommendation:** The system should be replaced.

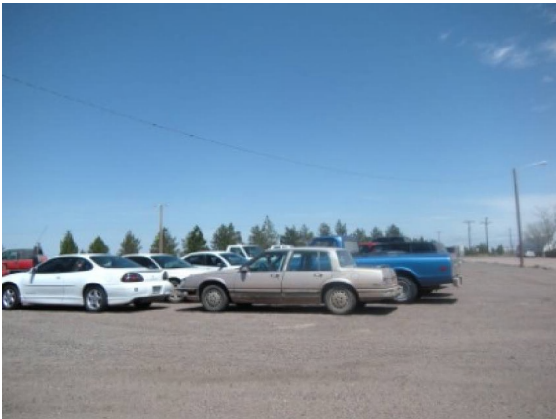
**System:** G2020 - Parking Lots

**Analysis:** The system age is either beyond expected life or does not meet its intended performance under the Guidelines. The system may be in service and functioning but it is recommended to be replaced due to probable increased condition budget needs, the potential failure of its components, or in order to meet the performance Guidelines for this system. The system was installed in 1954. It has a 50-year service life which expired in 2004.

**Recommendation:** The system should be replaced.

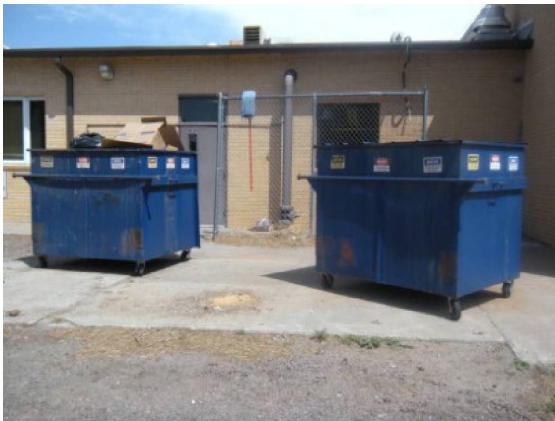
**System:** G2040 - Site Development

**Analysis:** The system is missing.

**Location:** Site  
**Material:** Site Development  
**Distress:** Missing  
**Category:** Environmental  
**Priority:** 3 - Necessary- 2-5 Yrs  
**Notes:** There is no fencing around dumpsters. Installation is recommended.

**Recommendation:** The system should be installed.

**Correction:** Replace and/or add fencing for security/appearance

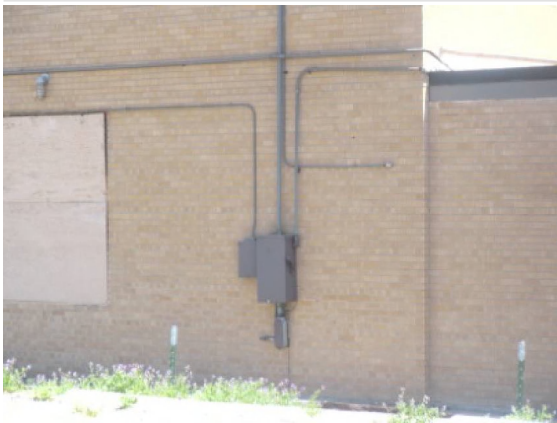
**System:** G4010 - Electrical Distribution

**Analysis:** The system age is either beyond expected life or does not meet its intended performance under the Guidelines. The system may be in service and functioning but it is recommended to be replaced due to probable increased condition budget needs, the potential failure of its components, or in order to meet the performance Guidelines for this system. The system was installed in 1954. It has a 30-year service life which expired in 1984.

Location: Site  
Distress: Beyond Useful Life  
Category: Deferred Maintenance  
Priority: 3 - Necessary- 2-5 Yrs  
Notes: The electrical distribution system has no room for additional capacity. Recommend upgrade.  
Correction: Renew System  
Qty: 1-Ea.  
Condition Budget: \$131,111

**Recommendation:** The system should be replaced.

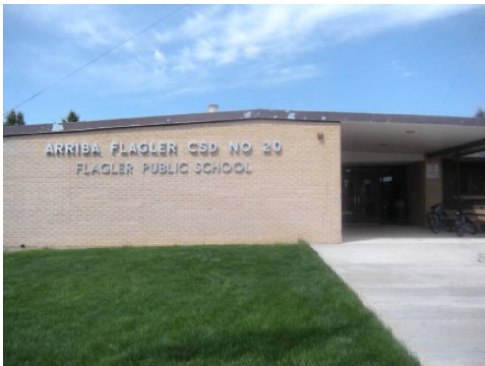
Location: Site  
Material: Site Communications and Security  
Distress: Missing  
Category: Compliance  
Priority: 3 - Necessary- 2-5 Yrs  
Notes: There are no bollards or any other means to protect the forced entry at the main entrance. Installation is recommended.

Correction: Add security barrier/ bollards at front entry.  
Qty: 30-L.F.  
Condition Budget: \$4,288

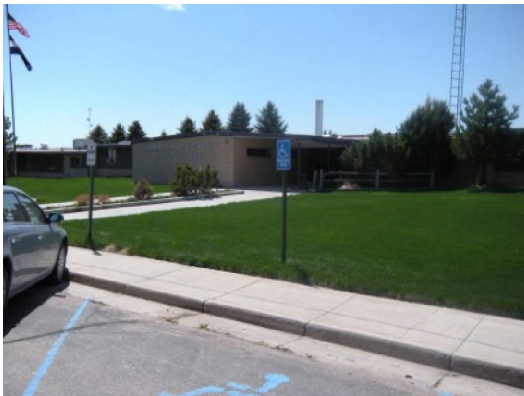
Location: Site  
Material: Site Development  
Distress: Missing  
Category: Compliance  
Priority: 3 - Necessary- 2-5 Yrs  
Notes: The TV tower beside the school building needs to be fenced as it provides uncontrolled access to the roof.

Correction: Replace and/or add fencing for security/appearance  
Qty: 1-Ea.  
Condition Budget: \$4,147

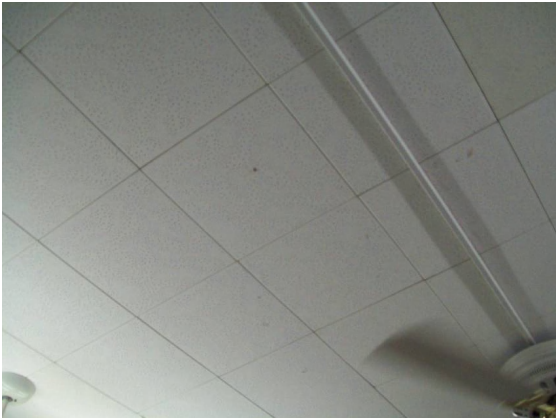
Location: Main  
Distress: Beyond Useful Life  
Category: Deferred Maintenance  
Priority: 3 - Necessary- 2-5 Yrs  
Notes: The ceiling finishes are beyond their expected lives. Replacement is recommended.  
Correction: Renew System  
Qty: 1-Ea.  
Condition Budget: \$728,886

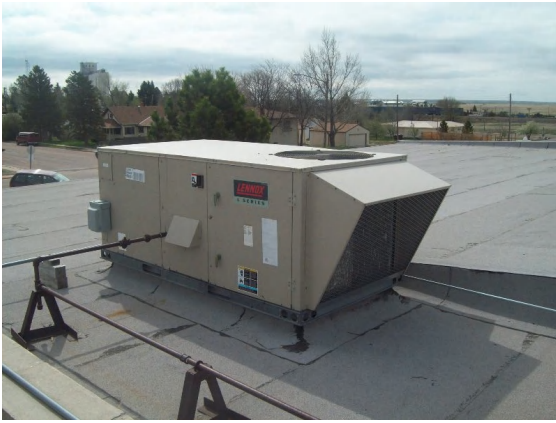
**System:** D3050 - Terminal & Package Units

**Analysis:** The system age is either beyond expected life or does not meet its intended performance under the Guidelines. The system may be in service and functioning but it is recommended to be replaced due to probable increased condition budget needs, the potential failure of its components, or in order to meet the performance Guidelines for this system. The system was installed in 1996. It has a 15-year service life which expired in 2011.

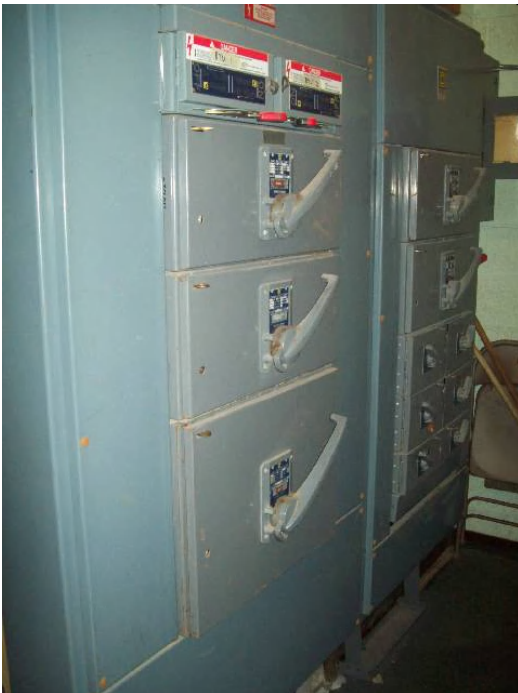
Location: Main  
Distress: Beyond Useful Life  
Category: Deferred Maintenance  
Priority: 3 - Necessary- 2-5 Yrs  
Notes: The electrical service and distribution is beyond its expected life. Replacement is recommended.  
Correction: Renew System  
Qty: 1-Ea.  
Condition Budget: \$298,138

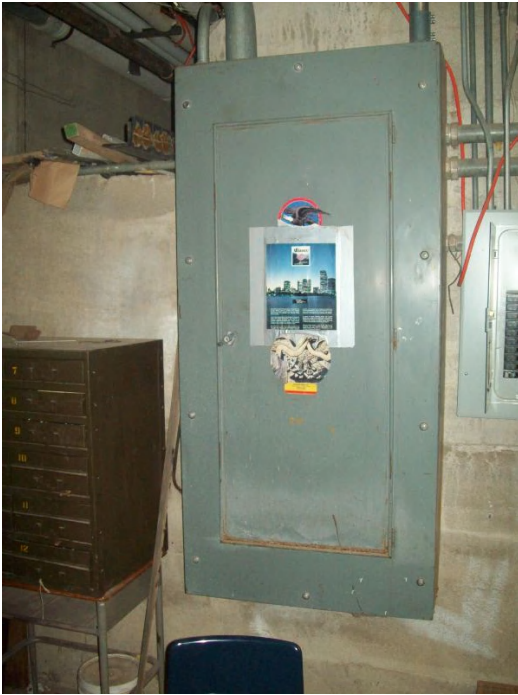
**System:** D5020 - Lighting and Branch Wiring

**Analysis:** The system age is either beyond expected life or does not meet its intended performance under the Guidelines. The system may be in service and functioning but it is recommended to be replaced due to probable increased condition budget needs, the potential failure of its components, or in order to meet the performance Guidelines for this system. The system was installed in 1954. It has a 30-year service life which expired in 1984.

**Recommendation:** The system should be replaced.

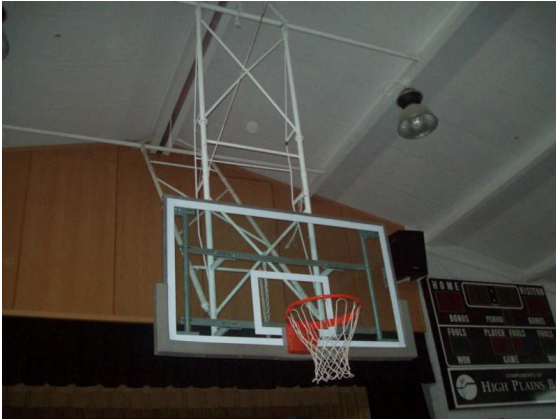
System: E1090 - Other Equipment

Analysis: The system age is either beyond expected life or does not meet its intended performance under the Guidelines. The system may be in service and functioning but it is recommended to be replaced due to probable increased condition budget needs, the potential failure of its components, or in order to meet the performance Guidelines for this system. The system was installed in 1954. It has a 20-year service life which expired in 1974.

Recommendation: The system should be replaced.

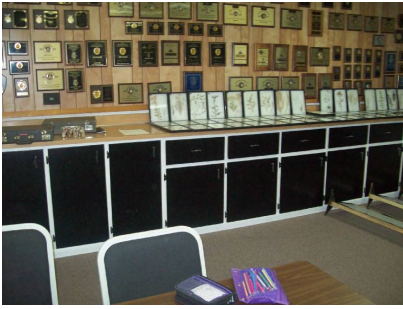
Location: Main  
Distress: Beyond Useful Life  
Category: Deferred Maintenance  
Priority: 3 - Necessary- 2-5 Yrs  
Notes: The fixed furnishings are beyond their expected life. Replacement is recommended.

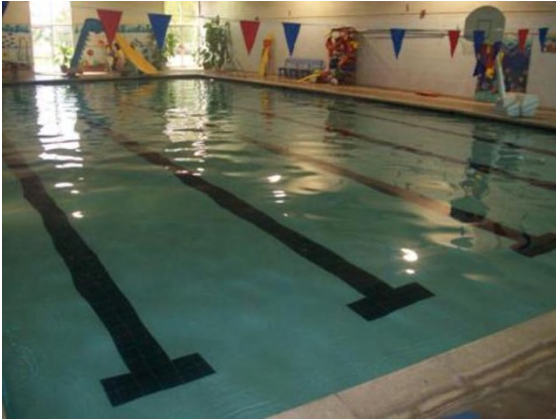
**System:** F1040 - Special Facilities

Analysis: The system age is either beyond expected life or does not meet its intended performance under the Guidelines. The system may be in service and functioning but it is recommended to be replaced due to probable increased condition budget needs, the potential failure of its components, or in order to meet the performance Guidelines for this system. The system was installed in 1964. It has a 40-year service life which expired in 2004.

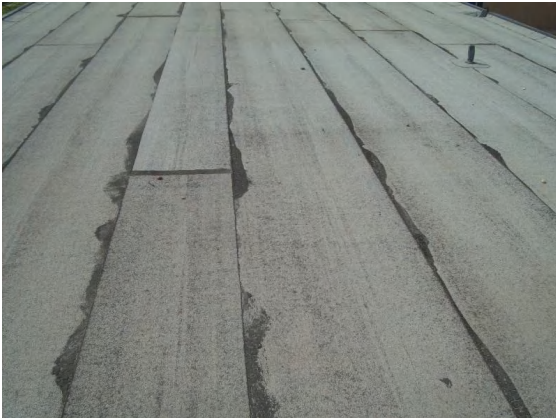
Location: 1983 Add  
Distress: Beyond Useful Life  
Category: Deferred Maintenance  
Priority: 3 - Necessary- 2-5 Yrs  
Notes: The roof covering is beyond its expected life. Replacement is recommended.  
Correction: Renew System  
Qty: 1-Ea.  
Condition Budget: \$24,200

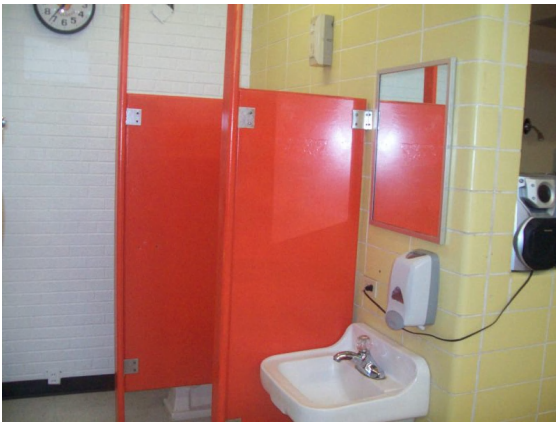
System: C1030 - Fittings

Analysis: The system age is either beyond expected life or does not meet its intended performance under the Guidelines. The system may be in service and functioning but it is recommended to be replaced due to probable increased condition budget needs, the potential failure of its components, or in order to meet the performance Guidelines for this system. The system was installed in 1983. It has a 20-year service life which expired in 2003.

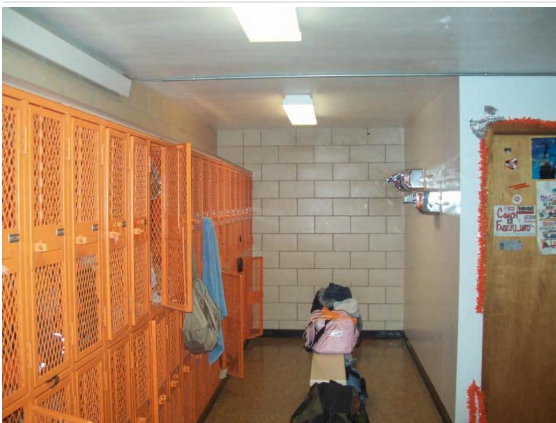
System: C3010 - Wall Finishes

Analysis: The system age is either beyond expected life or does not meet its intended performance under the Guidelines. The system may be in service and functioning but it is recommended to be replaced due to probable increased condition budget needs, the potential failure of its components, or in order to meet the performance Guidelines for this system. The system was installed in 1983. It has a 20-year service life which expired in 2003.

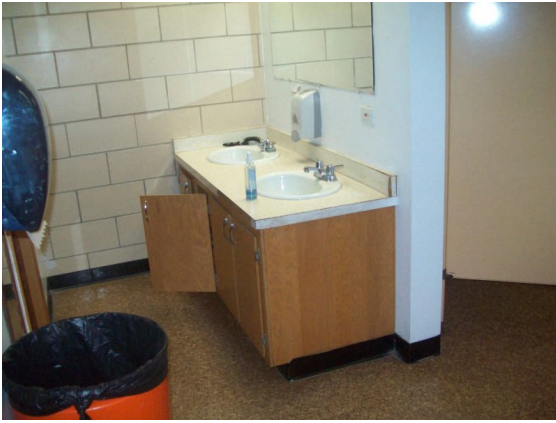
**System:** C3020 - Floor Finishes

**Analysis:** The system age is either beyond expected life or does not meet its intended performance under the Guidelines. The system may be in service and functioning but it is recommended to be replaced due to probable increased condition budget needs, the potential failure of its components, or in order to meet the performance Guidelines for this system. The system was installed in 1983. It has a 20-year service life which expired in 2003.

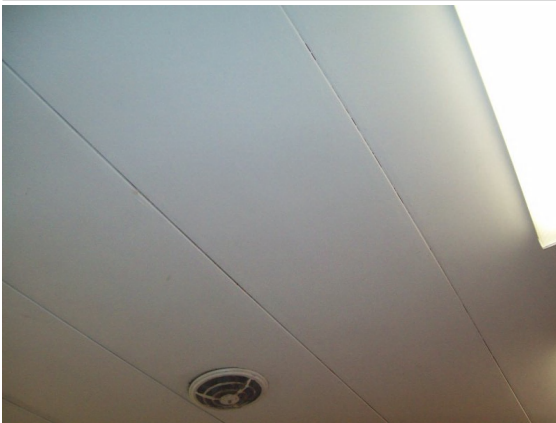
**System:** C3030 - Ceiling Finishes

**Analysis:** The system age is either beyond expected life or does not meet its intended performance under the Guidelines. The system may be in service and functioning but it is recommended to be replaced due to probable increased condition budget needs, the potential failure of its components, or in order to meet the performance Guidelines for this system. The system was installed in 1983. It has a 20-year service life which expired in 2003.

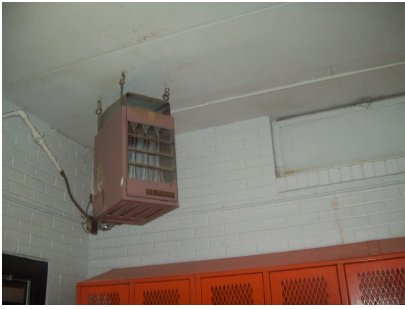
Location: 1983 Add  
Distress: Beyond Useful Life  
Category: Deferred Maintenance  
Priority: 3 - Necessary- 2-5 Yrs  
Notes: The gas piping is beyond its expected life. Replacement is recommended.

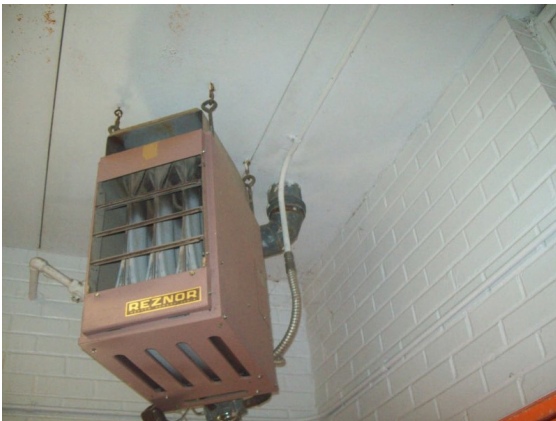
Location: 1983 Add  
Distress: Beyond Useful Life  
Category: Deferred Maintenance  
Priority: 3 - Necessary- 2-5 Yrs  
Notes: The terminal and package units are beyond their expected life. Replacement is recommended.

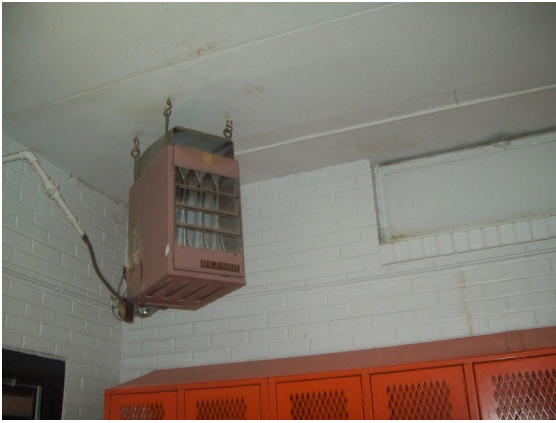
**System:** D3060 - Controls & Instrumentation

**Analysis:** The system age is either beyond expected life or does not meet its intended performance under the Guidelines. The system may be in service and functioning but it is recommended to be replaced due to probable increased condition budget needs, the potential failure of its components, or in order to meet the performance Guidelines for this system. The system was installed in 1983. It has a 20-year service life which expired in 2003.

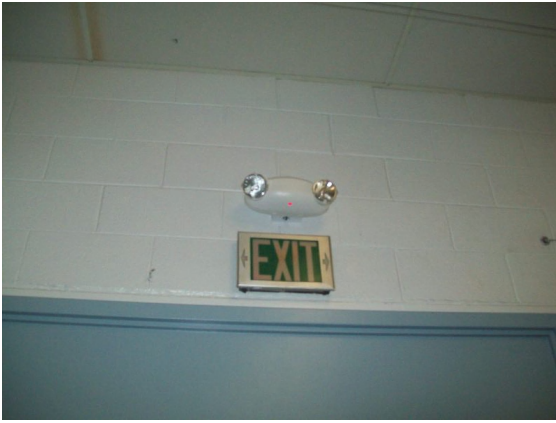
**System:** D5090 - Other Electrical Systems

**Analysis:** The system age is either beyond expected life or does not meet its intended performance under the Guidelines. The system may be in service and functioning but it is recommended to be replaced due to probable increased condition budget needs, the potential failure of its components, or in order to meet the performance Guidelines for this system. The system was installed in 1983. It has a 15-year service life which expired in 1998.

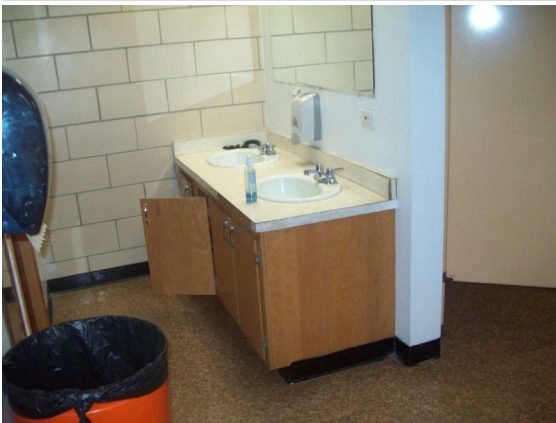
**System:** E2010 - Fixed Furnishings

**Analysis:** The system age is either beyond expected life or does not meet its intended performance under the Guidelines. The system may be in service and functioning but it is recommended to be replaced due to probable increased condition budget needs, the potential failure of its components, or in order to meet the performance Guidelines for this system. The system was installed in 1983. It has a 20-year service life which expired in 2003.

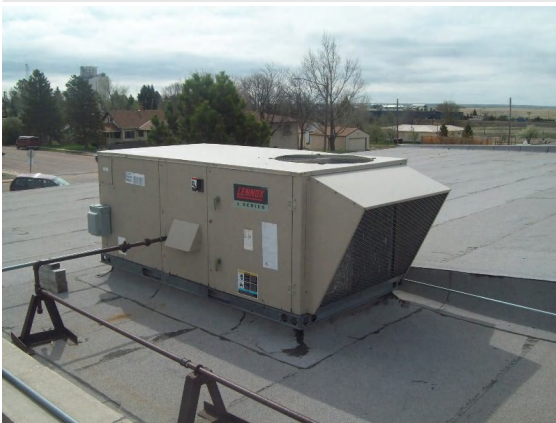
System: D3050 - Terminal & Package Units

Analysis: The system age is either beyond expected life or does not meet its intended performance under the Guidelines. The system may be in service and functioning but it is recommended to be replaced due to probable increased condition budget needs, the potential failure of its components, or in order to meet the performance Guidelines for this system. The system was installed in 1996. It has a 15-year service life which expired in 2011.

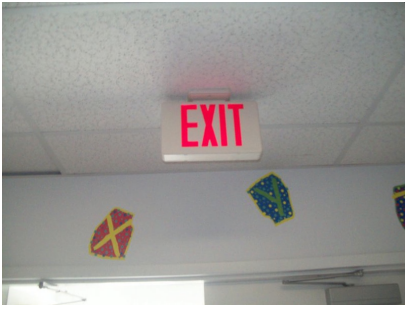
Location: 1996 Add  
Distress: Beyond Useful Life  
Category: Deferred Maintenance  
Priority: 3 - Necessary- 2-5 Yrs  
Notes: The other electrical systems are beyond their expected life. Replacement is recommended.  
Correction: Renew System  
Qty: 1-Ea.  
Condition Budget: \$1,596
