MSD of New Durham Township Westville Schools

2017 Facility Assessment Report Overview

April 10, 2017

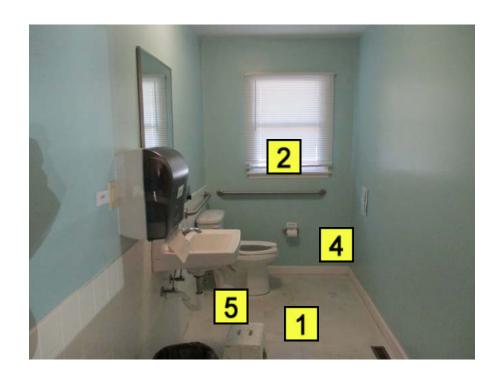
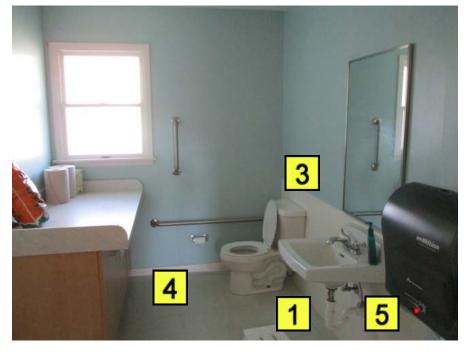
RESTROOM

Restroom Data		
Location:	Restroom #1	
Fixtures:	Good	
Flooring:	Fair	
Walls:	Fair	
Ceiling:	Fair	
Doors:	Good	
Accessories:	Good	
Overall Condition:	Fair	
Replacement Cost:	\$15,000 - \$20,000	
Gene	General Notes:	
Restrooms do not meet current ADA requirements.

- 1. Wear and tear on existing flooring system.
- 2. No vertical grab bar per ADA requirements.
- 3. No horizontal grab bar per ADA requirements.
- 4. No turn / maneuvering space per ADA requirement.
- 5. Pipe covers do not cover entire pipe.

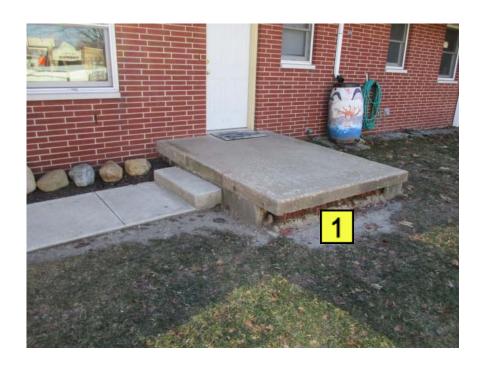
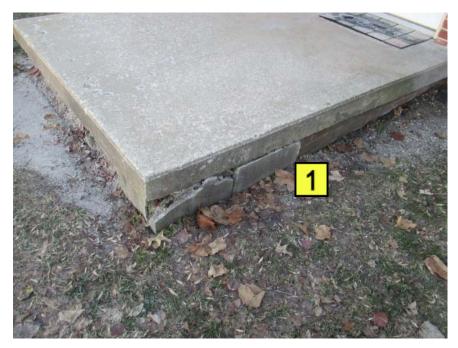
PARKING AND HARDSCAPES

Parking and Hardscapes		
Location:	Back of Main Building	
Sidewalk Material:	Concrete	
Sidewalk Condition:	Failed	
Replacement Cost:	\$5,000	
Gene	General Notes:	
Replace damaged stoop in its entirety.

1. Some concrete step / stoop damage due to freeze / thaw.

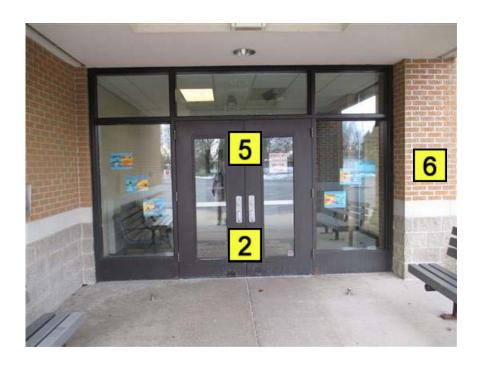
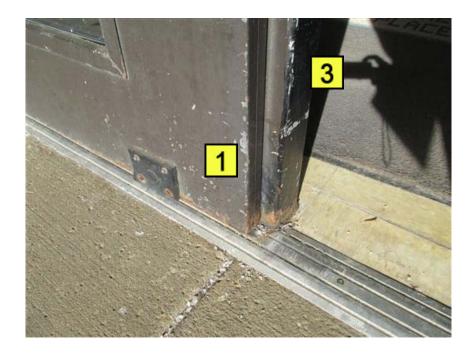
Location: #1 Exterior

Exterior Door System Data	
Door Designation:	#1 Exterior
Door Material:	Hollow Metal
Weather Stripping:	Poor
Door Closers:	Good
Door Glazing:	Insulated 1" & 1/2"
Sidelites/Transoms:	Poor
Vestibule:	Yes
Overall Condition:	Poor
Replacement Cost:	\$16,500
General Notes:	
Recommended to inspect, maintain, and clean door	
system regularly to prolong life expectancy. Door	
does not have electronic security.

Image Legend:	
1. Door rusting.	
2. Newer hardware.	
3. Some weather stripping missing.	
4. Sweeps worn out.	
5. Excessive wear / abuse.	
6. No ADA push buttons.

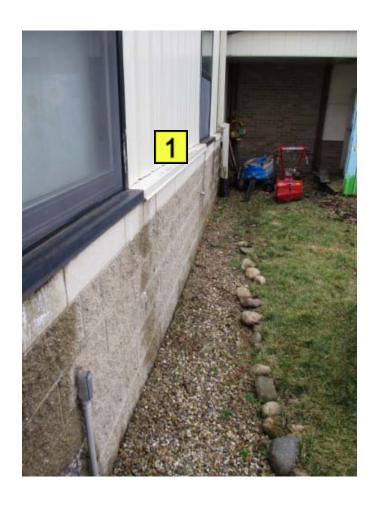
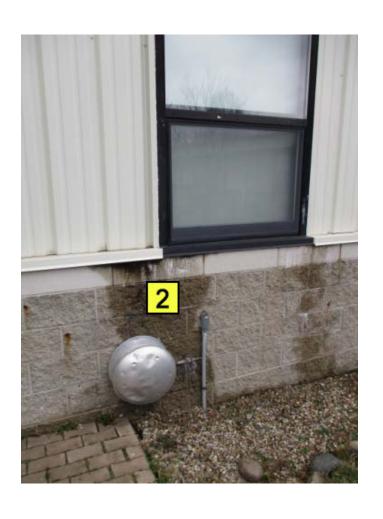
MASONRY / SEALANT

Masonry / Sealant Data (Con.)	
Masonry:	Good
Cladding:	Poor
Flashing / Trim:	Poor
Caulking / Sealant:	Fair
Overall Condition:	Failed
Replacement Cost:	\$125,000 - \$150,000
General Notes:	
Recommend replacing trim to ensure water sheds away from building to prevent water issues in the future

- 1. Trim Slopes back towards building
- 2. Transition between window and facade trim not aligned causing water issues.

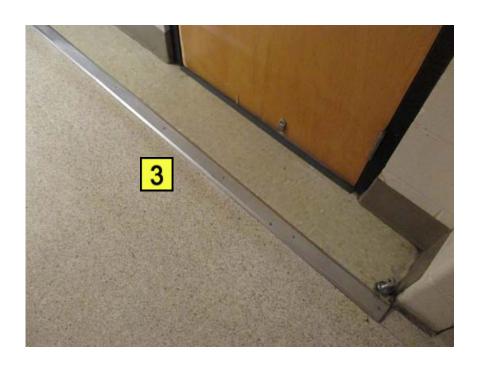
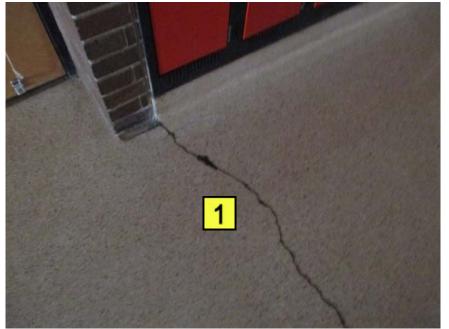
CORRIDORS

Corridor Data		
Category:	Floors	
Flooring Type:	Terrazzo	
Flooring Condition:	Poor	
Wall Base Type:	Rubber	
Wall Base Condition:	Fair	
Accessories:	Good	
Overall Condition:	Poor	
Replacement Cost:	\$90,000 - \$140,000*	
General Notes:		
General condition of corridor flooring is poor. The floor is cracking and needs repaired / replaced. *(Estimate of repair cost based on \$2-\$3/SF)

- 1. Floor surface is cracking in many places.
- 2. Flooring surface is damaged.
- 3. Threshold in corridor. Some floor mounted door stops in corridor are trip hazards.
- 4. Floor tile gap developing.

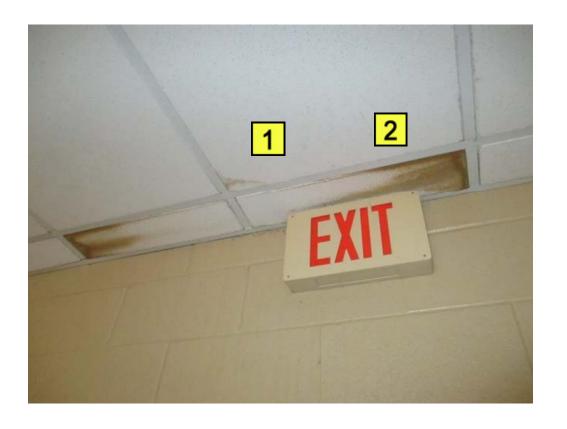
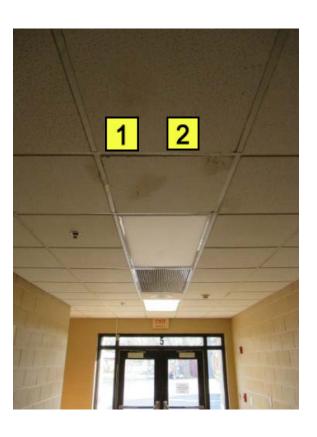
CORRIDORS

Corridor Data	
Category:	Ceiling (Con.)
Ceiling Type:	Drop - ACT
Panel Condition:	Poor
Grid / Accessories:	Good
Overall Condition:	Fair
Replacement Cost:	\$90,000 - \$145,000*
General Notes:	
Various ceiling tiles need to be replaced. Sources of	
water damage need to be identified and repaired.	
Panels are overall rated as 'Poor' due to many	
instances of damage/stains.

- 1. Various ceiling tiles have water stains.
- 2. Various ceiling tiles are physically damaged.
- 3. Some ceiling tiles are loose due to damage or warping.

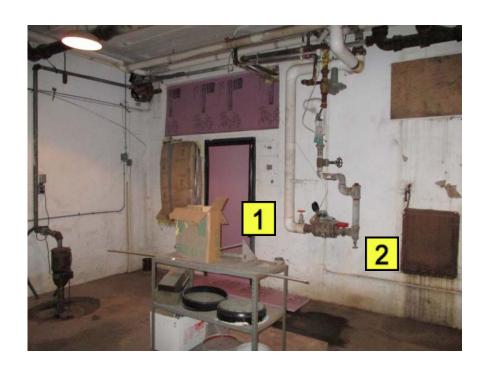
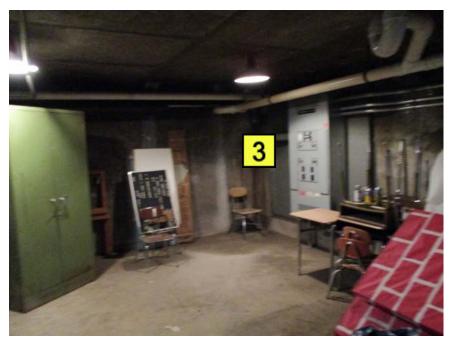
MAINTENANCE / STORAGE

Maintenance & Storage Data		
Location:	Maintenance & Storage	
Floor Material:	Concrete	
Wall:	CMU Block	
Storage Conditions:	Poor	
Lighting:	Poor	
Overall Condition:	Poor	
Replacement Cost:		
General Notes:		
Storage room has major	Storage room has major drainage issues.

- 1. Drainage issues in space
- 2. Walls need painted.
- 3. Abestos on present on pipes in tunnels

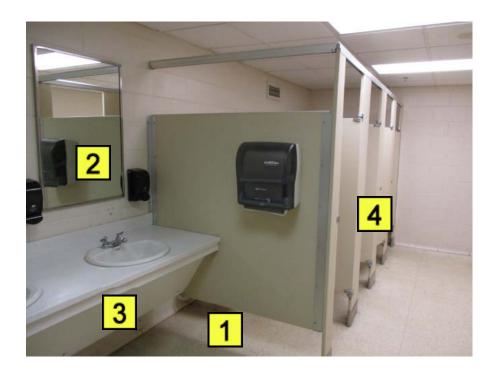
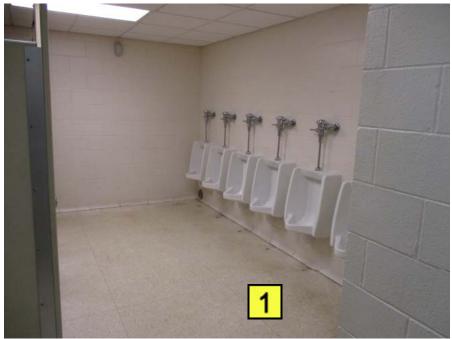
RESTROOMS

Restroom Data		
Location:	Men	
Fixtures:	Fair	
Flooring:	Fair	
Walls:	Fair	
Ceiling:	Good	
Accessories:	Good	
Overall Condition:	Fair	
Replacement Cost:	\$60,000 - \$75,000	
Gene	General Notes:	
Condition of finishes is fair to good. However, the		
restroom layout is not ADA compliant.

- 1. Flooring is damaged / deteriorated.
- 1. Mirror installed above height required for ADA.
- 2. Pipe cover does not meet current ADA access requirements.
- 4. No ADA stalls / urinals.

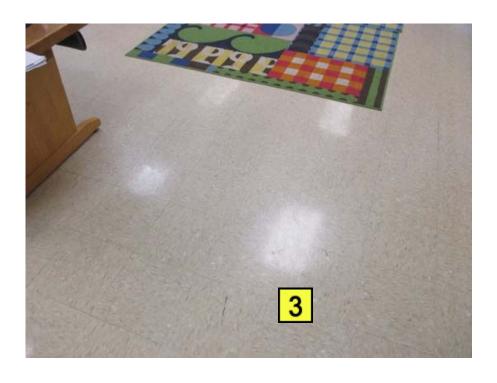
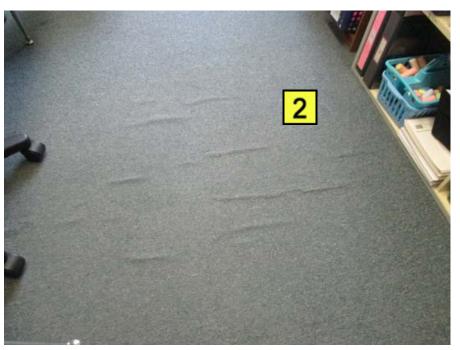
ELEMENTARY CLASSROOMS

Classroom Data		
Category:	Flooring	
Туре:	VCT & Carpet	
Category:	Wall Base	
Туре:	Rubber	
Overall Condition:	Fair	
Replacement Cost:	\$115,000 - \$176,000*	
General Notes:		
The elementary school classroom flooring is in fair		
condition.		
*(Cost basis for all classrooms)

- 1. Carpet is showing signs of aging and wear.
- 2. Carpet is wrinkling, which poses a tripping hazard.
- 3. VCT is showing signs of aging and wear.

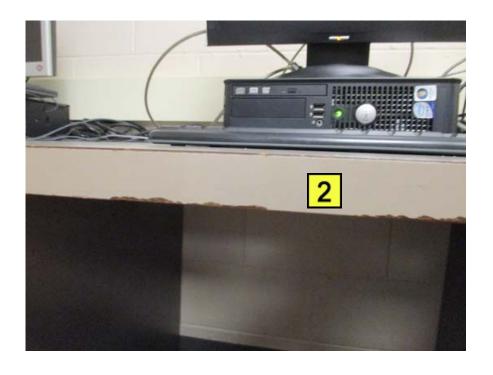
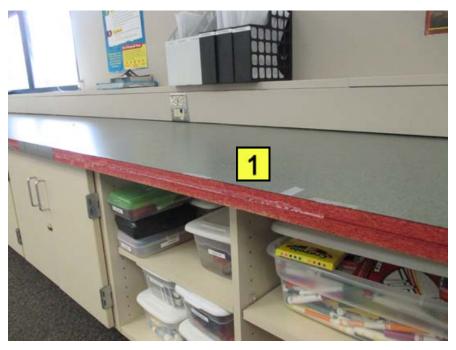
MIDDLE SCHOOL CLASSROOMS

Classroom Data		
Category:	Casework	
Type:	Lower	
Countertop:	Laminate	
Casework Material:	Laminate and Wood	
Overall Condition:	Poor	
Туре:	Full Height Cabinet	
Casework Material:	Laminate and Wood	
Overall Condition:	Fair	
Replacement Cost:	\$125,000 - \$140,000	
Gene	General Notes:	
Overall condition of casework is poor and needs replaced.

- 1. Laminate is peeling off.
- 2. Countertop edges are worn.

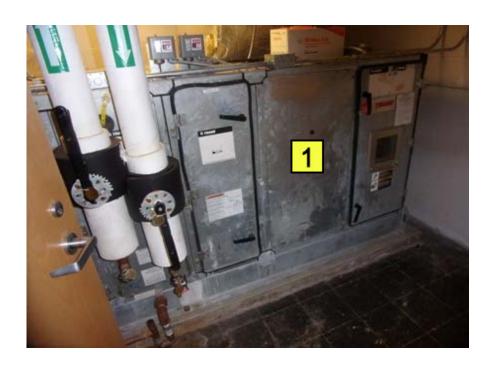
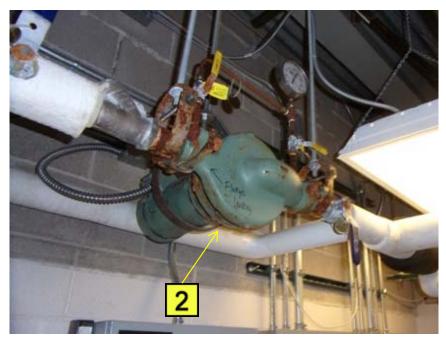
CAMPUS MECHANICAL

Media Center Air Handler	
Tag	AHU-4
Type:	Modular Air Handler
Zone Control:	Variable air volume boxes with hot water reheat
Installation Date:	2000
Controls:	DDC
Overall Condition:	Good
Pumps:	Inline cooling pump
Controls:	DDC
Overall Condition:	V 100000000
Replacement Cost:	\$140,000-\$165,000
General Notes:	
AHU-4 is a cooling only variable air volume air handler

- 1. AHU-4
- 2. AHU-4 chilled water pump.

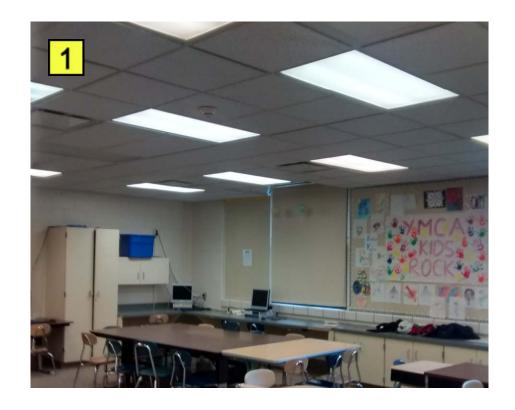
CAMPUS ELECTRICAL

Current lighting system is inefficient and aged, several lamps are out, and lenses are dingy. Light levels in many areas are dim. Upgrade to newer LED light fixtures is needed. Occupancy sensor controls

1. Elementary classroom showing dim lighting and aged light fixtures.

should also be installed in most areas for energy savings.

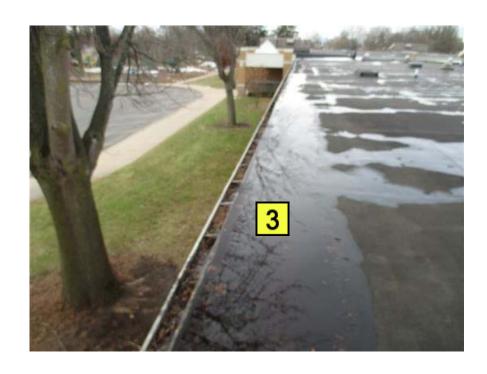
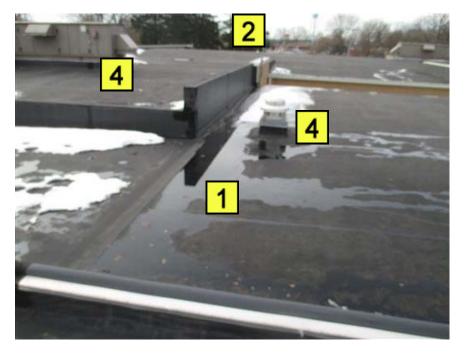
Existing Roof Data					
Roof Section Number:	2				
Roof Area:	27,626 SF				
Year Installed:					
Warranty Period:					
Roof Composition:	Single Ply-EPDM over Rigid Polyisocyanurate				
Core Sample:	Not Available				
Overall Roof Condition:	Poor				
Visible Defects:	1 -Sealant issues.2 -Ponding around drains.3 -Ponding near gutters.4. General maintenance.				
Recommendations:	Roof replacement.				
Cost of Repairs:	See probable cost section.

- 1. Internal ponding, not sloping properly to drains or gutter. High points not allowing water to flow through.
- 2. No coping on top of wall.
- 3. Lip at gutter edge prevents flow of water to drain.
- 4. Mechanical penetrations to have crickets to drain water away from their curbs.

General Note: Roof membrane overall is in fair condition, but lack of drainage at gutters, equipment curbs lack of coping and general bad maintenance may create serious issues soon!

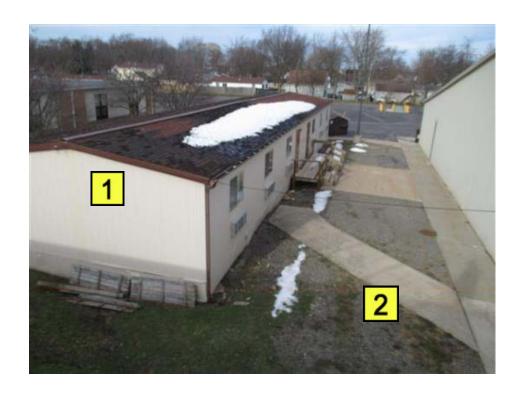
Existing Roof Data			
Roof Section Number:	20		
Roof Area:	2,538 SF		
Year Installed:			
Warranty Period:			
Roof Rating:	Failed		
Roof Composition:	Asphalt Shingle		
Core Sample:	Not Available		
Overall Roof Condition:	Failed		
Visible Defects:	1 - Shingle old, deteriorated.2. General maintenance.		
Recommendations:	Due to expansion of caffeteria, building indicated may be removed.		
Cost of Repairs:	See probable cost section.

Image Legend:
1. Shingles are old and deteriorated.	
2. General site condition has lack of drainage.

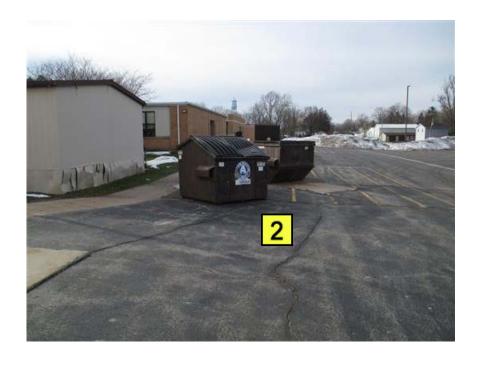
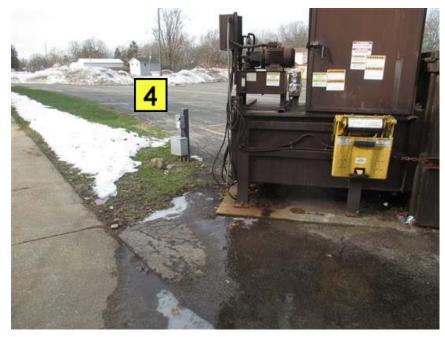
PARKING AND HARDSCAPES

Parking and Hardscapes				
Location:	See Key Plan			
Surfacing Material:	Asphalt			
Parking Condition:	Poor			
Drainage:	Poor			
Sidewalk Material:	Material: Concrete			
Sidewalk Condition:	Fair			
Pavement Cost:	\$500,000.00			
Drainage Cost:	\$1M-\$2M			
Sidewalk Cost:	\$250,000-\$750,000			
General Notes:				
Recommend to replace and repair sidewalk /

- 1. Shear cracks and missing concrete at sidewalks.
- 2. Parking lot showing signs of aging and cracking needs to be resurfaced.
- 3. Some sidewalk collapse due to drainage issues.
- 4. No inlet in parking lot.
- 5. Some concrete step / stoop damage due to freeze / thaw.

asphalt that is damaged / deteriorated. Parking has
drainage issues that need to be addressed.

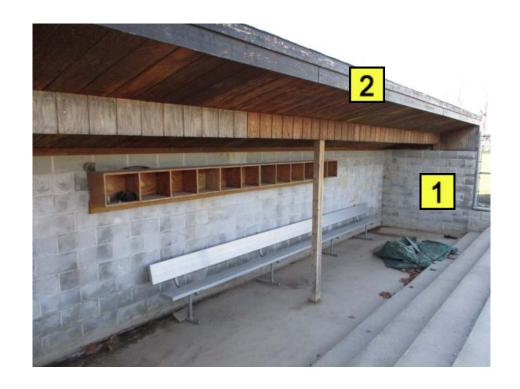
ATHLETIC FIELDS

Athletic Fields Data - Itemized			
Location: Baseball Field			
Category:			
Condition:			
Replacement Cost:	\$80,000 -\$100,000		
General Notes:			
Recommende paint, ma wood and walls to prolo	intain, and clean exposed ong life expectancy.

- 1. Block walls not painted.
- 2. Exposed wood shows signs of aging, paint is peeling off.

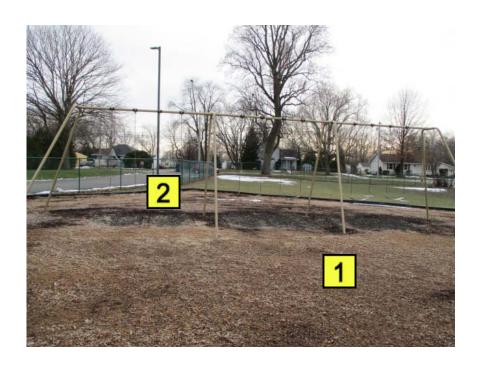
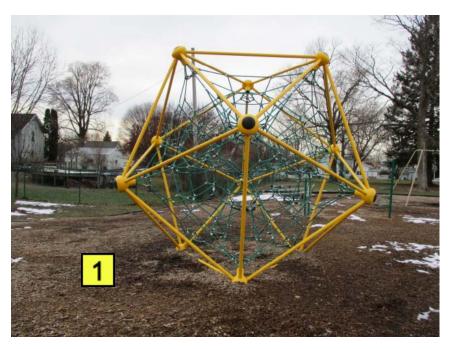
PLAYGROUND

Playground Data (Con.)				
See Key Plan				
Wood chips / Mulch				
Metal / Plastic				
Fair				
\$75,000 - \$125,000				
\$150,000 -\$350,000				
General Notes:

- 1. Playground does not drain well.
- 2. Playground swing area needs rebuilt.
