GENERAL FACILITY ASSESSMENT FOR

2021

Sumter County Schools General Facilities Assessment

York West End Junior High School

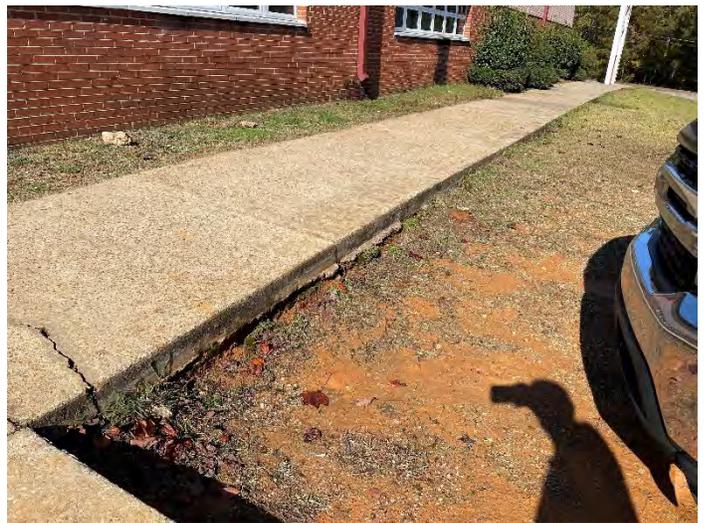
Example of trip Hazard at Exterior Walkway

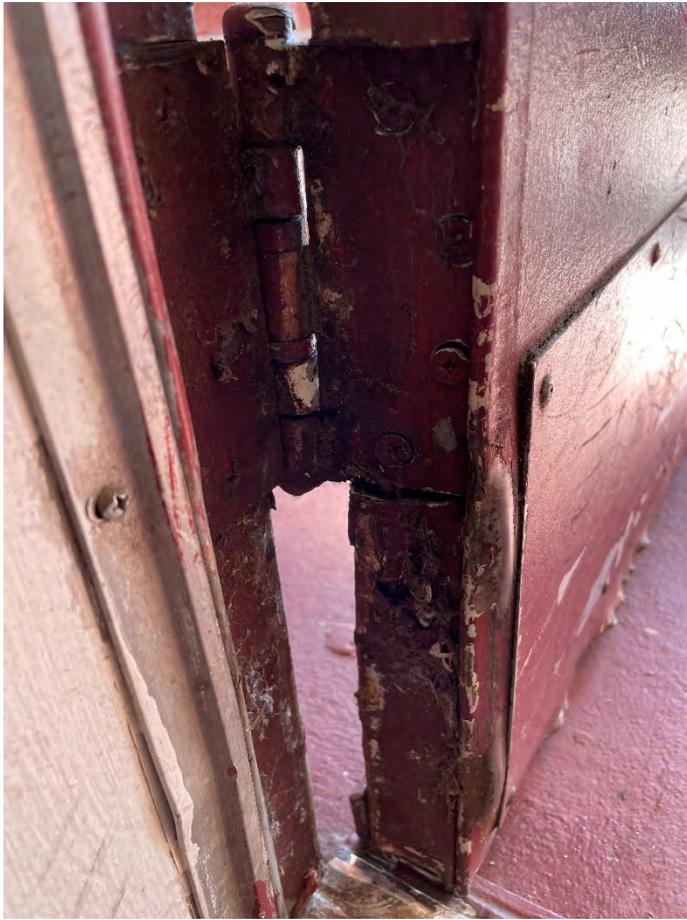
Example of Aging Door Hardware

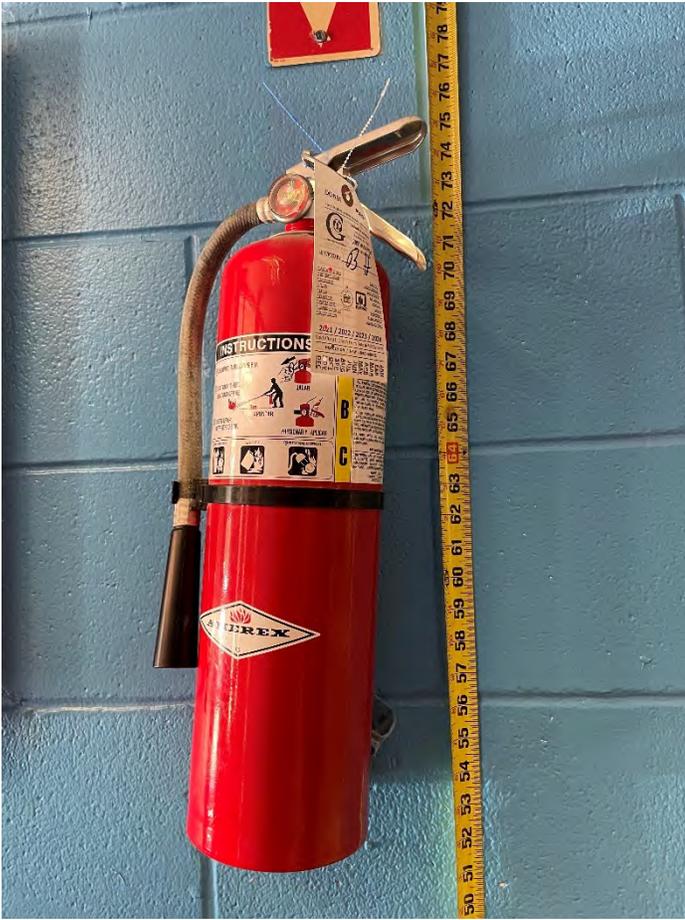
Example of Pull Stations, Light Switches & Fire Extinguishers Above 48"

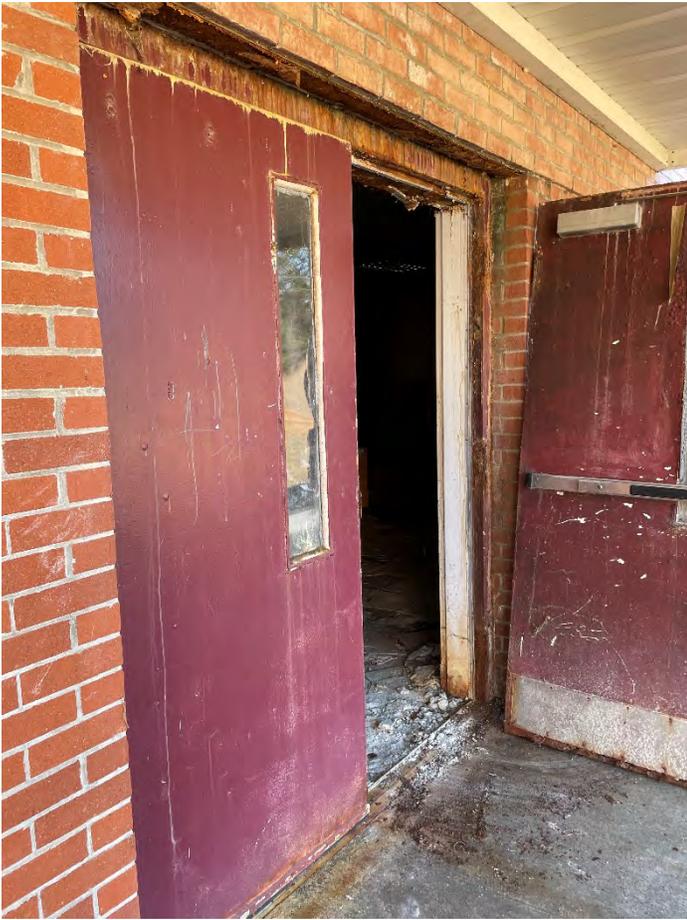
Shop Building Should NOT Be Occupied In Any Capacity

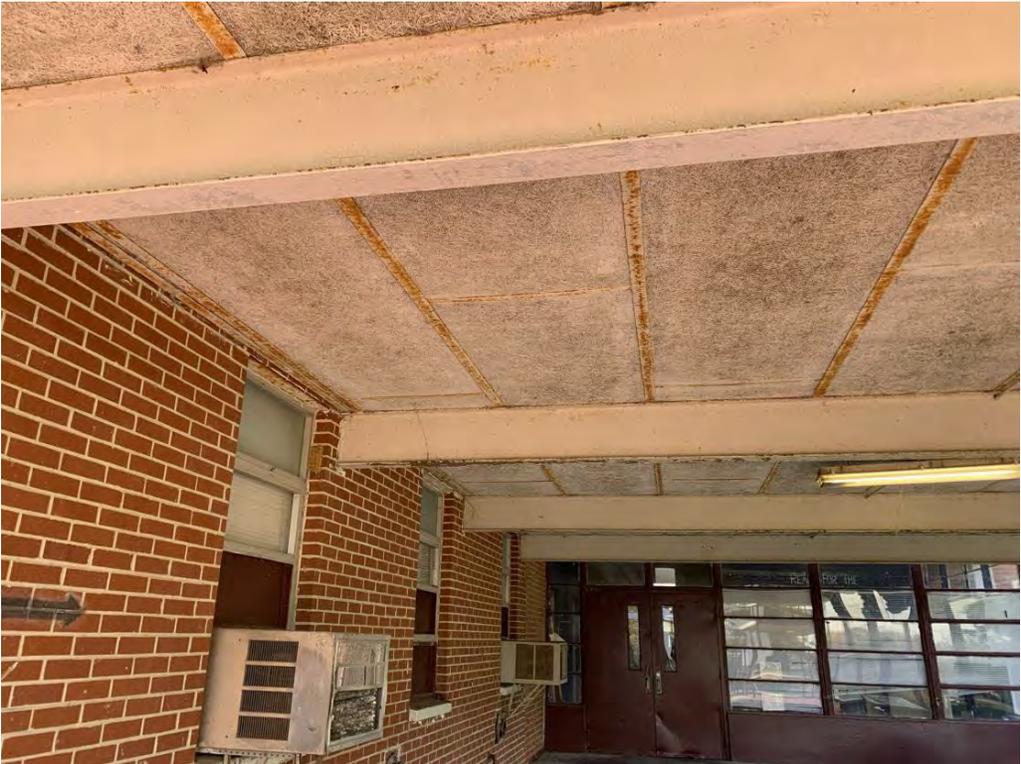
Minor rusting of Exterior Roof Tees and Beams

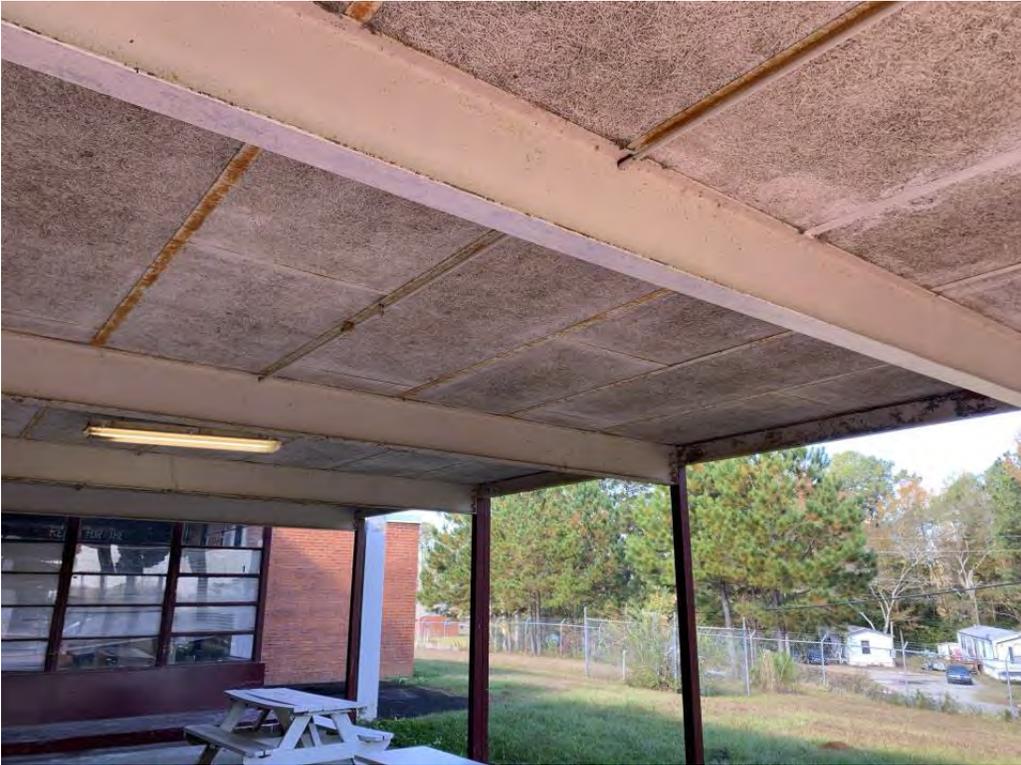
Minor Rusting of Exterior Roof Tees and Beams

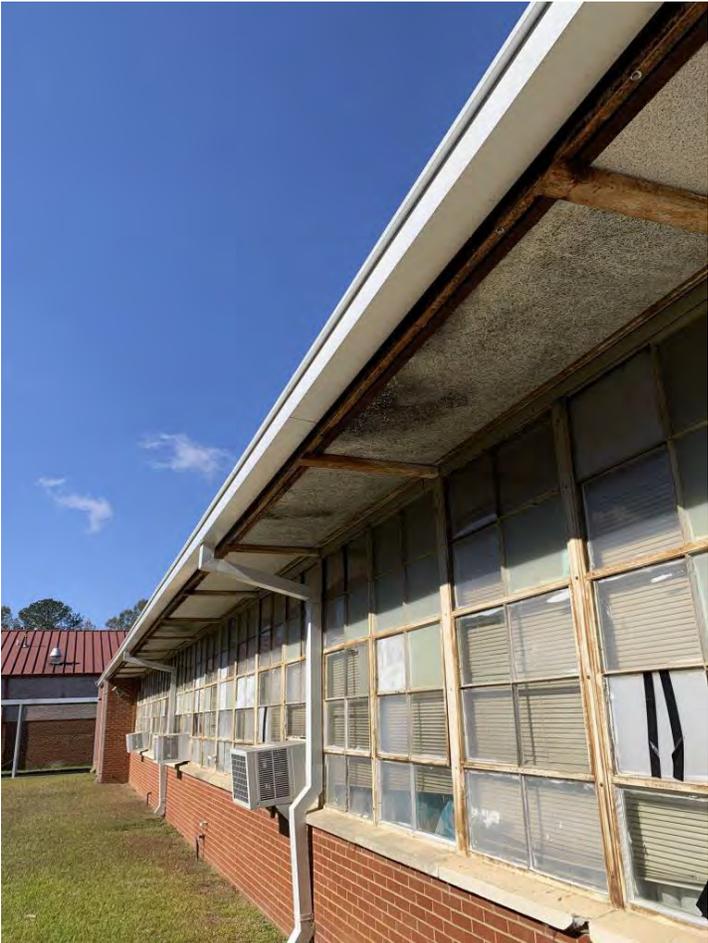
Rusting of exterior Window Jambs, Roof beams and deterioration to Roof decking

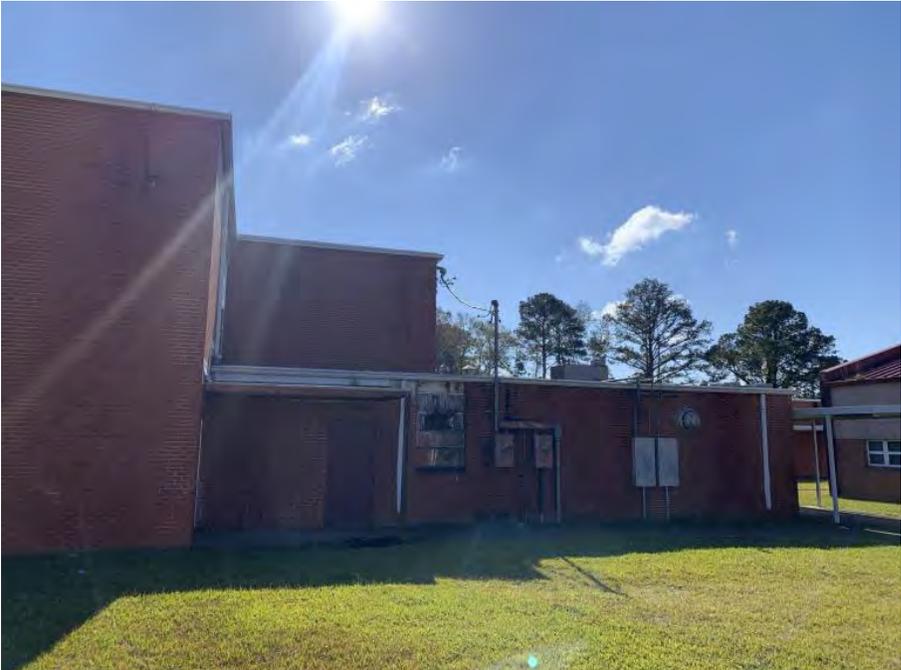
Missing Windows

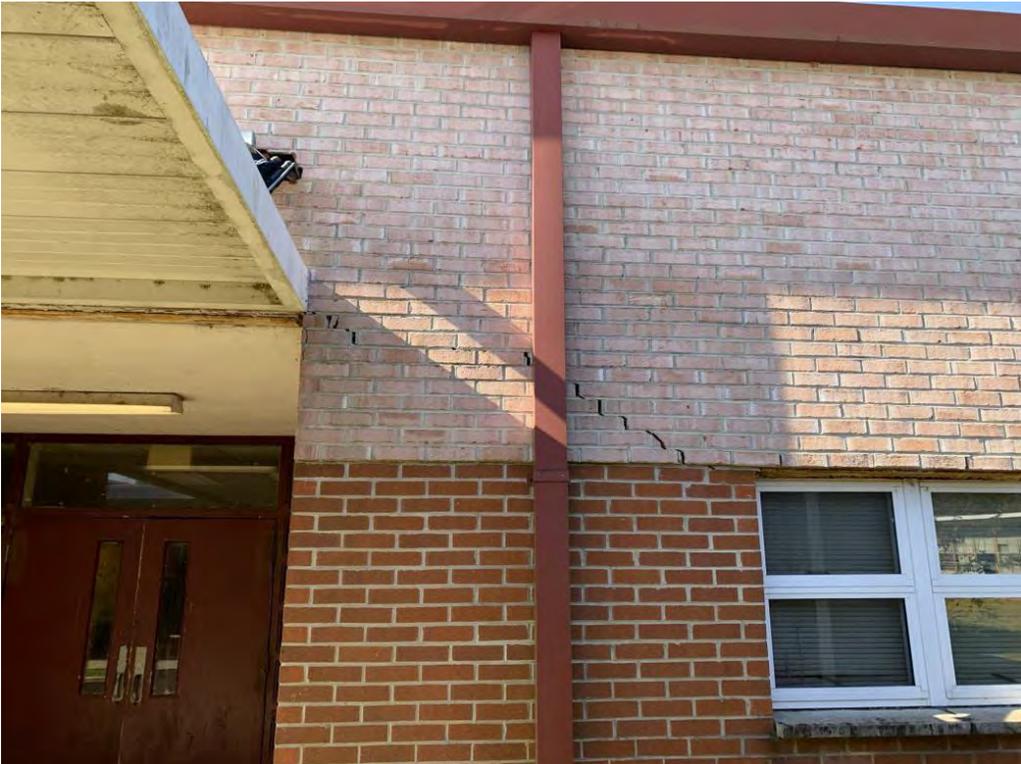
Cracks in Exterior Brick Façade

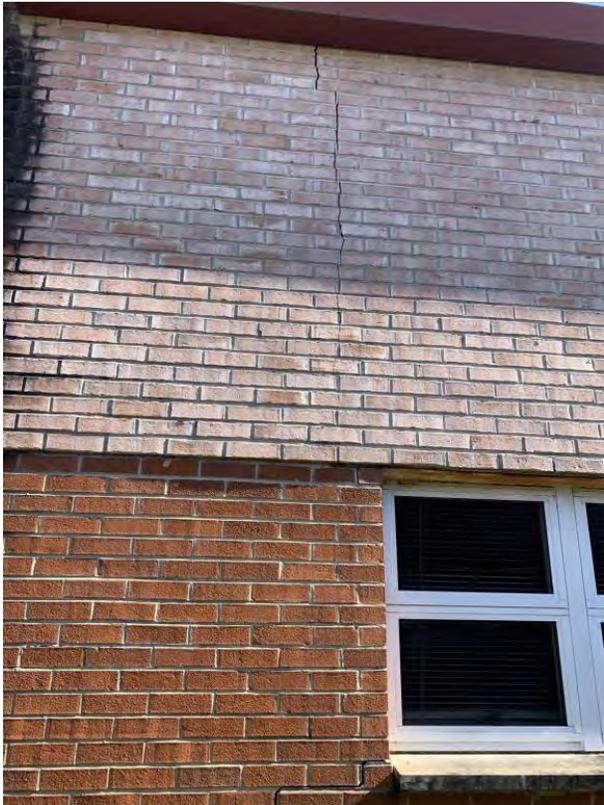
Cracks in Exterior Brick Façade

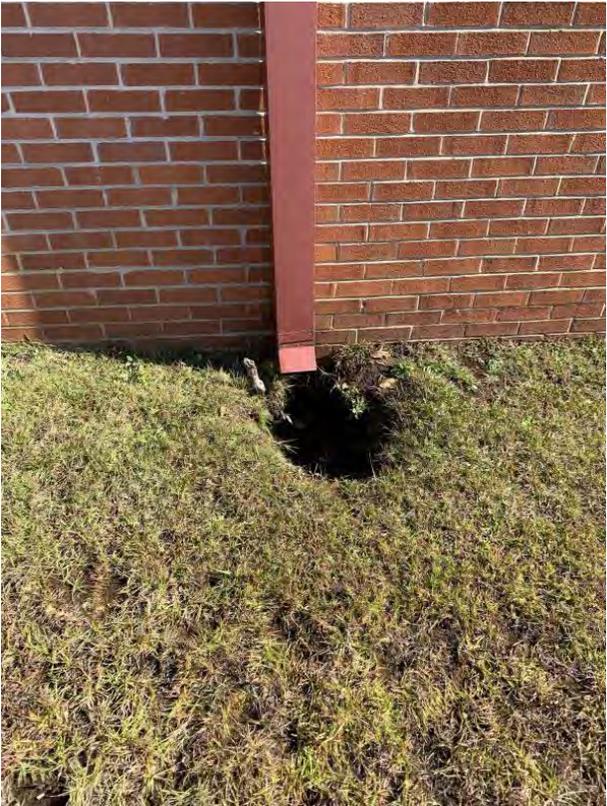
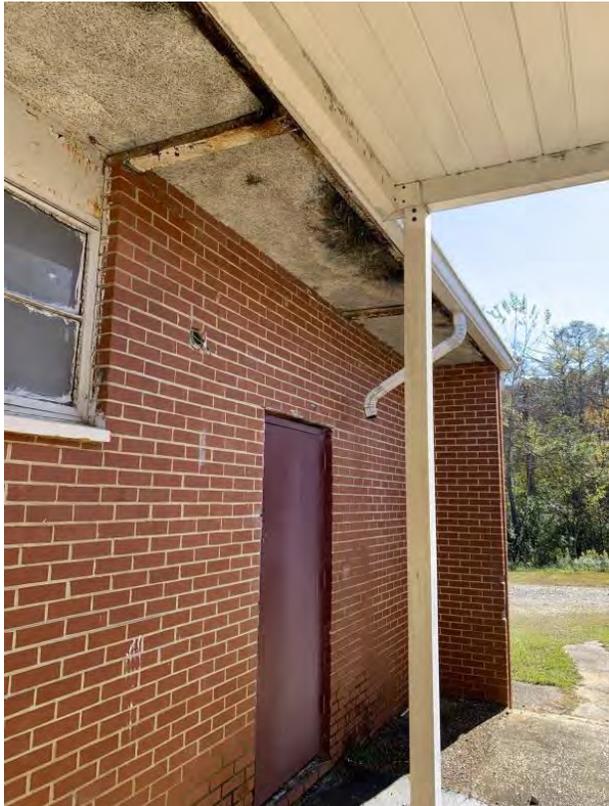
Missing or Damaged Gutters and Splash Guards

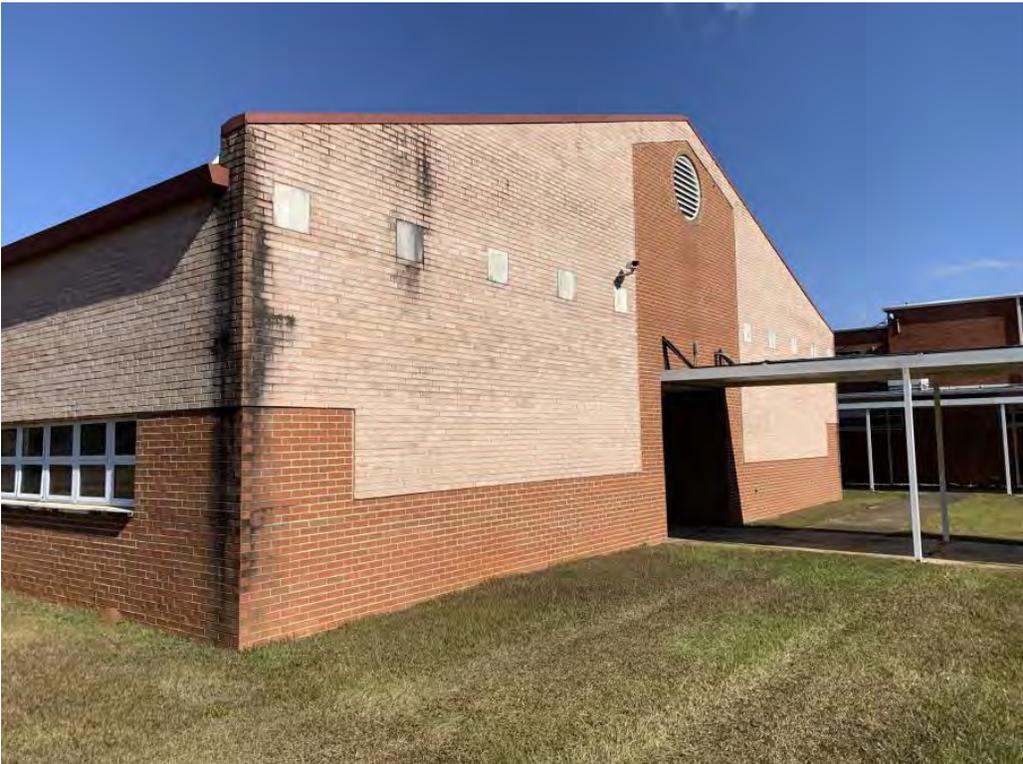
Missing or Damaged Gutters and Splash Guards

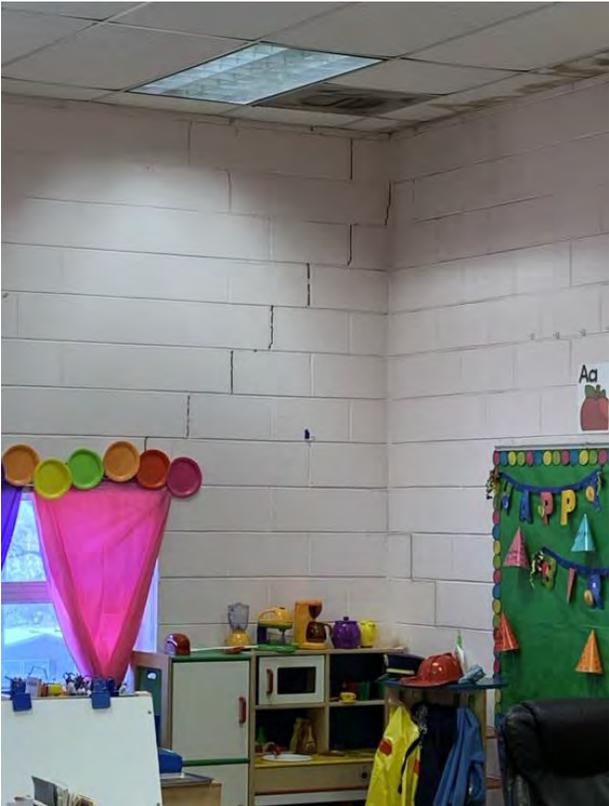
Minor Cracking of CMU Walls and Roof Leaks

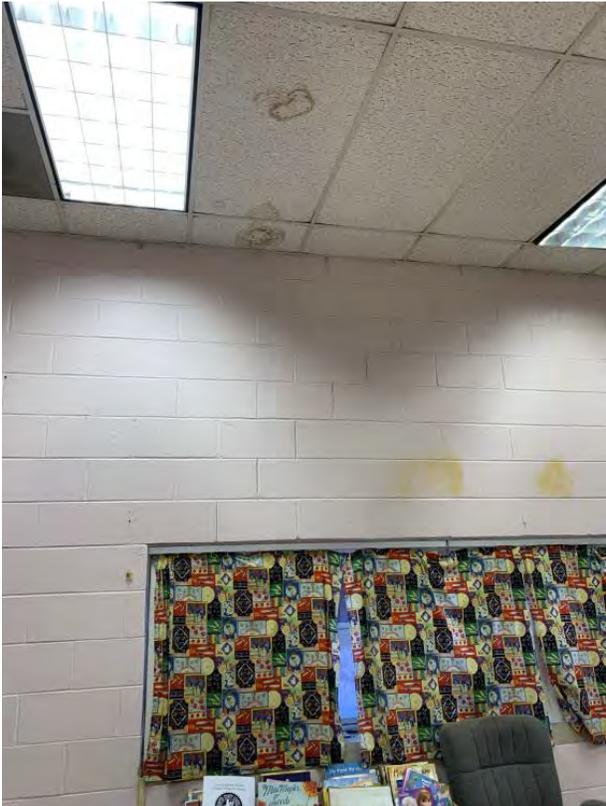
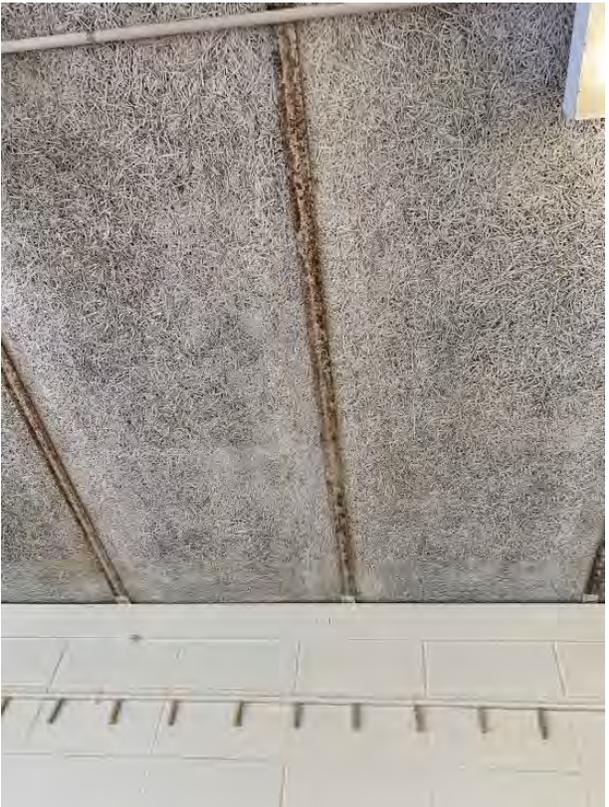
Rusting of Blub Tees at Roof decking

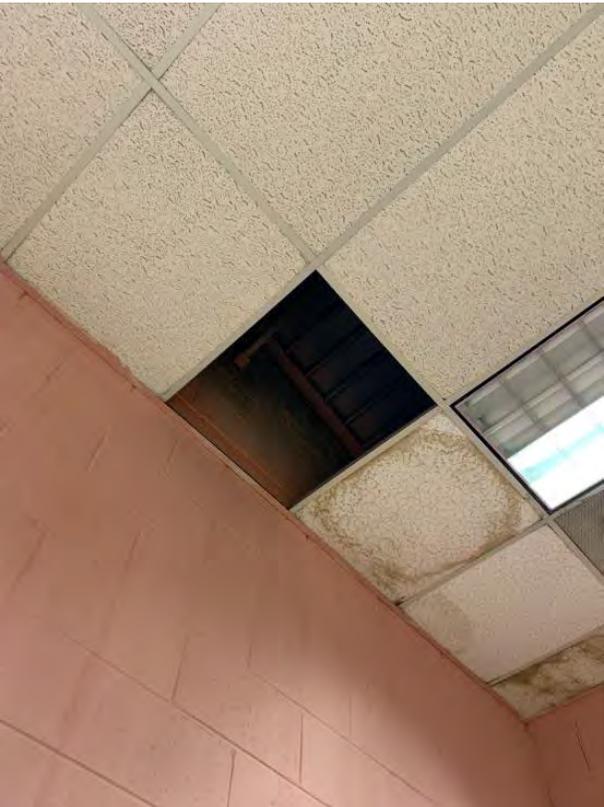
Water intrusion at Gable end walls

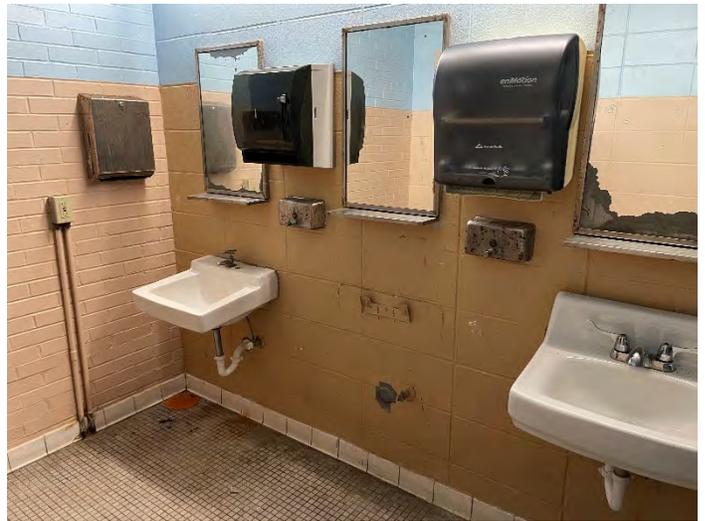
Sinks Do Not Meet ADA – Rusted Accessories & Dispensers Above 48”

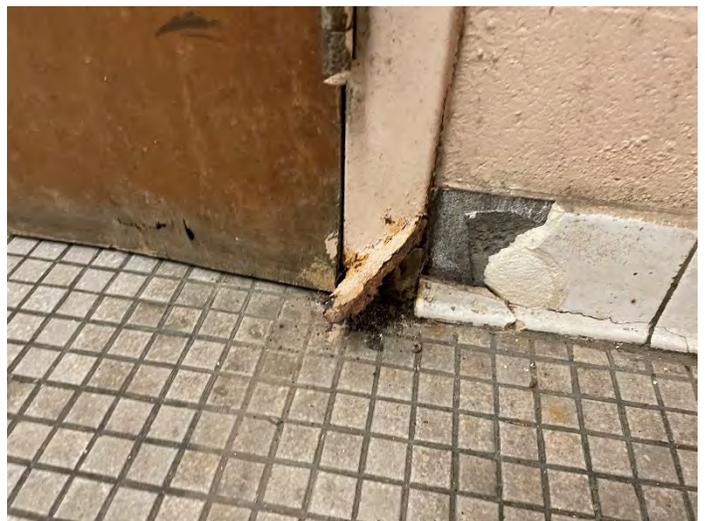
Example of Metal Door Frames Rusting On Bottom

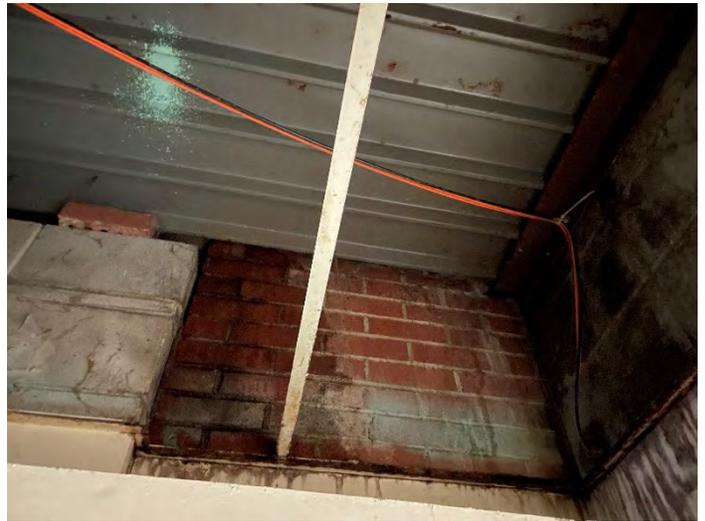
Multiple Roof Leaks Reported

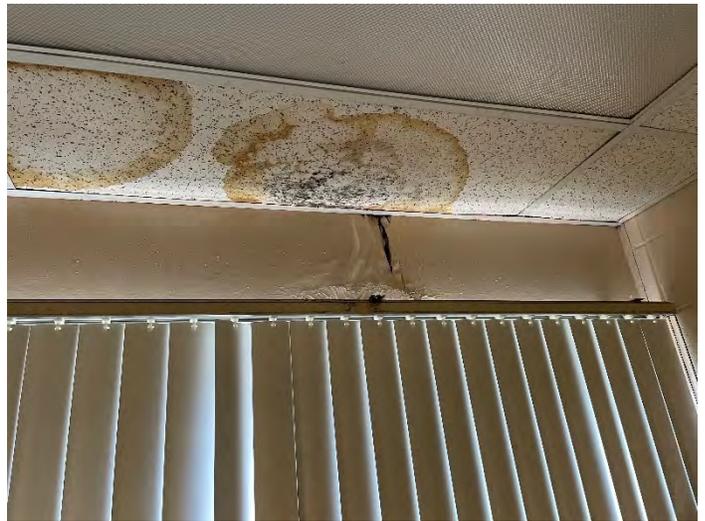
Multiple Roof Leaks Reported

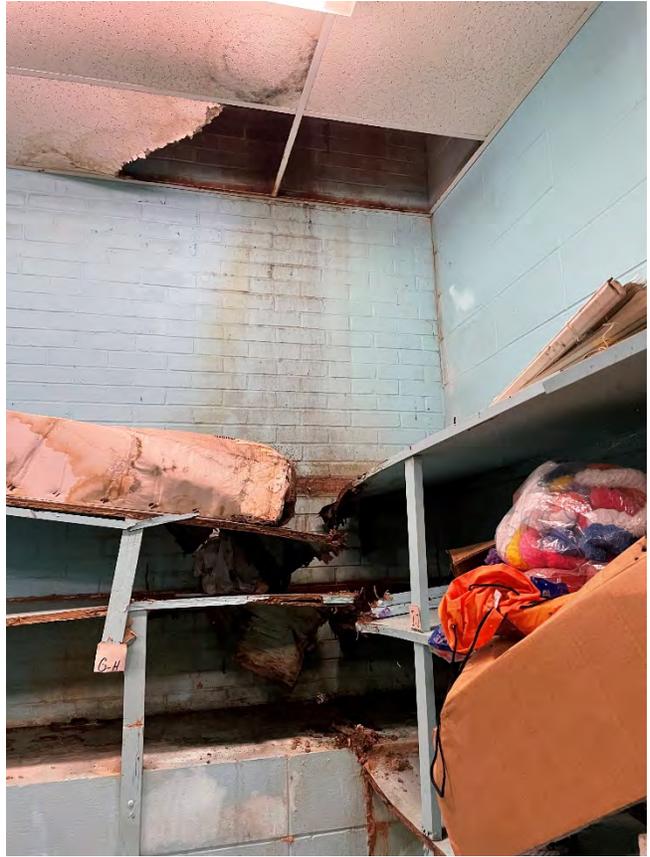
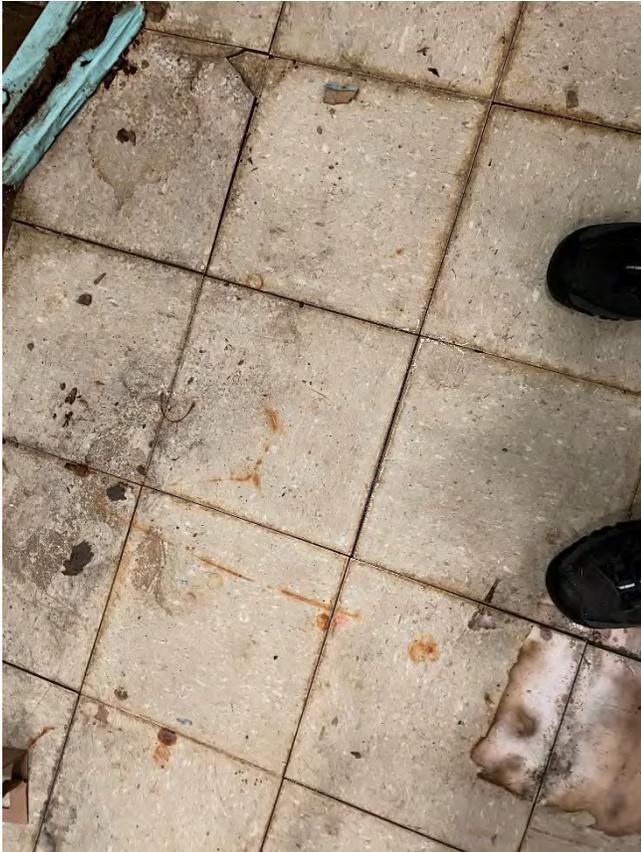
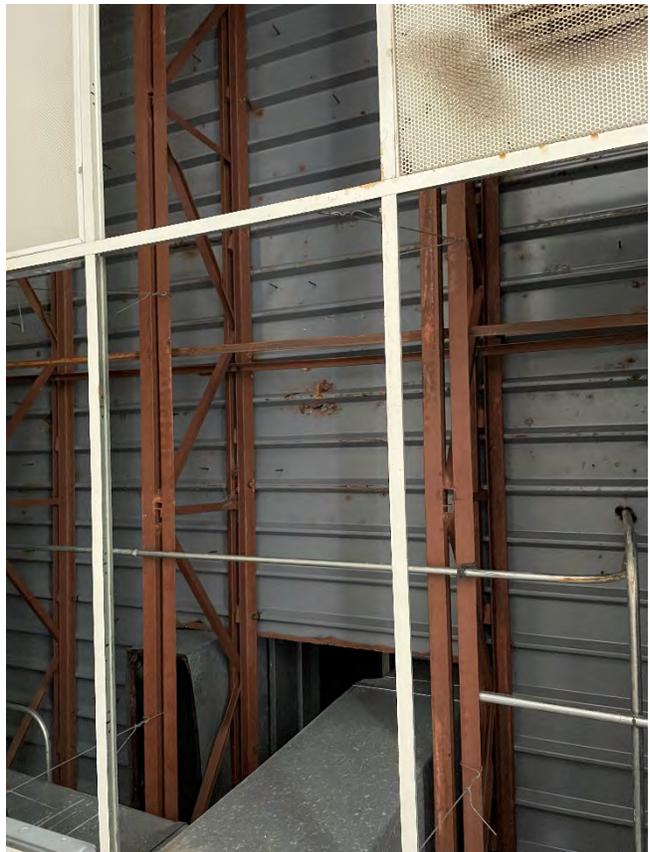
Water Damage From Extreme Roof leak In Band Room – Mold Is Evident – SAFETY HAZARD

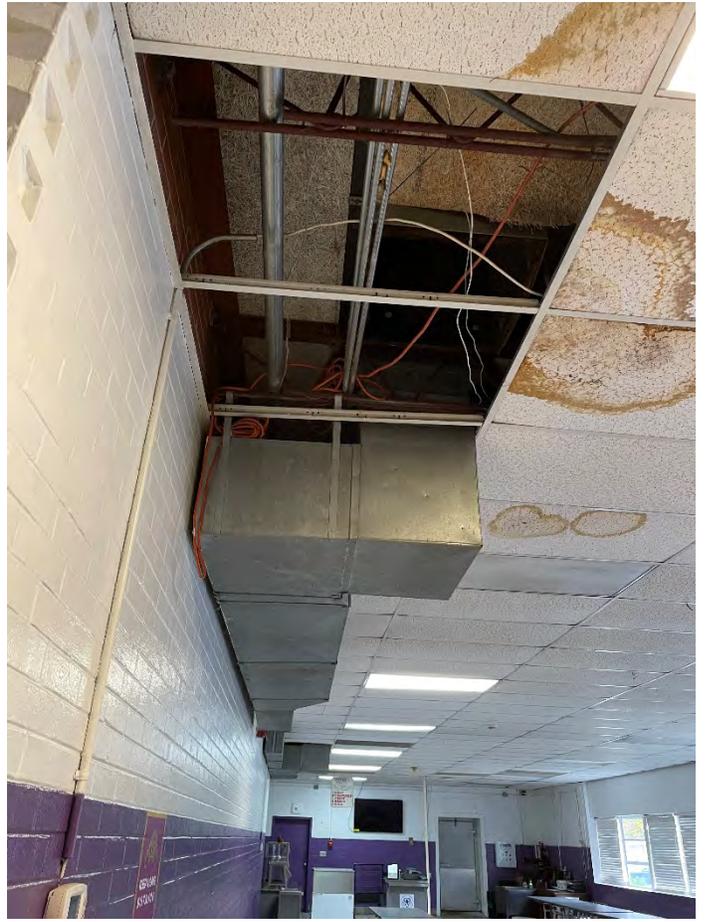
Cafeteria Roof Leak

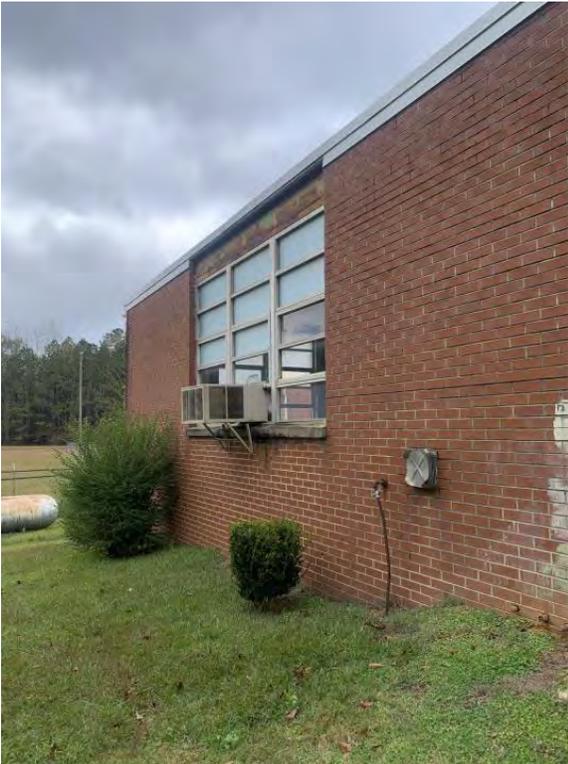
Missing Exterior Façade Over Window

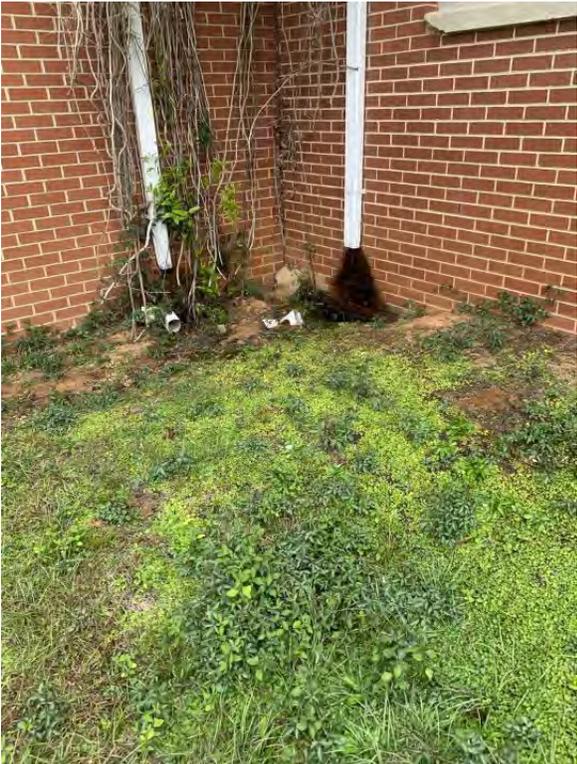
Gutters and Splash Guards Missing

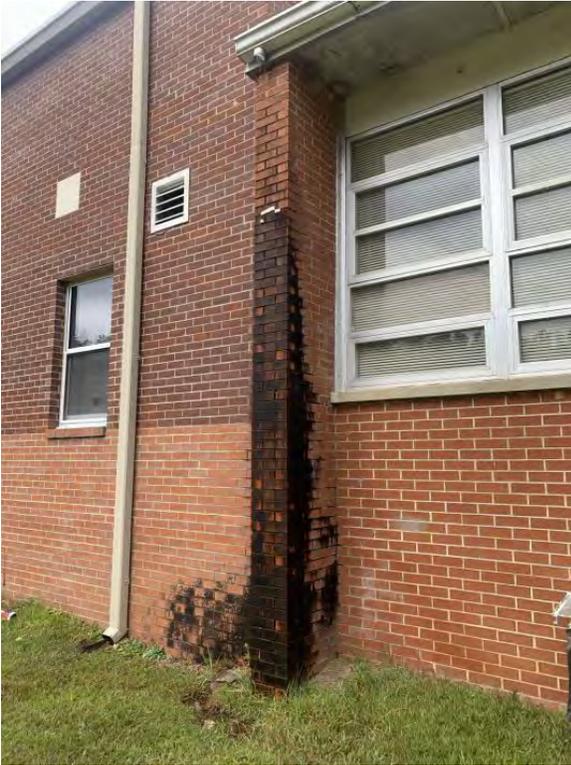
Gutters and Splash Guards Missing

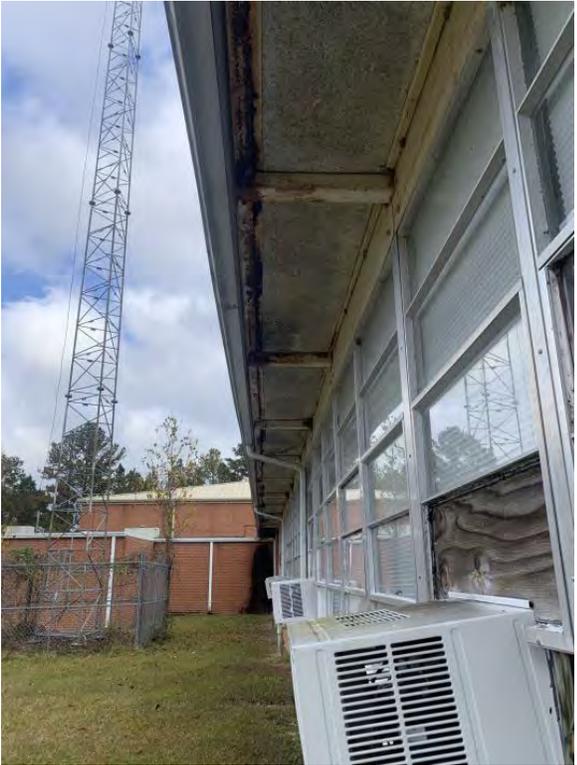
Deterioration of Exterior Eave Steel

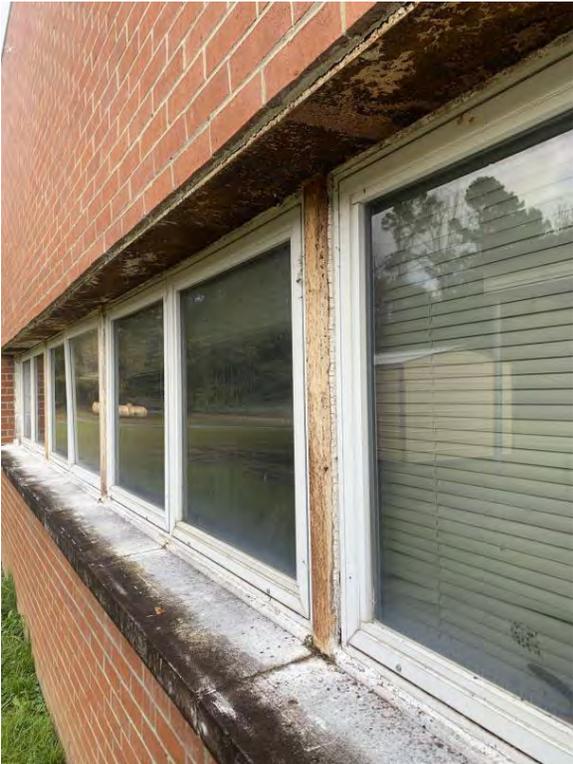
Deterioration of Steel At Exterior Window

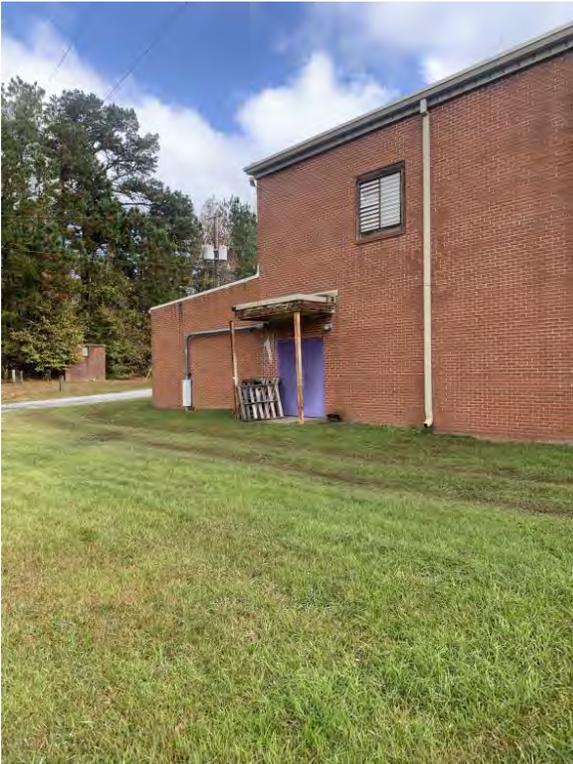
Deterioration of Steel At Exterior Canopy

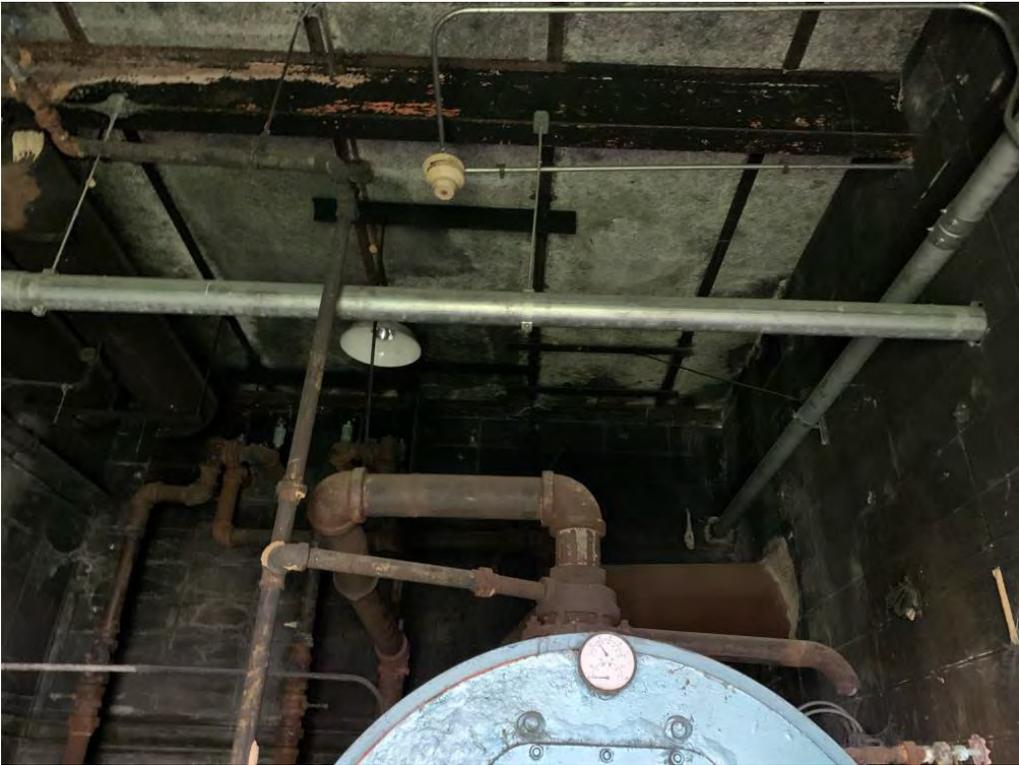
Deteriorated roof steel over mechanical room

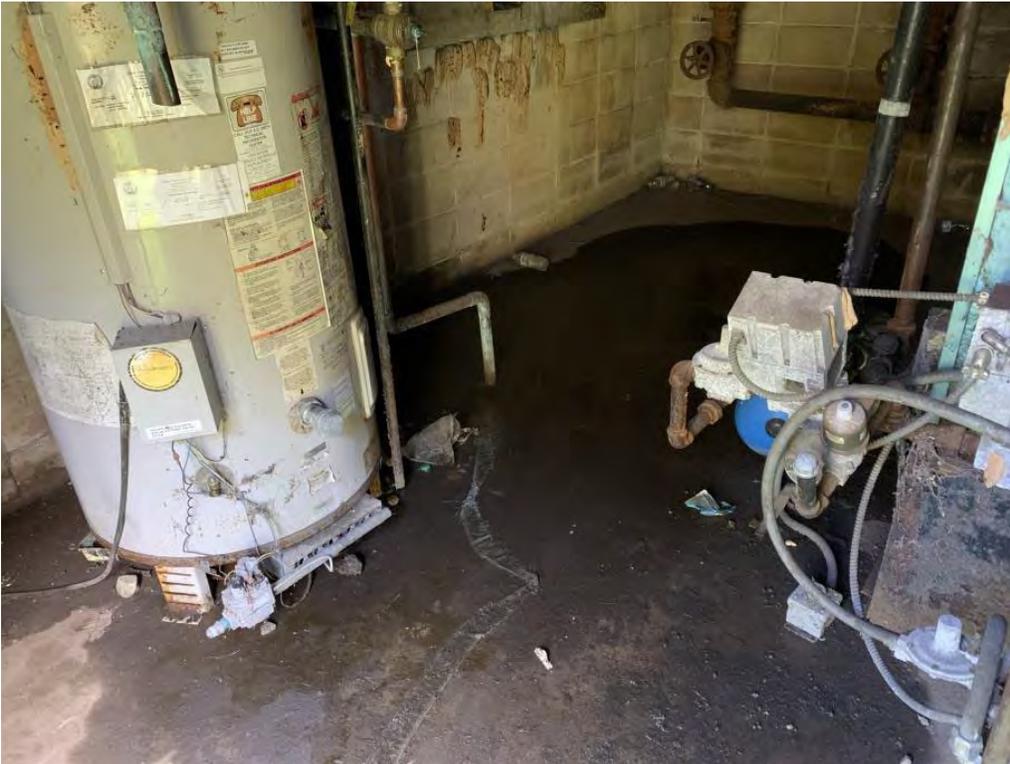
Water Ponding in Mechanical Room

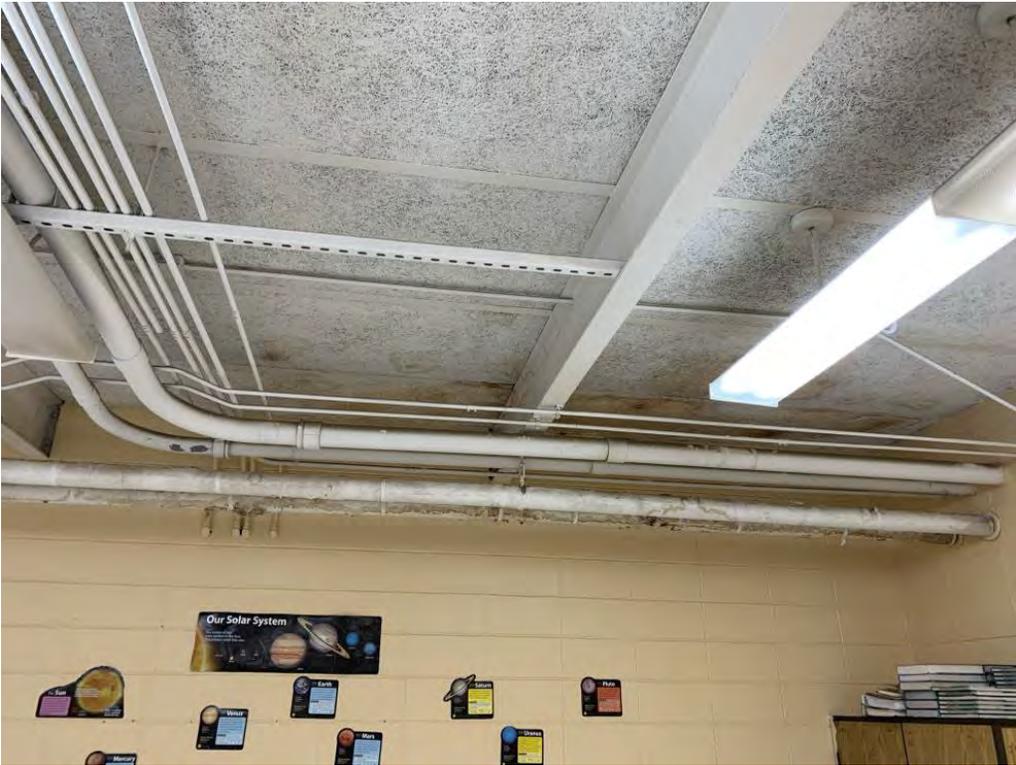
Water Staining of Teckum Roof Decking

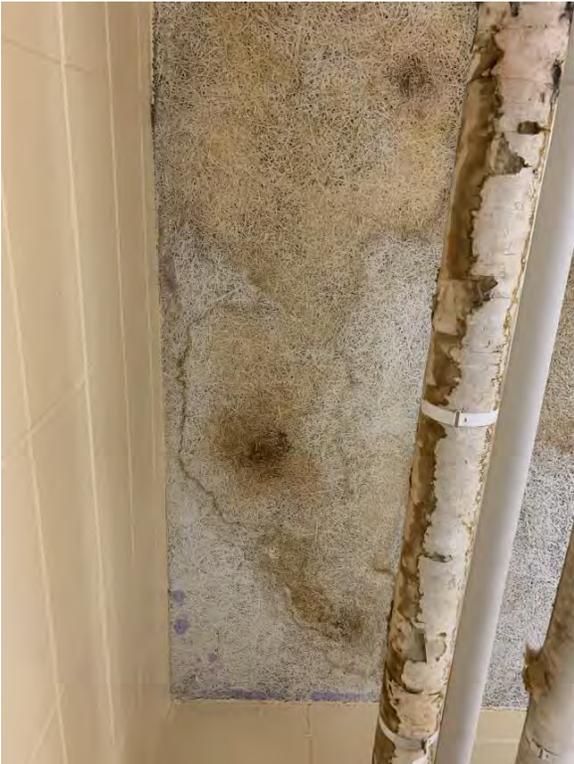
Water Staining of Tecktum Roof Decking

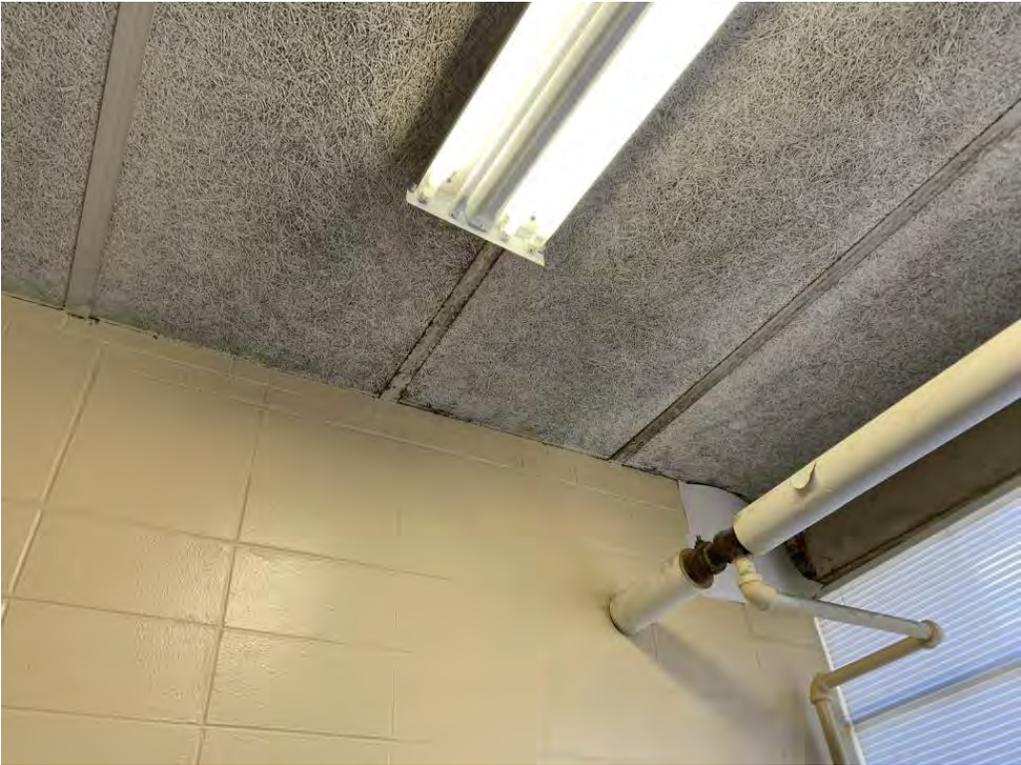
Rusting of Bulb Tees At Roof

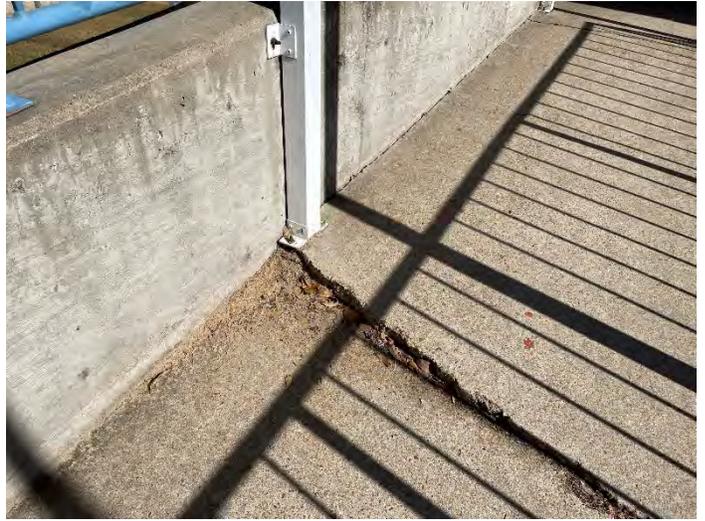
Concrete Failure at Canopy Support – Trip Hazard

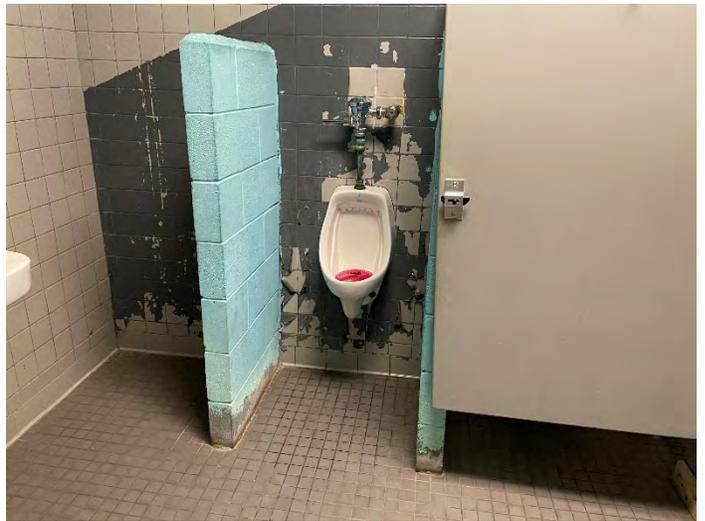
Paint Peeling In Bathroom

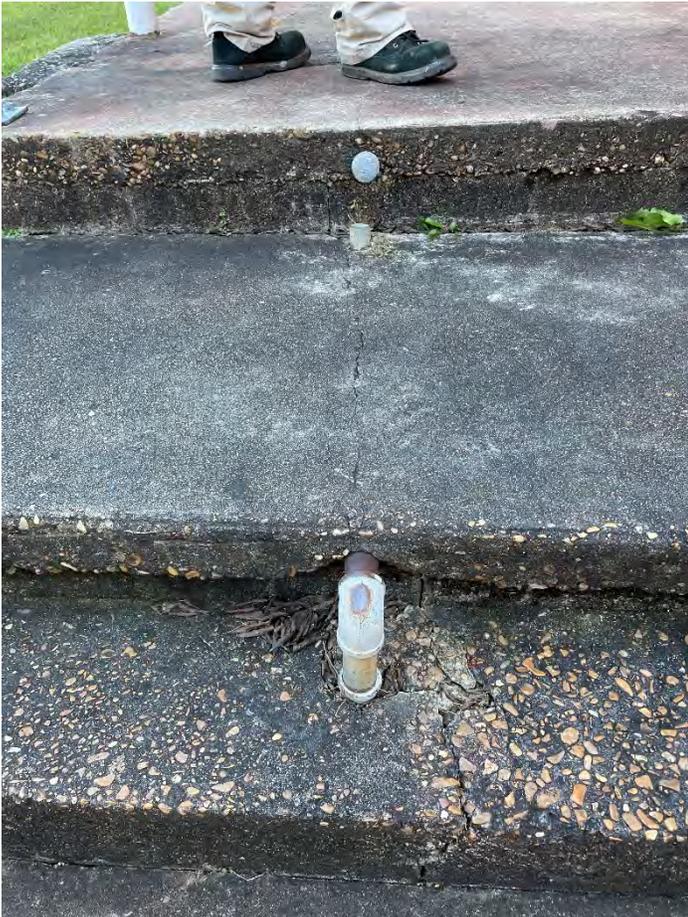
Steps On Grade Are Tripping Hazard & Not ADA

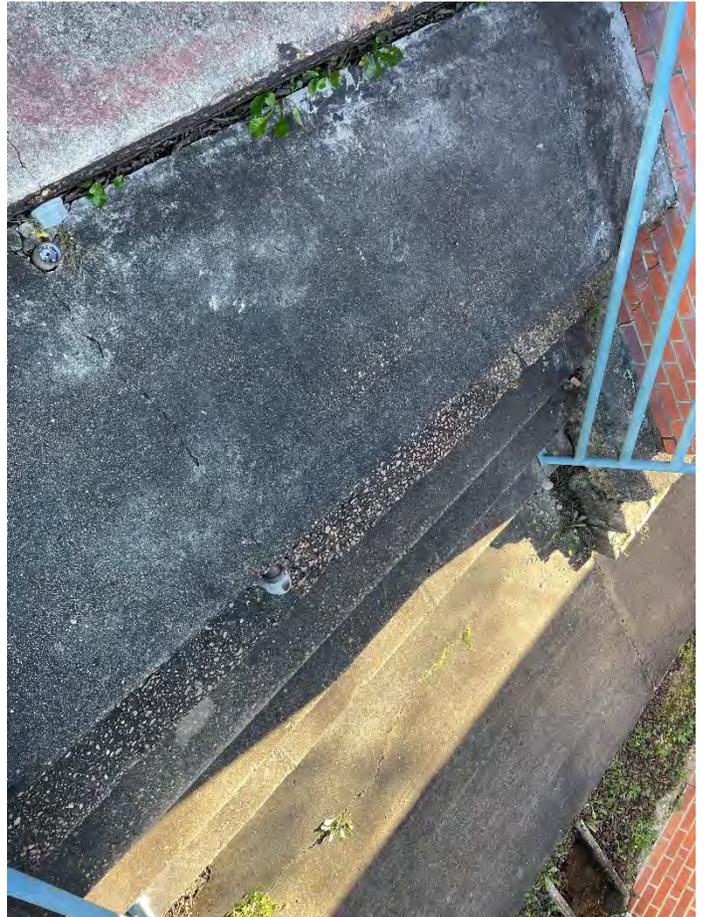
Steps Do Not Meet ADA

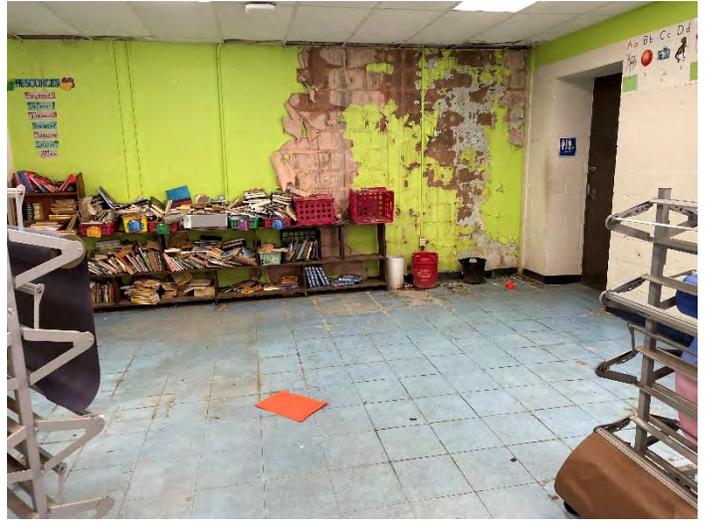
Roof Leak Causing Water Damage & Mold

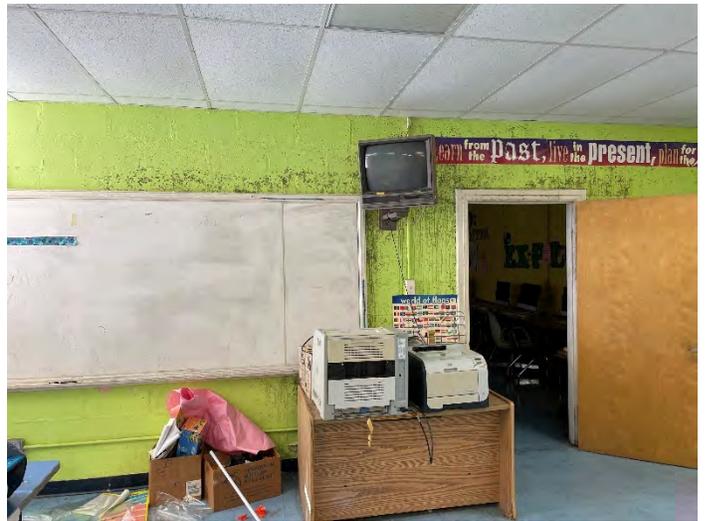
Mold Appears to Be Growing On This Wall
