GENERAL FACILITY ASSESSMENT FOR

2021

Sumter County Schools General Facilities Assessment

York West End Junior High School

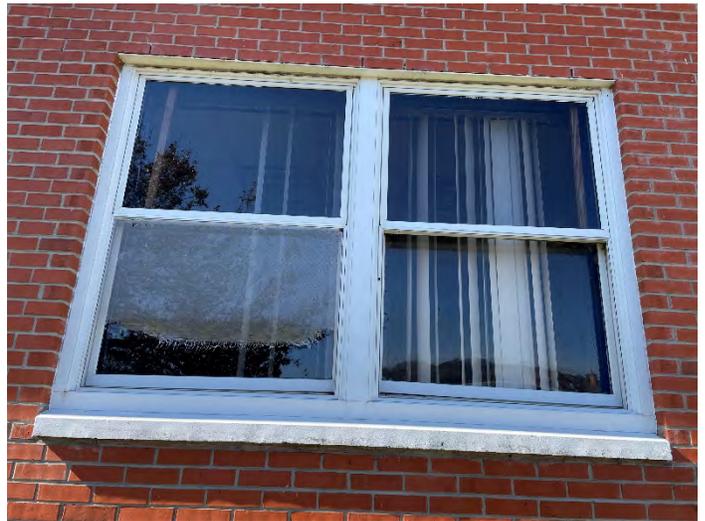
Broken Glass at Front Elevation

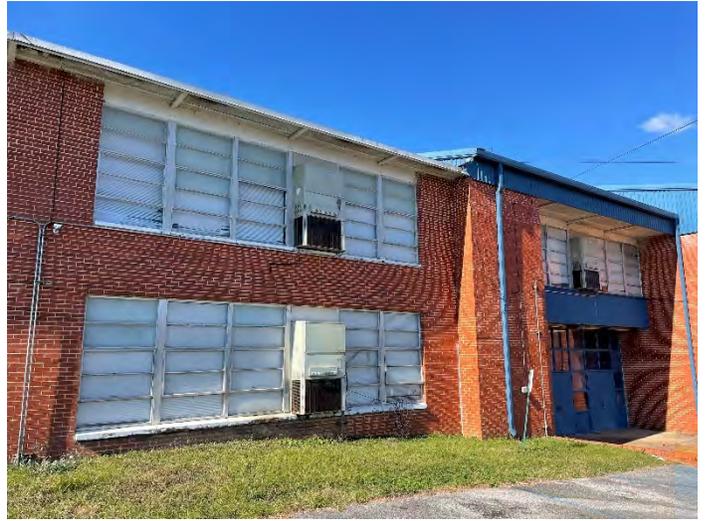
Example Of Older Window Assemblies

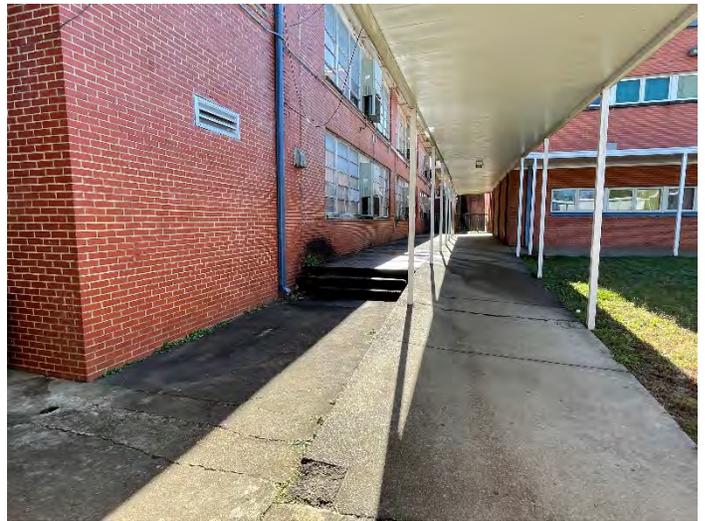
Walkway & Steps Do Not Meet ADA

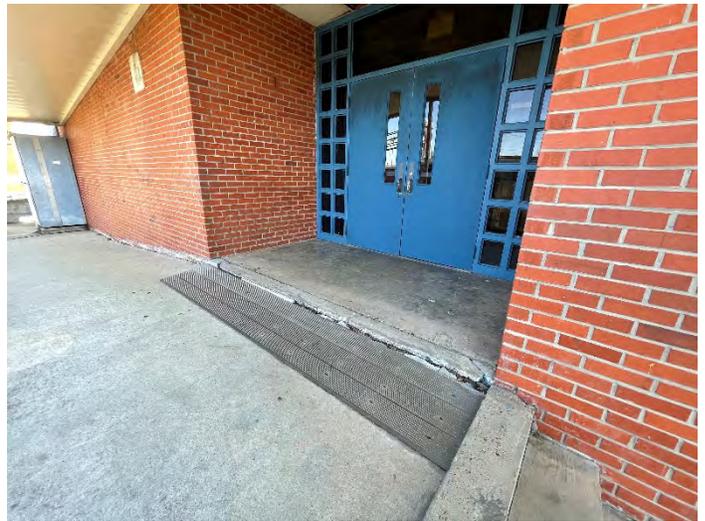
Example of Trip Hazard at ADA Egress Door

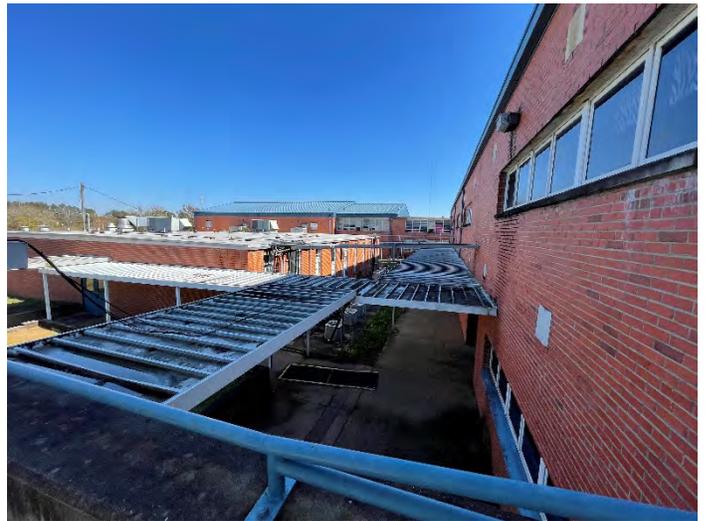
Canopies May Be Holding Water On Top

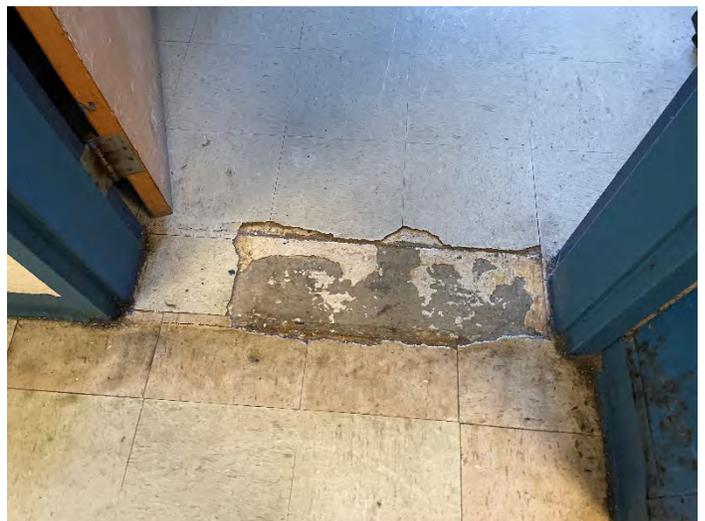
Example of Deteriorated / Damaged Floor at Doorway Causing Trip Hazard

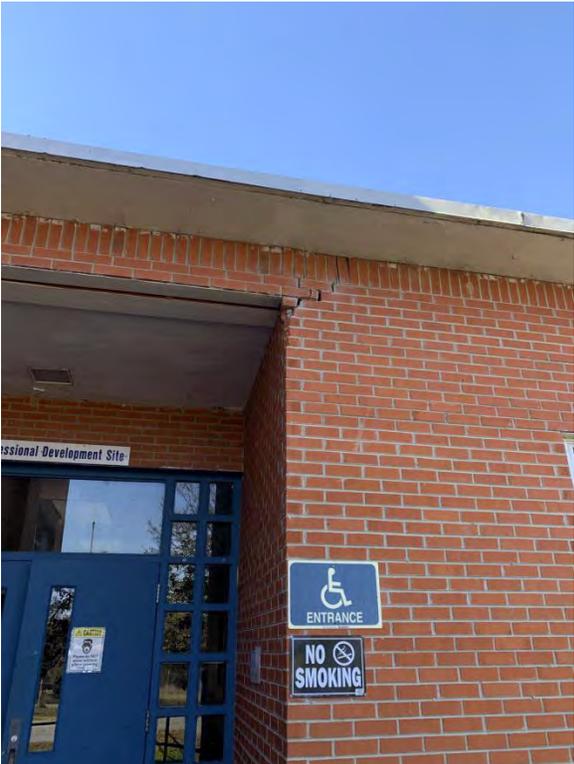
Cracking of Brick Façade at Front Entry

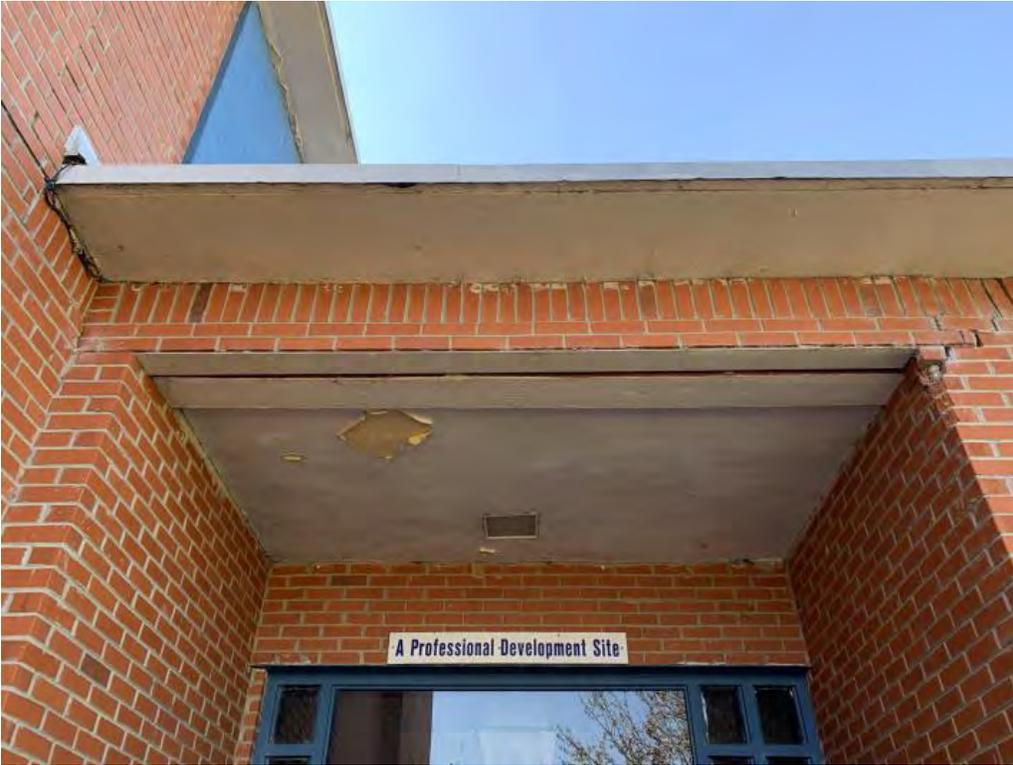
Cracking of Brick Façade at Front Entry

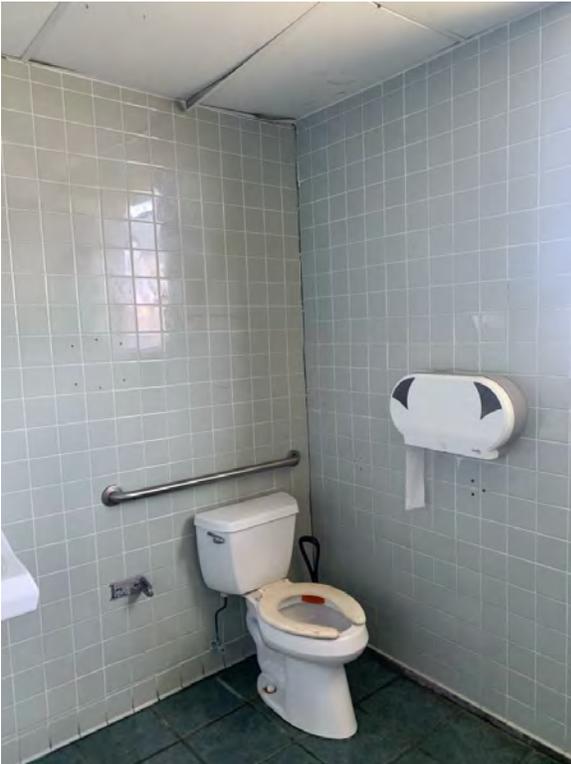
Settlement of Floor Slab in Main Hall Bathroom

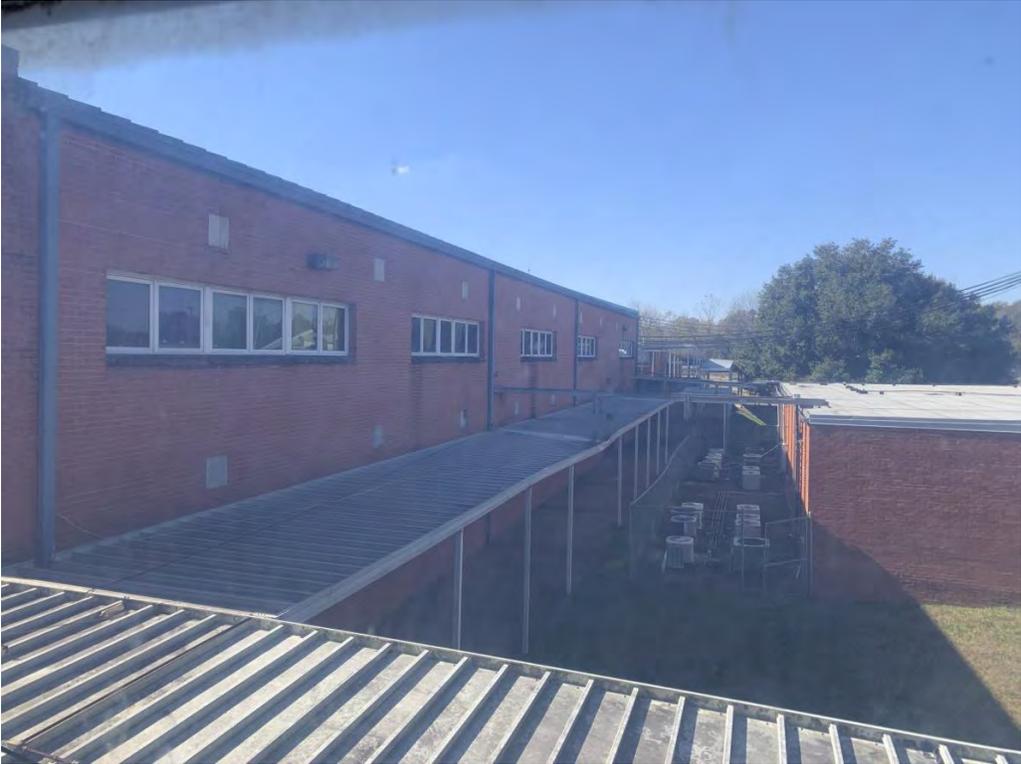
Damage to Exterior Canopy

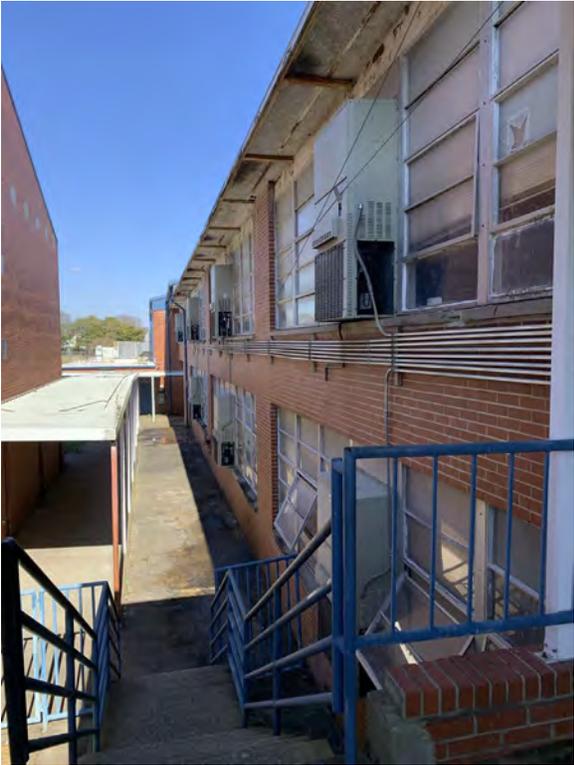
Deterioration of Steel and Tecktum Decking At High Roof Eave

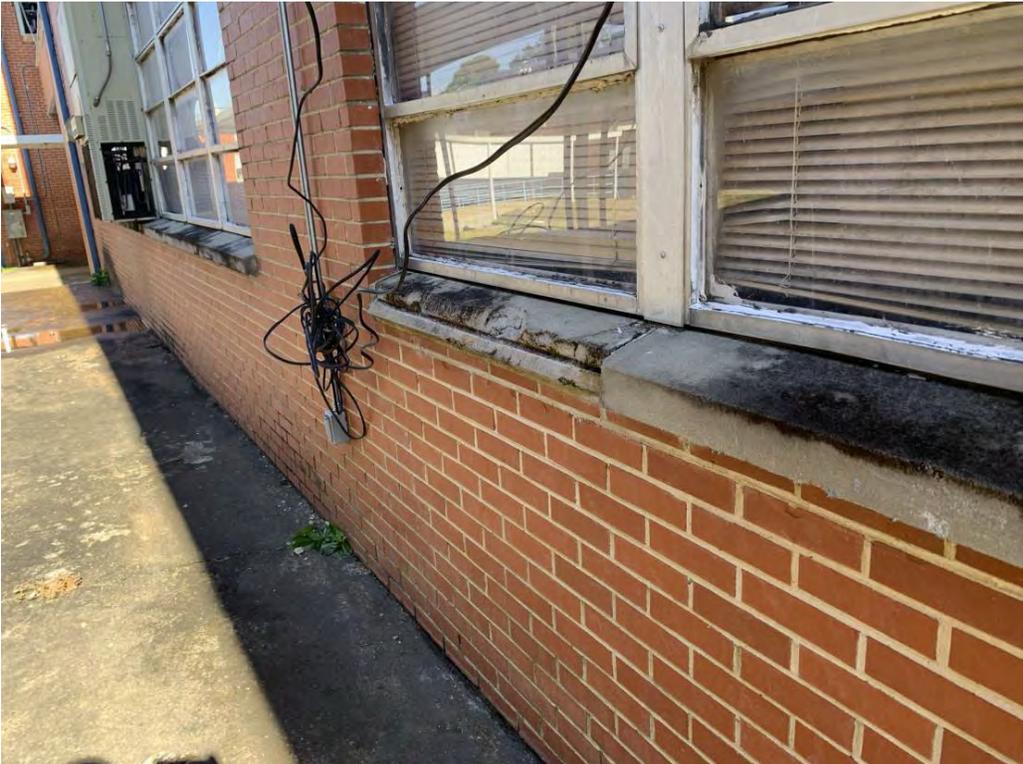
Deterioration of Precast Window Sills

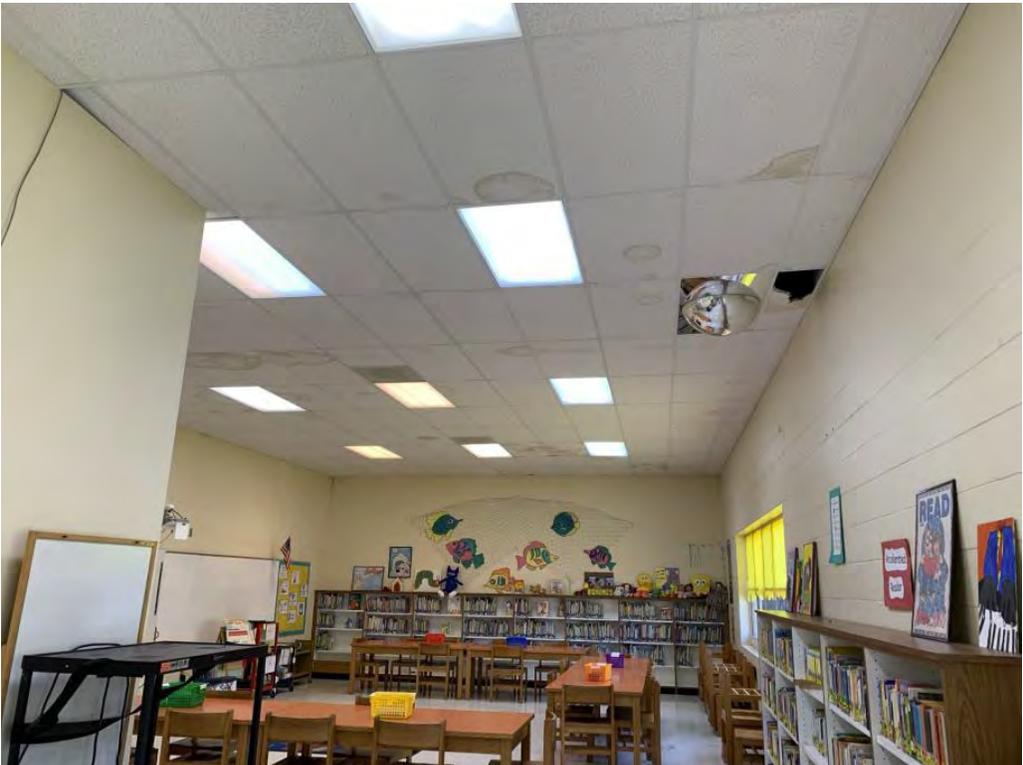
Possible Roof Leaks Over Media Center

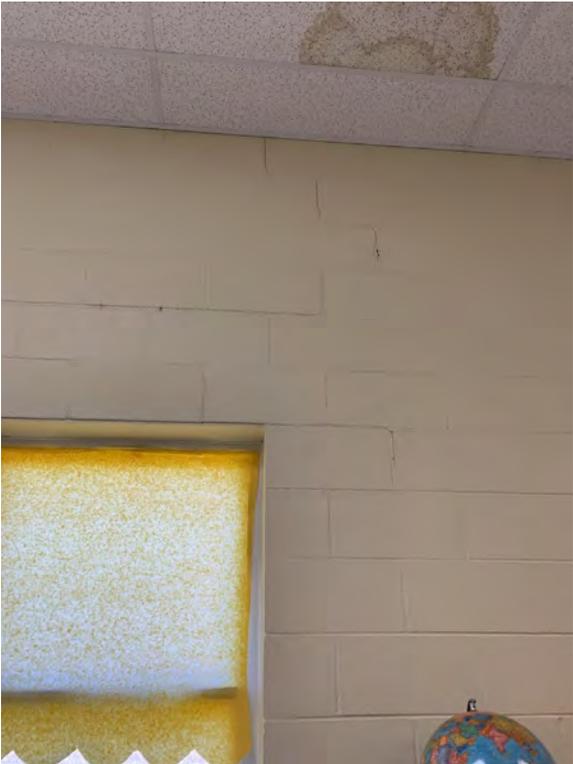
Minor Cracking in CMU Walls

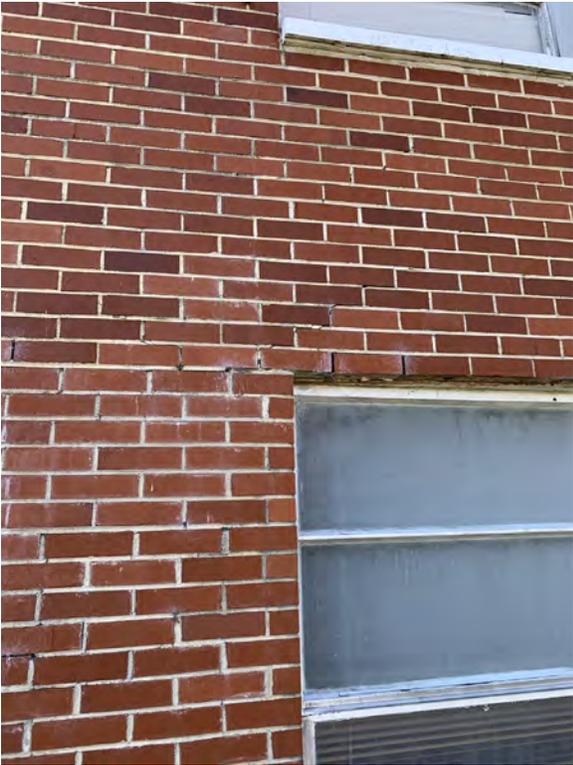
Minor Cracking in Exterior Brick Facade
