Progress Report

Client: Wendell School District

Facility: Wendell High School

Title
Wendell High School Final Report

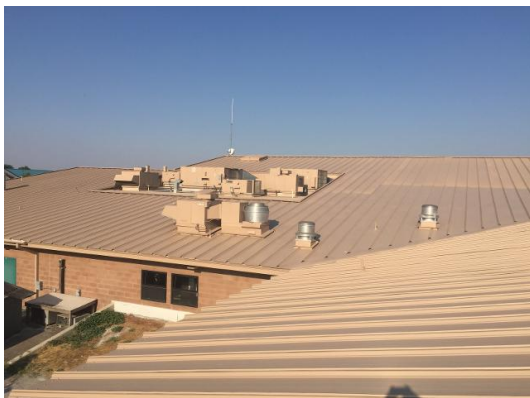
Photo 1

Field photo of the suede coating completely installed- North section of the metal roof

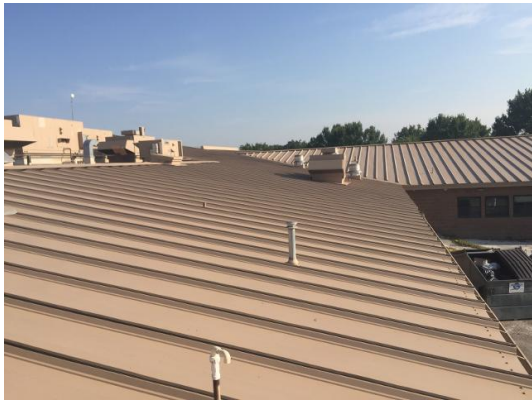
Photo 2

Continued- alternate angle

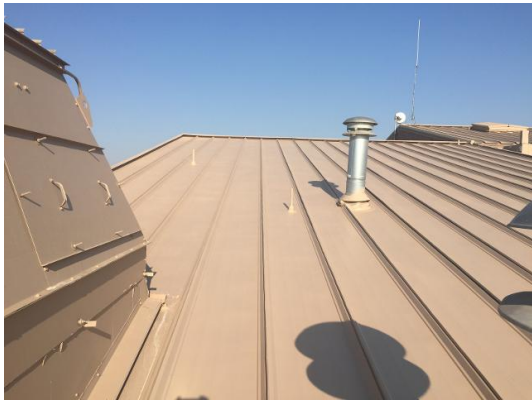
Photo 3

Continued- North section of metal roof

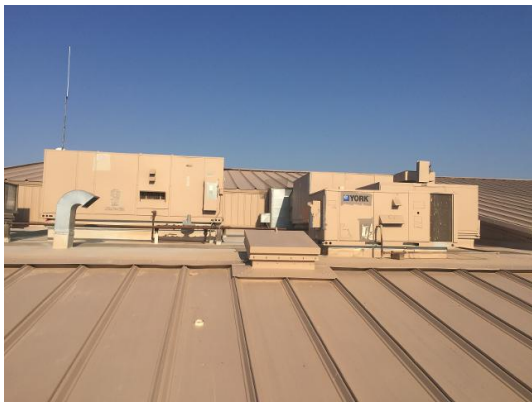
Photo 4

Continued- rooftop units coated

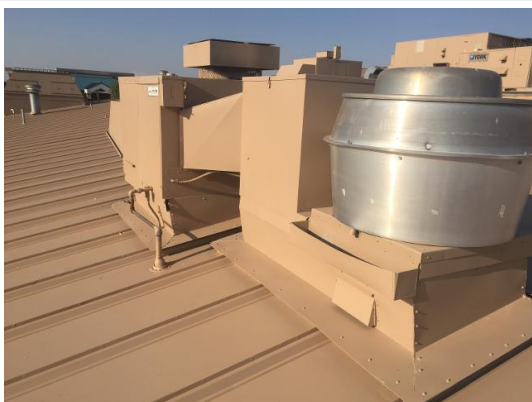
Photo 5

Continued

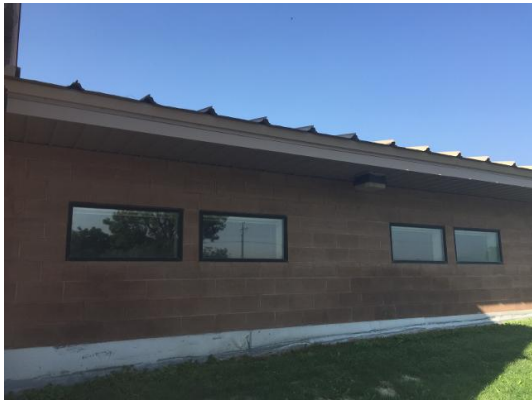
Photo 6

Installed coating to the fascia and soffit

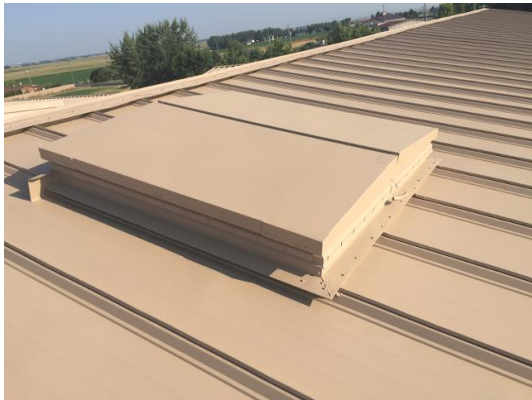
Photo 7

Roof smoke hatch coated

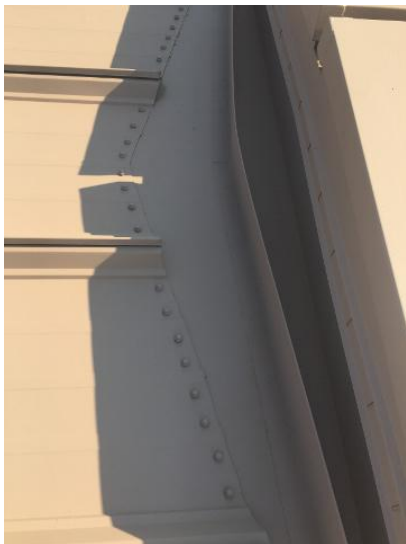
Photo 8

Metal roof saddle detail

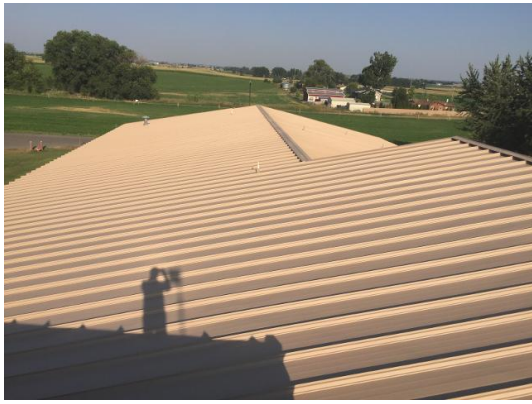
Photo 9

Continued- East section of the metal roof

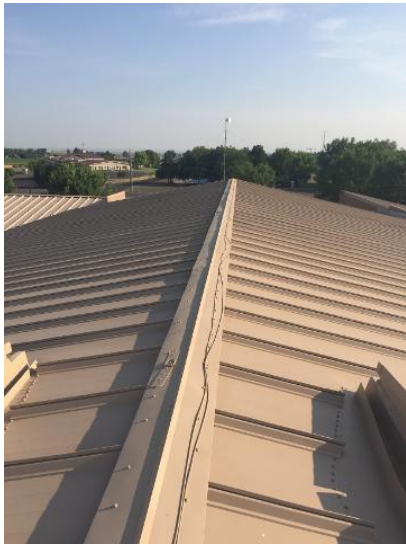
Photo 10

Photo of the roof ridge

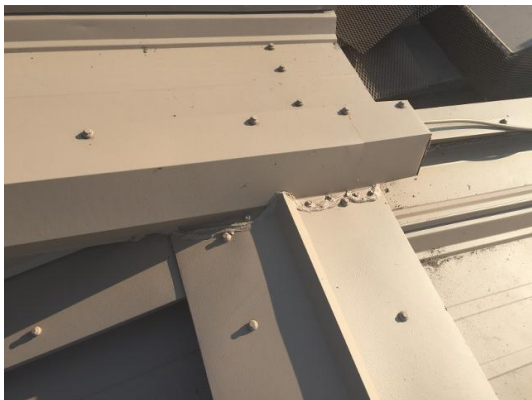
Photo 11

Up close view of the coping ridge detail

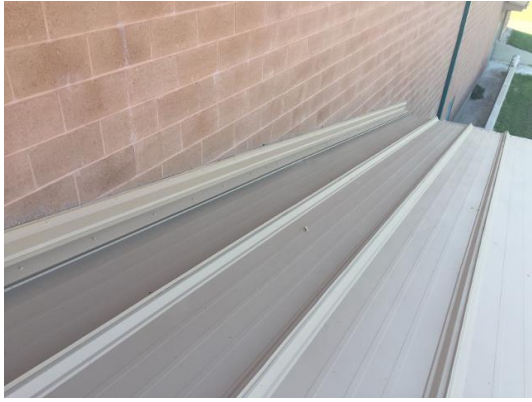
Photo 12

Metal roof flashing detail along the wall coated

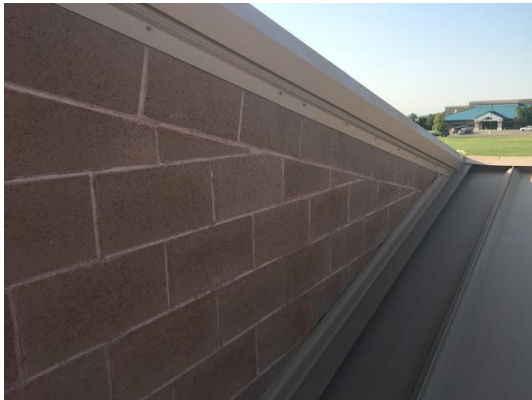
Photo 13

Photo of the fascia coated in suede

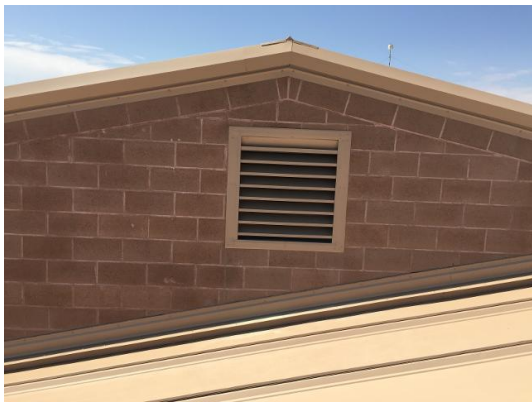
Photo 14

Continued- coating installed on vent

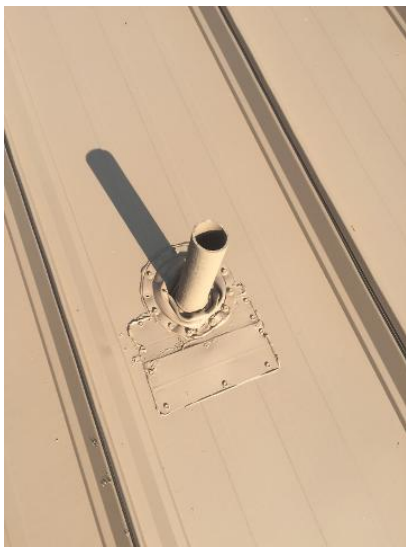
Photo 16

Continued

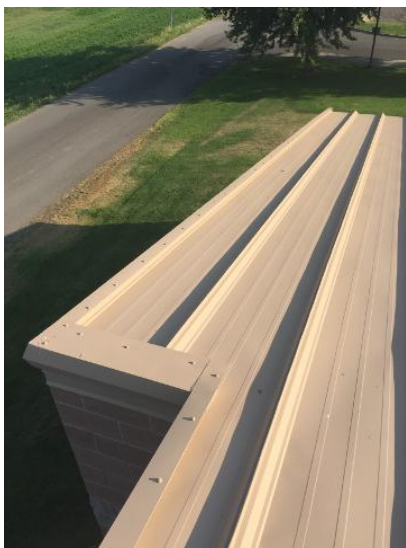
Photo 17

Photo of roof edge coated

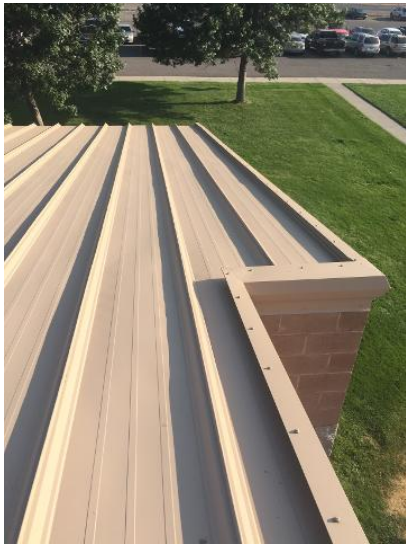
Photo 18

Continued- alternate roof edge

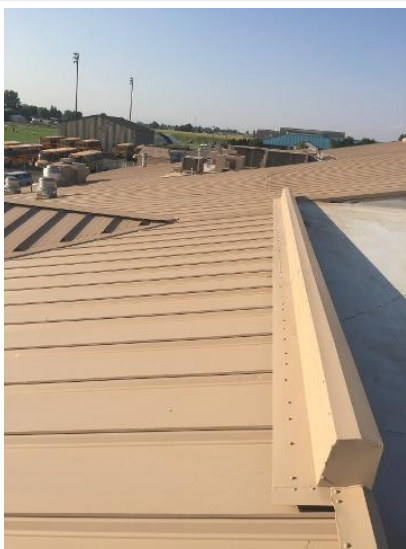
Photo 19

Photo of the middle of the roof facing North

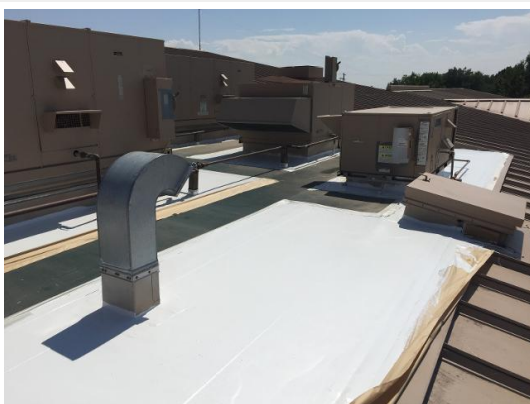
Photo 20

Photo of flat roof section on the North- installed white knight plus to the field

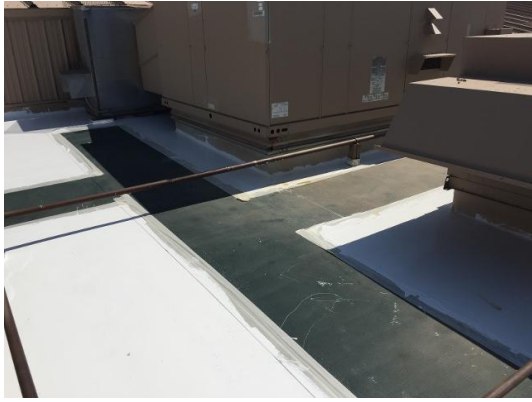
Photo 21

Continued- alternate angle

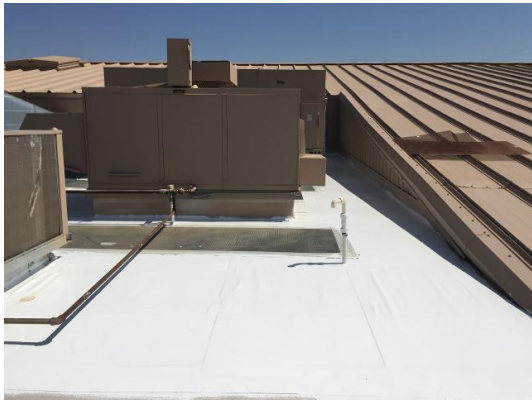
Photo 22

Continued

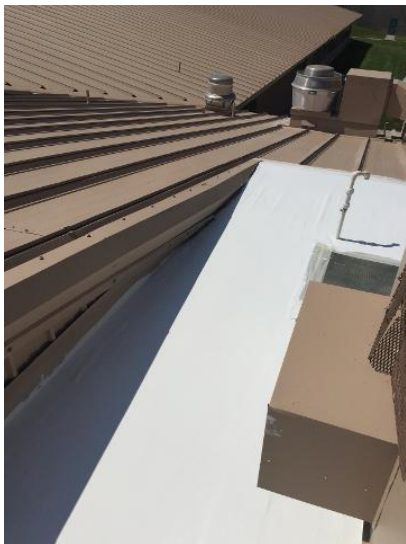
Photo 23

Continued- along perimeter of flat section

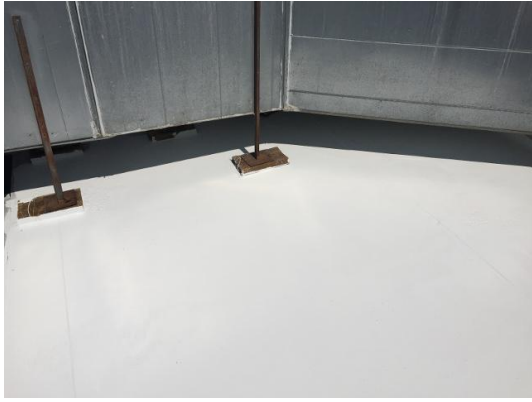
Photo 24

Photo of the single-ply field coated

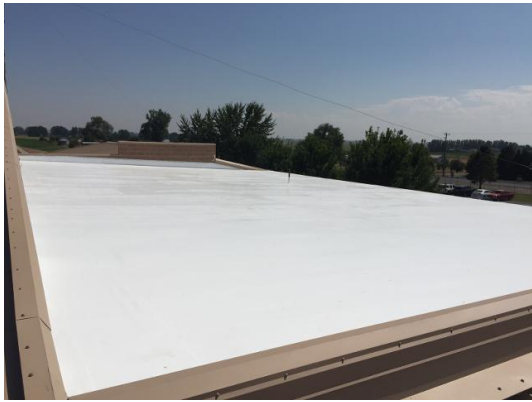
Photo 25

Field photo of the flat section in the middle of the roof- White Knight Plus coating installed

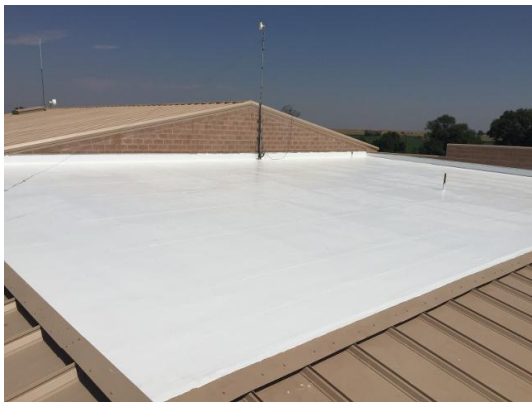
Photo 26

Continued- alternate angle

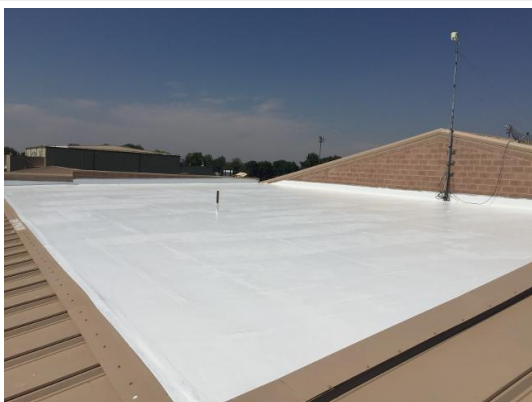
Photo 27

Continued- alternate angle facing northwest

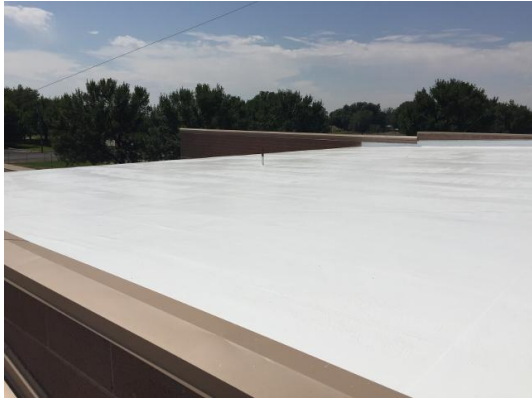
Photo 28

Continued- facing south towards the front of the school

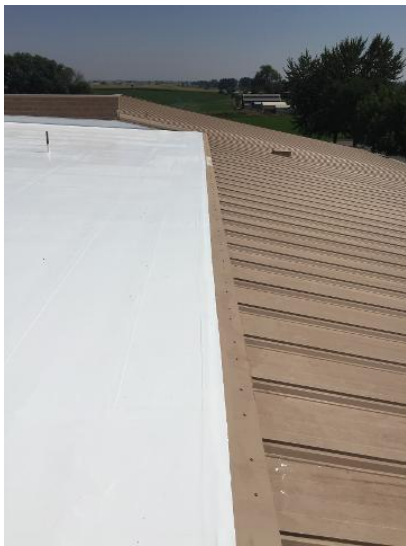
Photo 30

White Knight Plus installed along perimeter

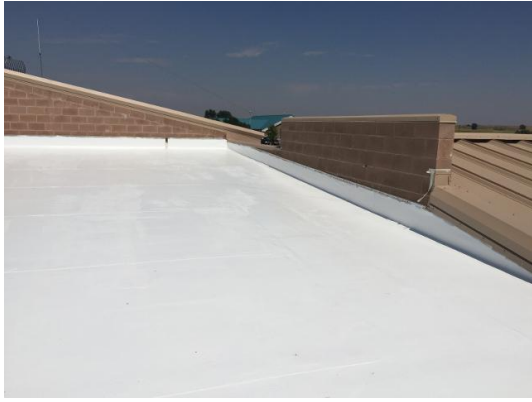
Photo 31

Continued
