# School Assessment Report

District: Arriba-Flagler C-20

School: Flagler ES/MS/HS

Date: Mar 18, 2013

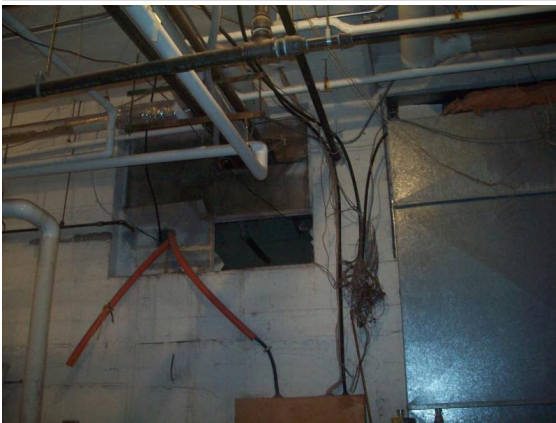
**Analysis:** The system is in use and functioning with an estimated remaining service life as indicated in the report section "Condition/Replacement Budget Detail". The system was installed in 2000. It has a 30-year service life. Based on the assessment, it is expected to expire in 2030.

**Recommendation:** No action is required.
