GENERAL FACILITY ASSESSMENT FOR

2021

Sumter County Schools General Facilities Assessment

York West End Junior High School

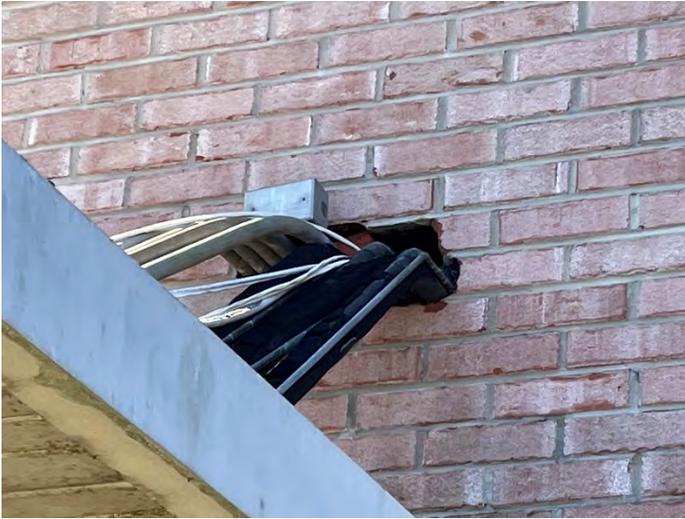
- Observed some masonry separations - May be due to no control joints
- Observed unsealed penetrations through brick
- Brick needs cleaning

Example of Unsealed Penetration

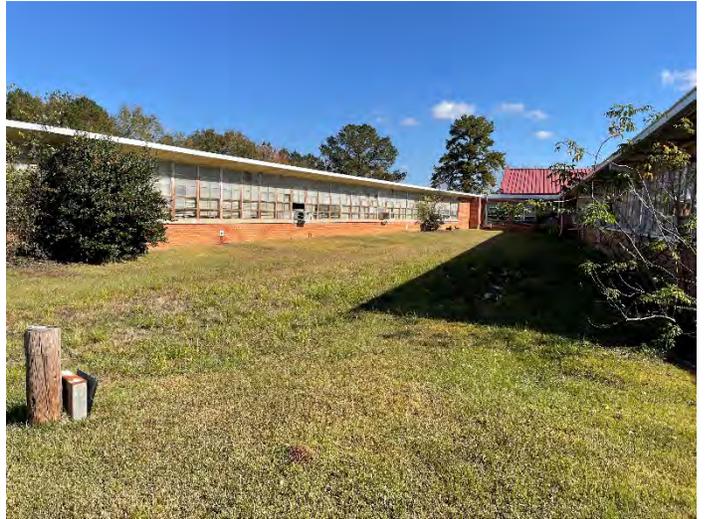
No Drainage in This Courtyard

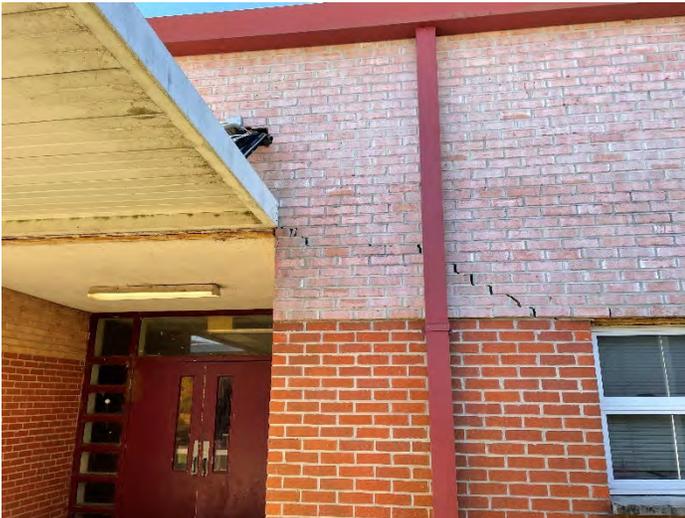
Masonry Separation. Possibly Due To Absence of Control Joints

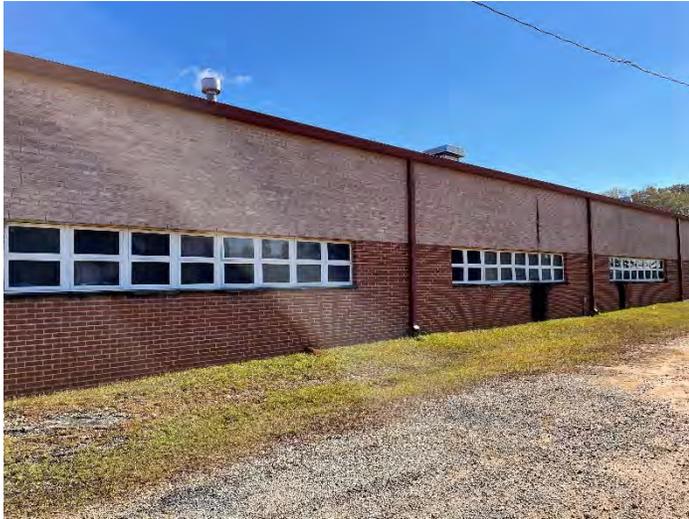
Windows Such As These Appear To Be In Good Condition

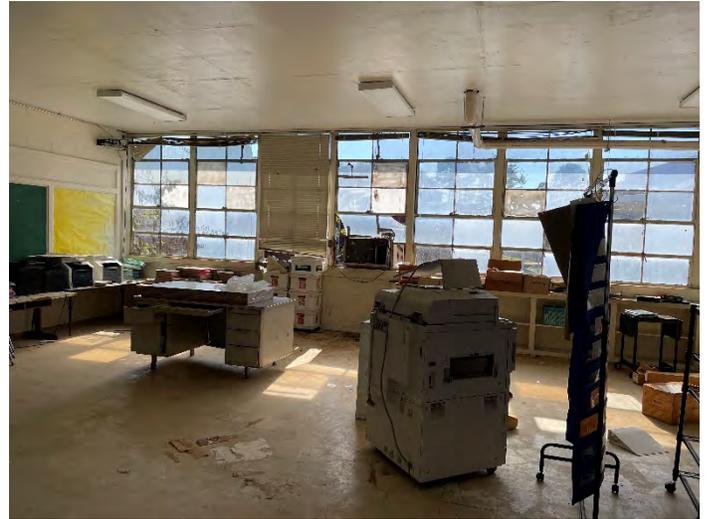
Windows Such As These Should Be Replaced

- 1) Older Windows need replacing
- 2) Some broken glass was observed

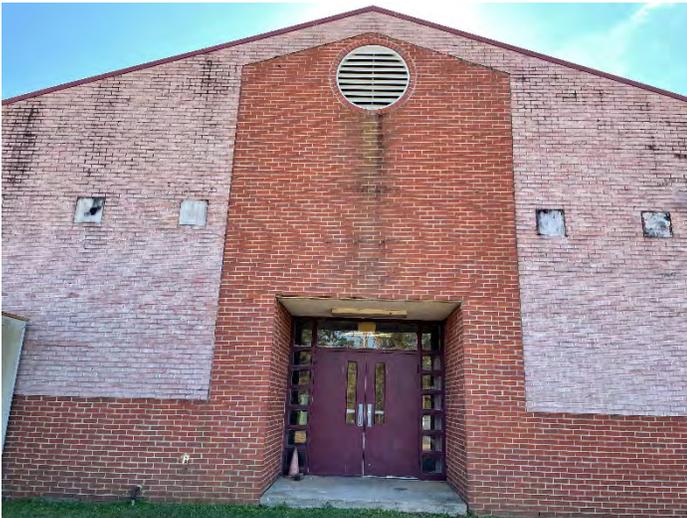
Example of Brick That Could Use Cleaning

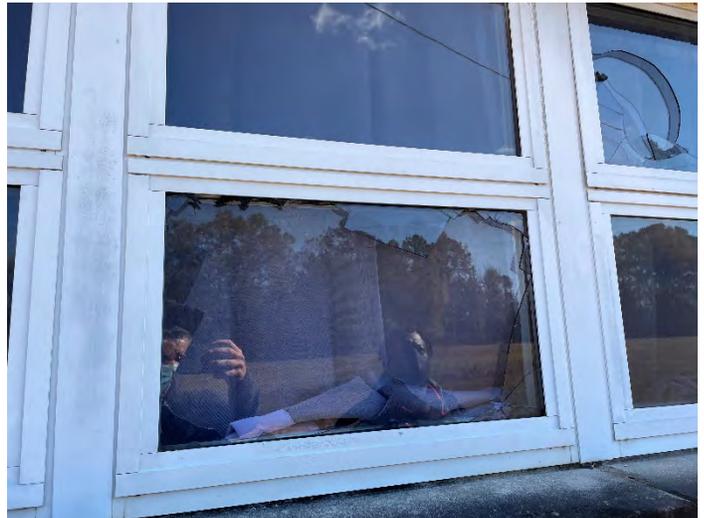
Broken Glass Found on Back Classroom Wing

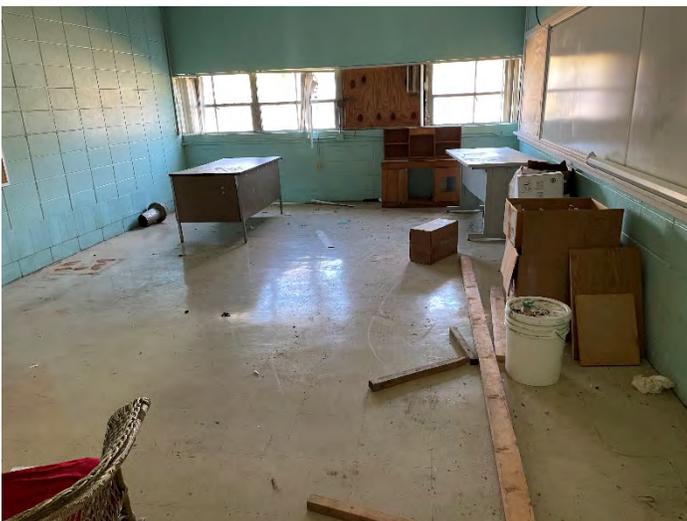
Unoccupied Classroom Wing

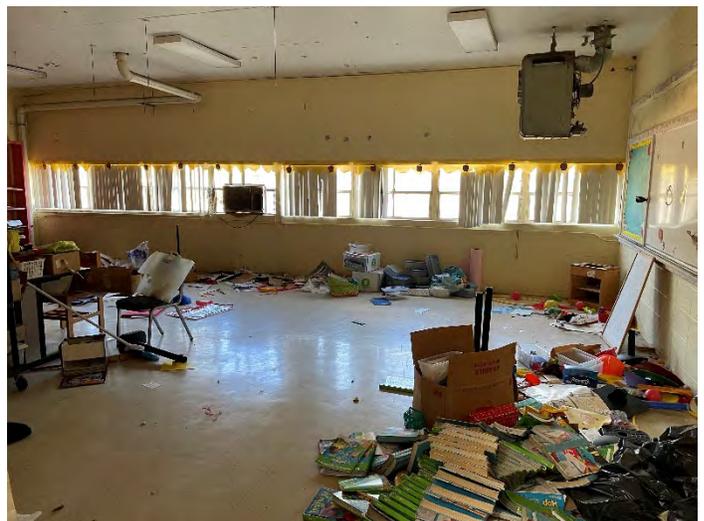
Unoccupied Classroom Wing

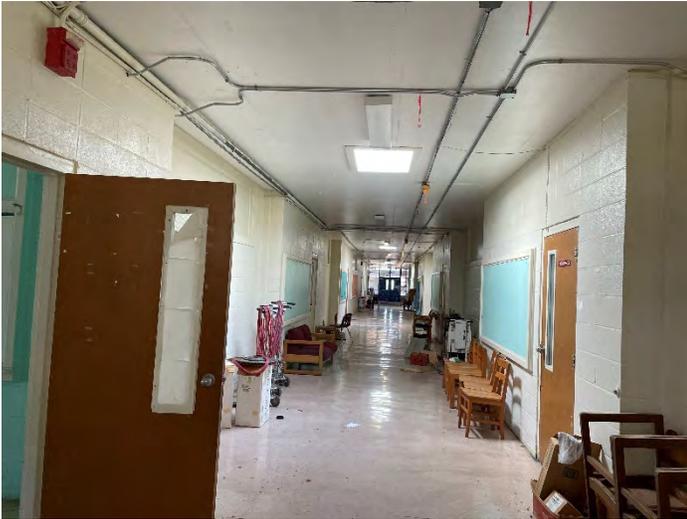
Unoccupied Classroom Wing

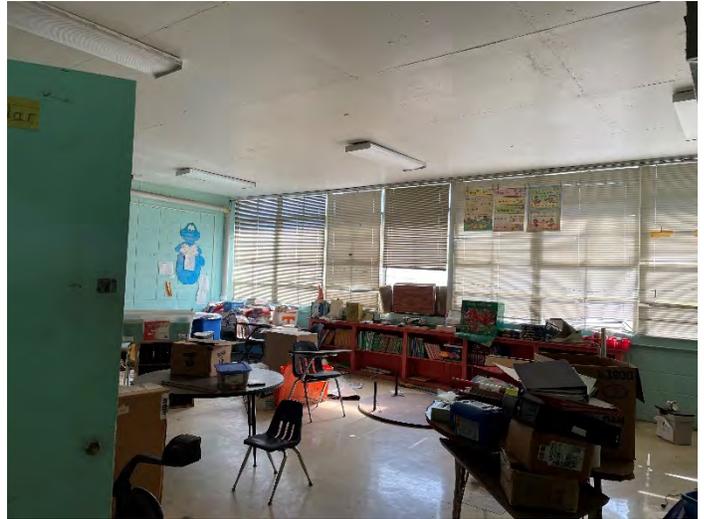
Unoccupied Classroom Wing

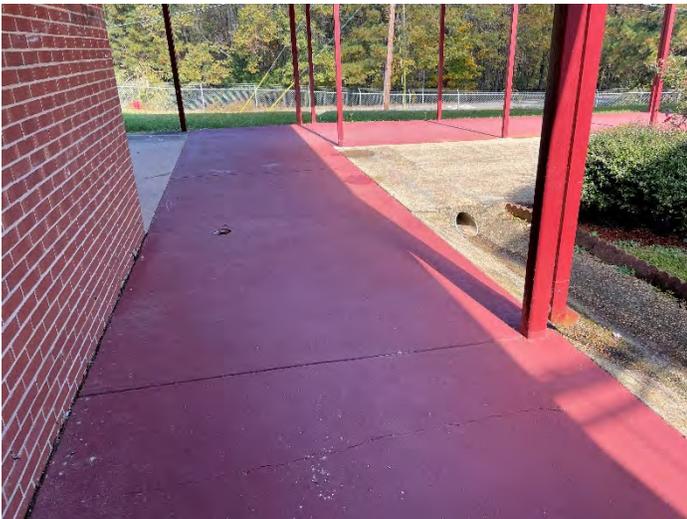
Coated Concrete Walks Appears to Be In "Fair" Condition

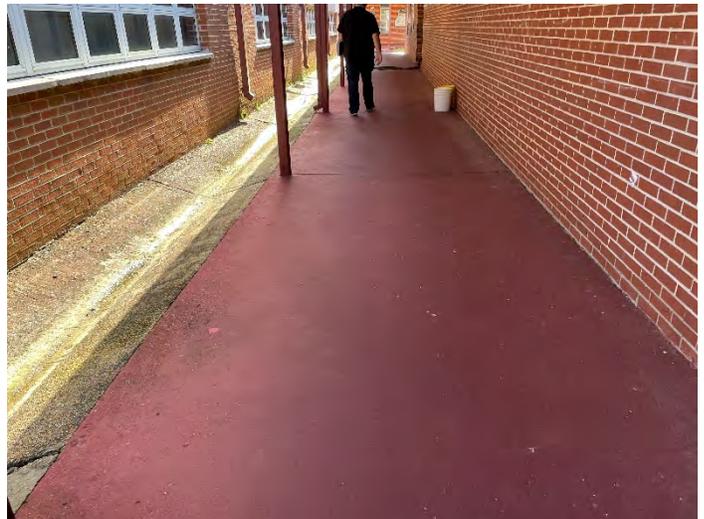
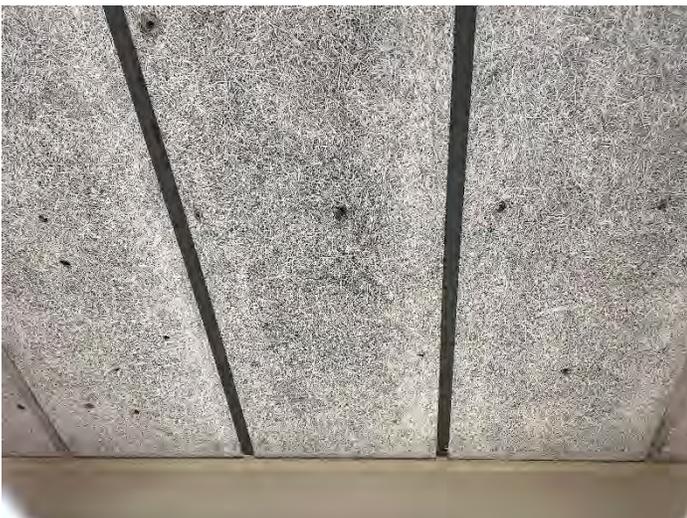
Areas That Have Been Re-Roofed Have Toggle Anchors Exposed

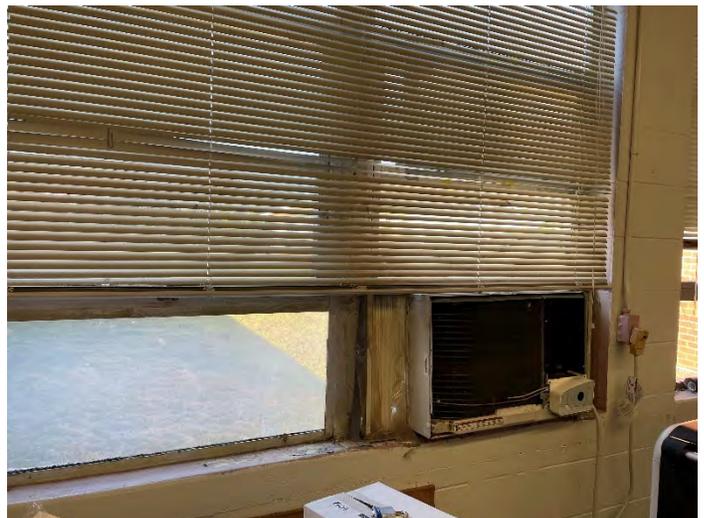
Air Conditioning is Achieved By Older Window Units

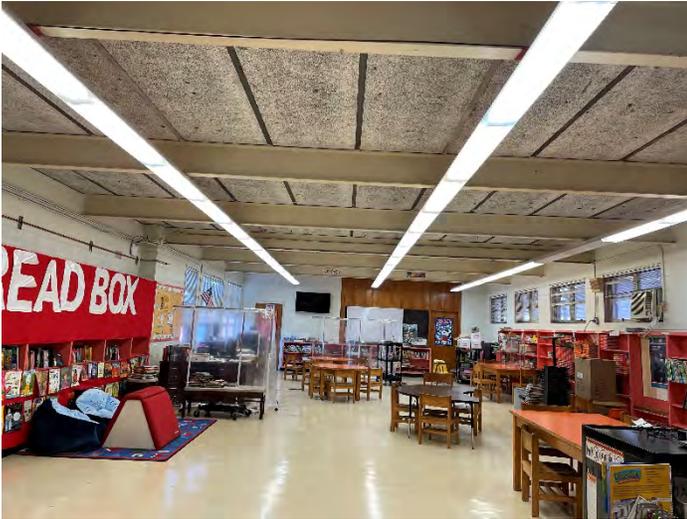
Library Lighting Appears to Be In “Good” Condition

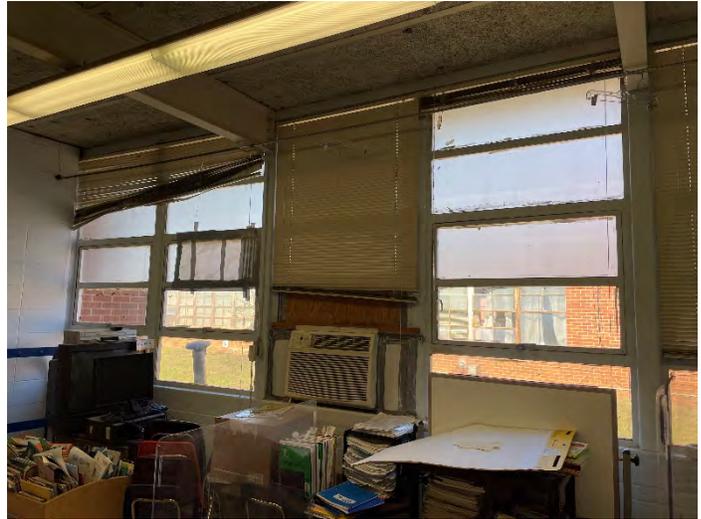
Example of Window System That Needs To Be Replaced

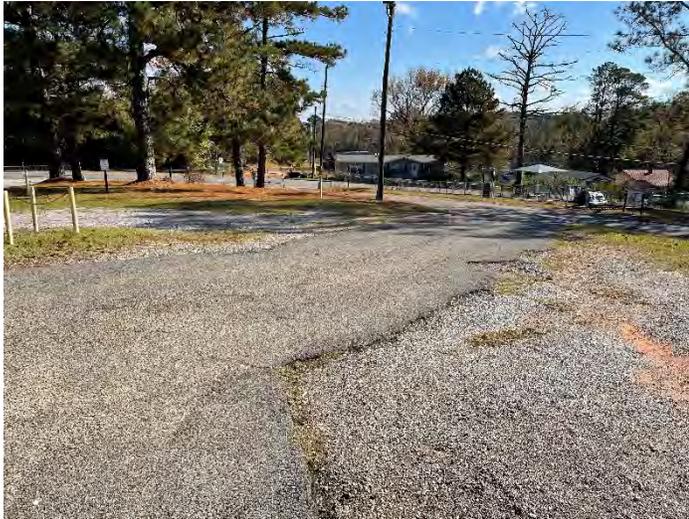
View of Front Drive With No Parking Identified

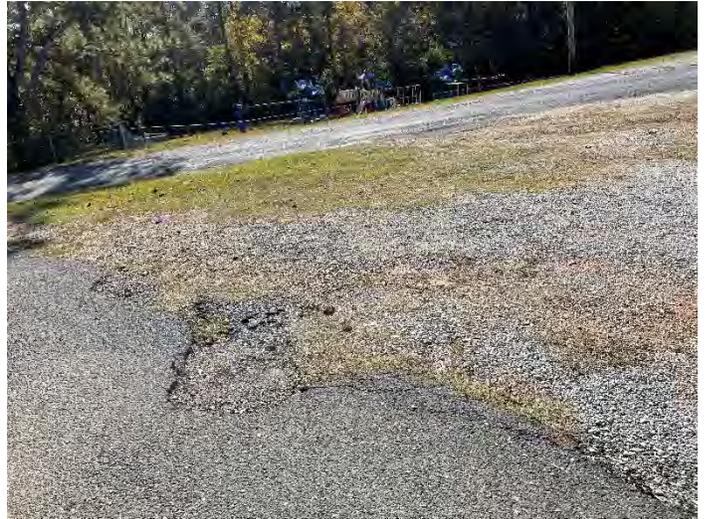
Asphalt Is Mostly Damaged

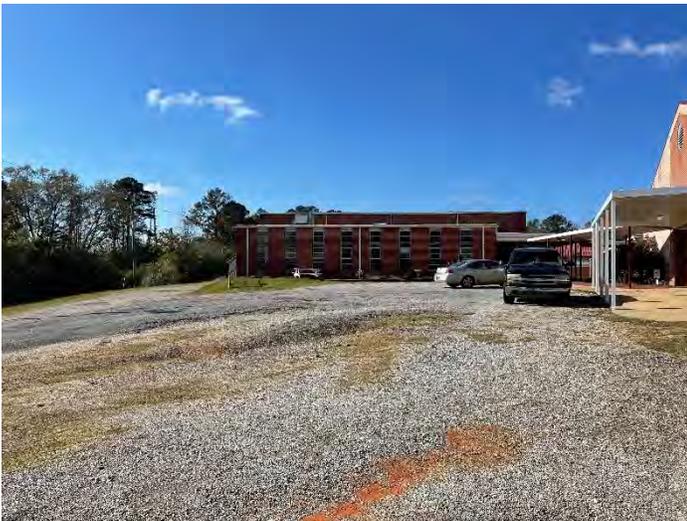
Example of Ruts / Washing In Gravel Lot

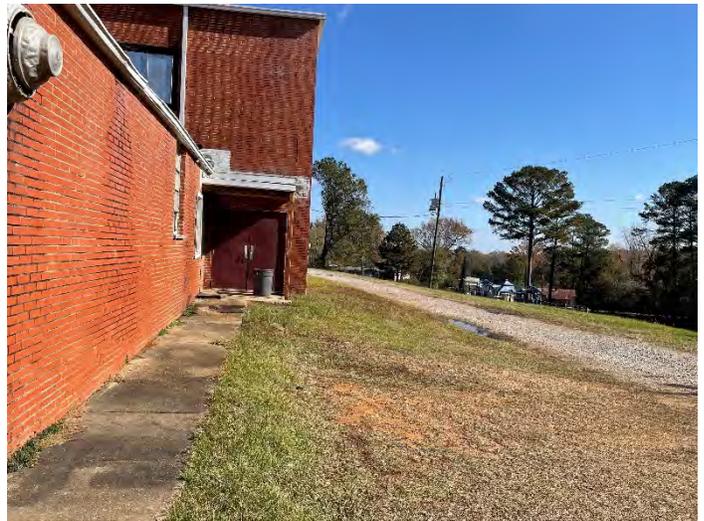
Gravel Loop Drive

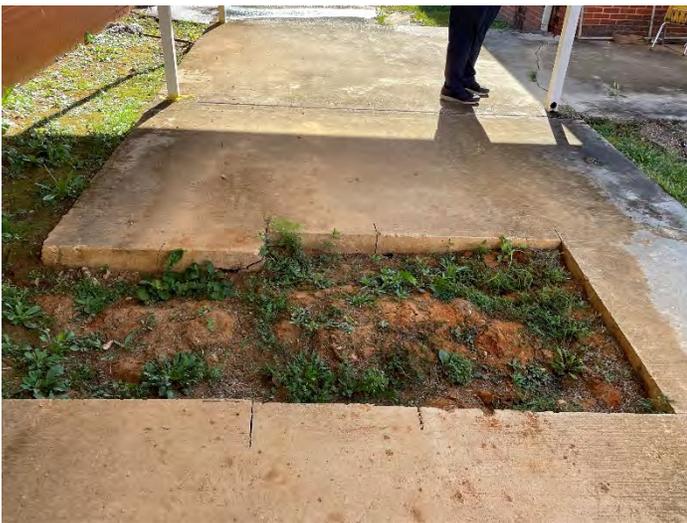
Example of trip Hazard at Exterior Walkway

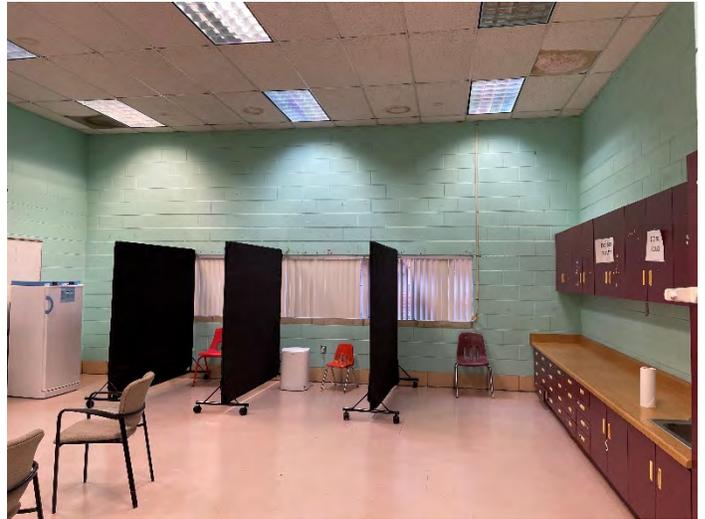
Dated Finishes & Evidence of Roof Leaks

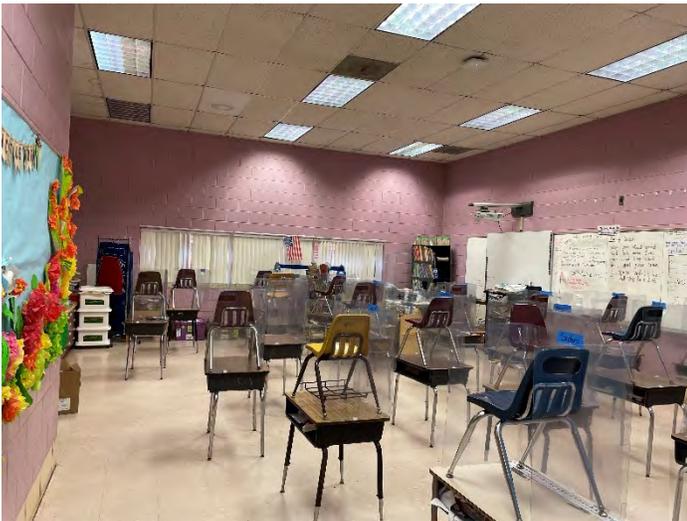
Dated Finishes & Evidence of Roof Leaks

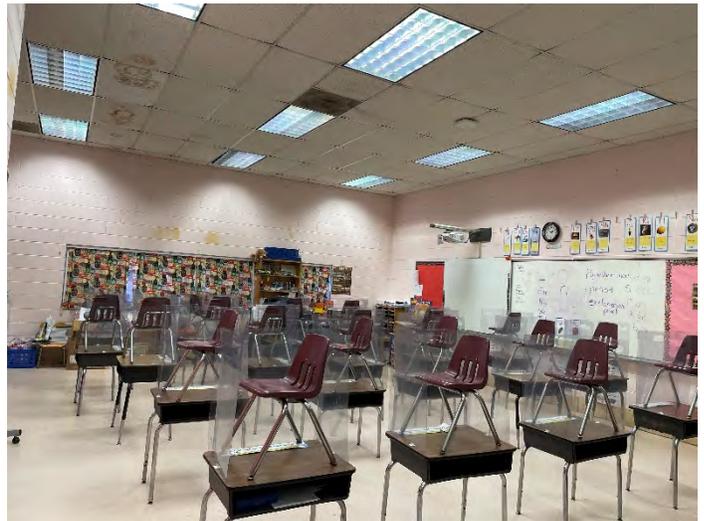
Dated Finishes & Evidence of Roof Leaks

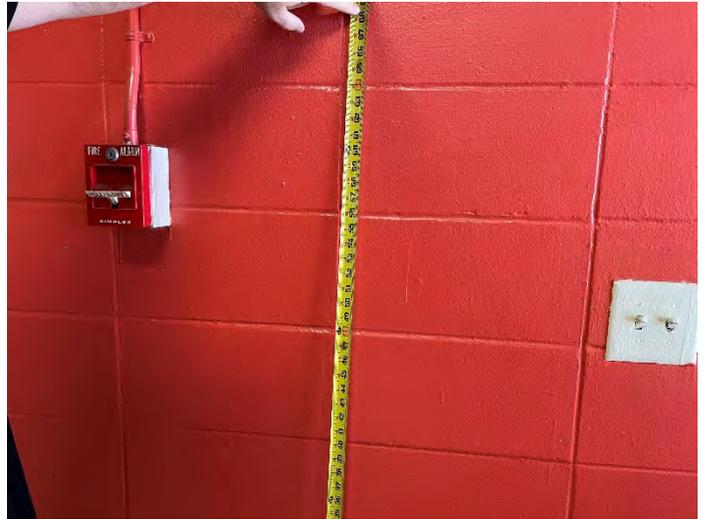
Example of Pull Stations, Light Switches & Fire Extinguishers Above 48"

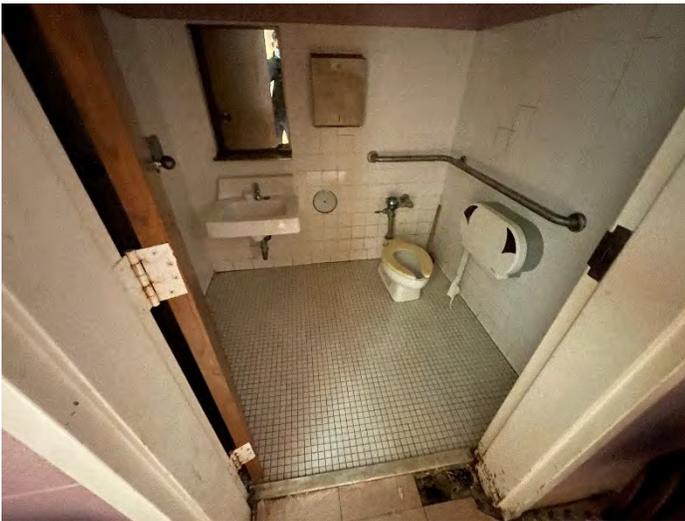
Example of Hard Tile In "Fair" Condition if Cleaned
Note Rusted Door Frame & Hinges

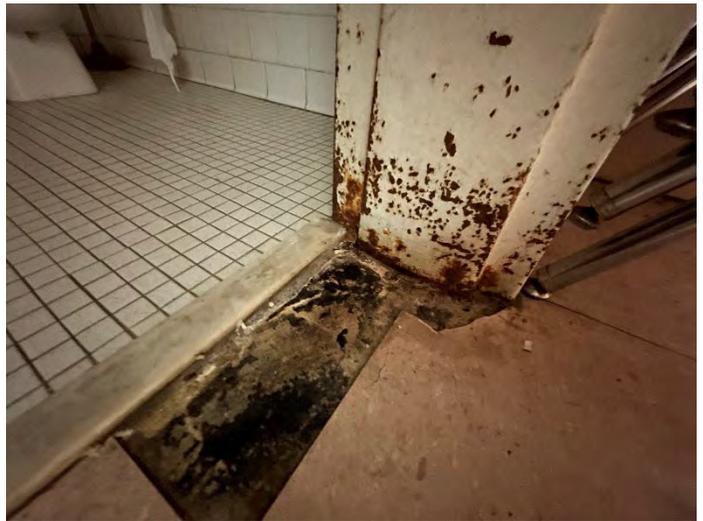
Metal Door Frames Are Deteriorating Rapidly In
High-Moisture Conditions

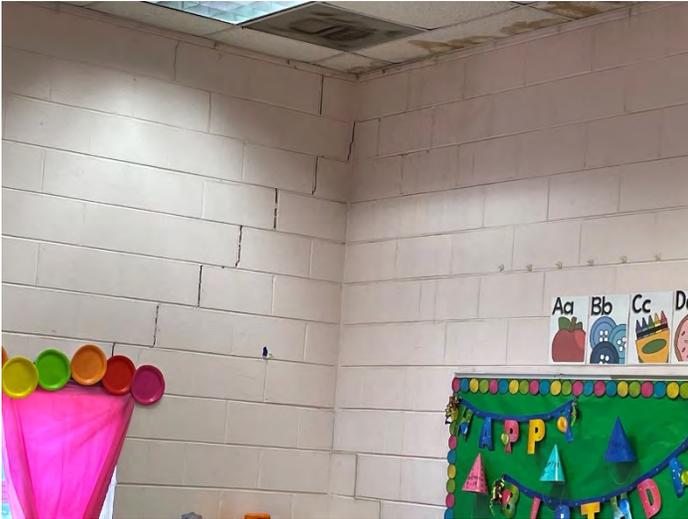
Observed Crack in CMU & Evidence of Roof Leaks

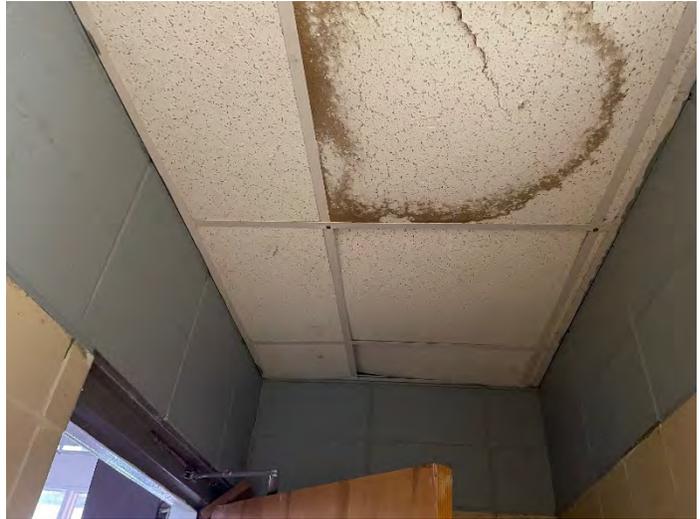
Example of Roof Leaks Throughout Campus

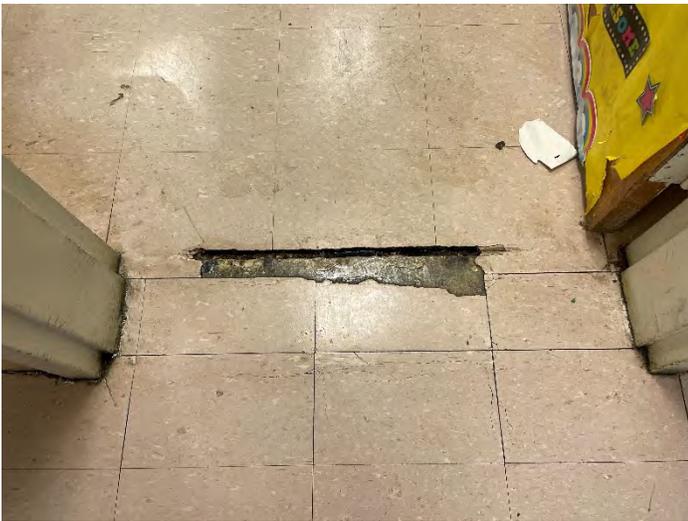
Trip Hazard at Doorway

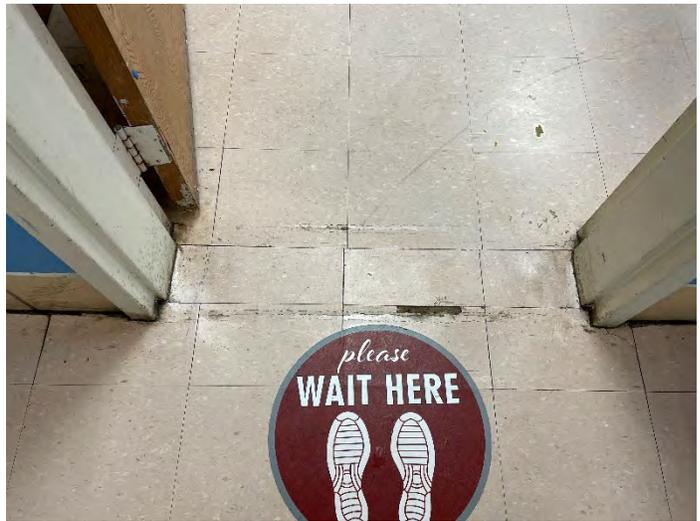
Example of Aging VCT

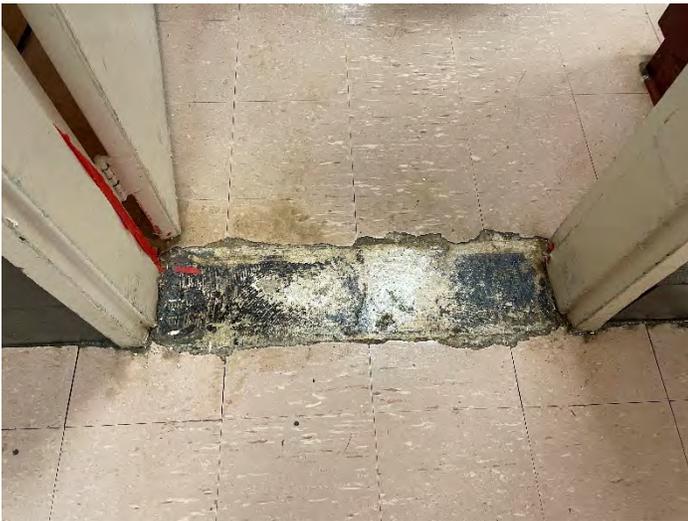
Example of Damaged Flooring

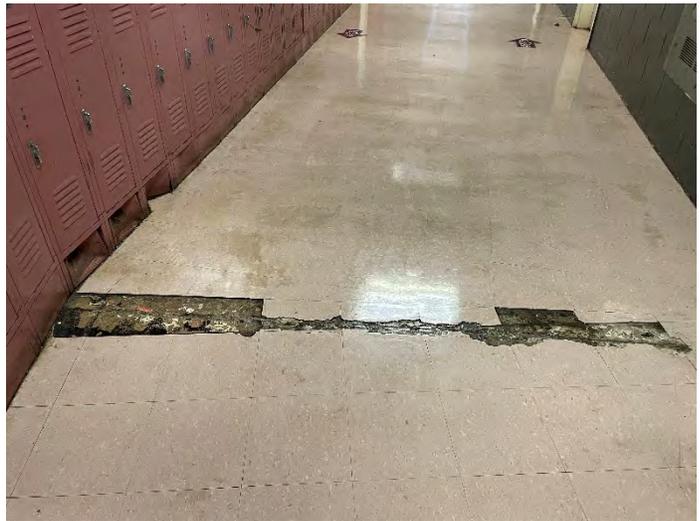
Example of Damaged Flooring

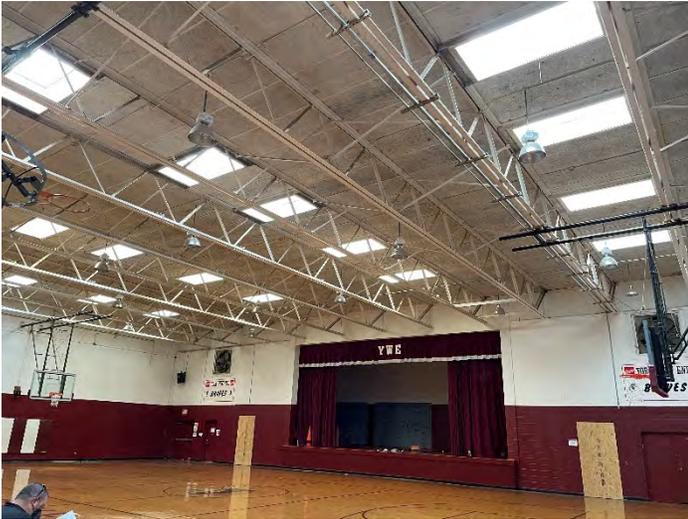
Skylights In Gym Are Aging & May Begin To Leak

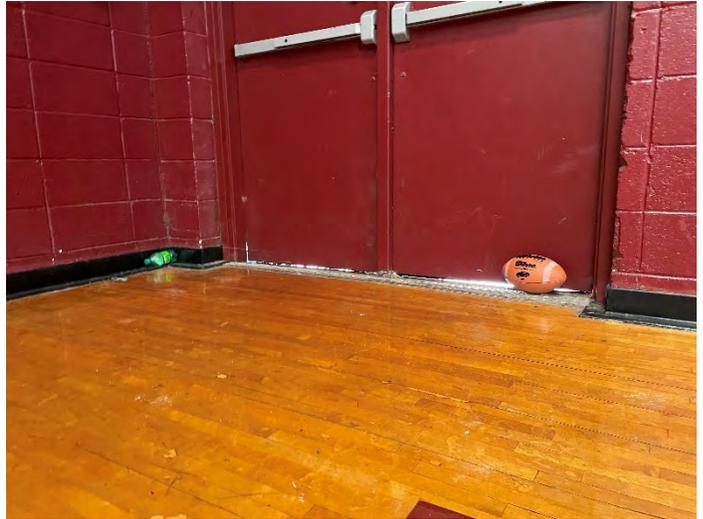
Gaps Found Under Metal Doors

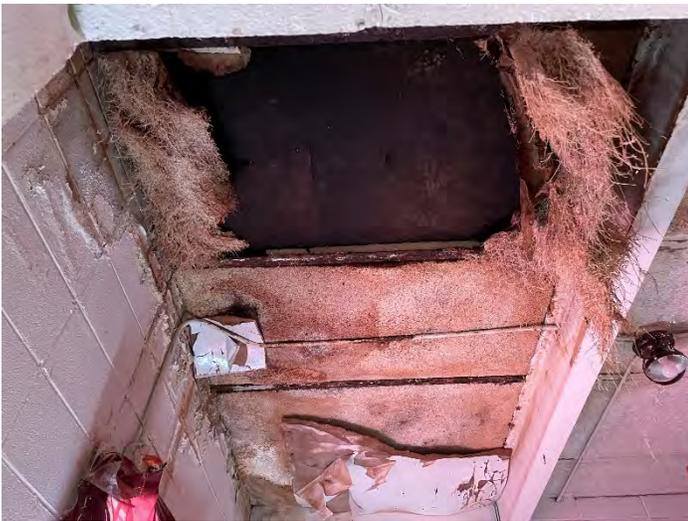
Dilapidated Roof Over Locker Room

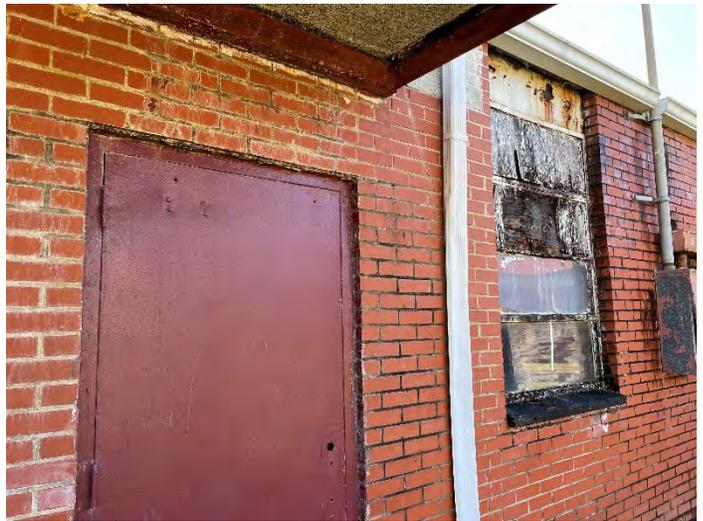
Example of Exterior Doors / Windows in Bad Condition

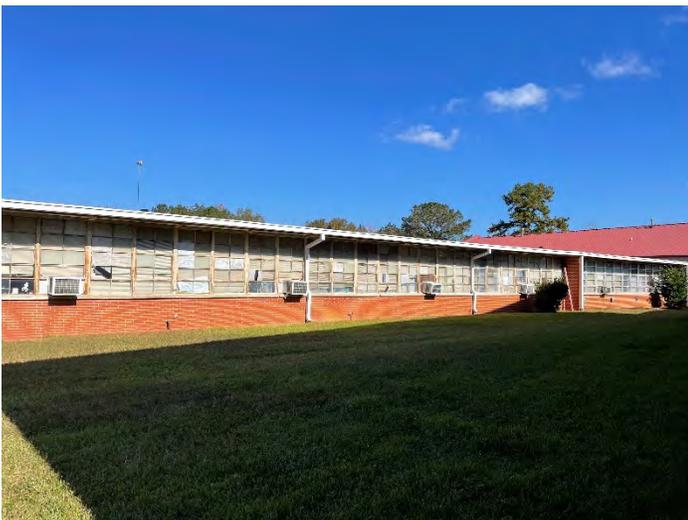
This Window System Needs To Be Replaced

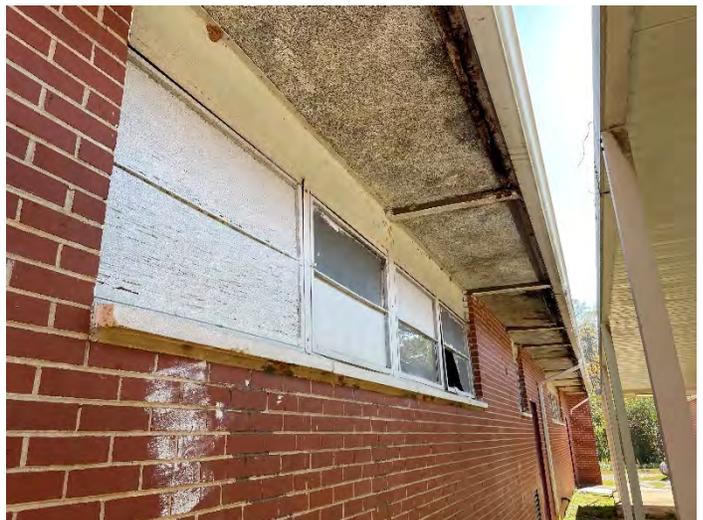
Teckum Deck Deterioration At Perimeter

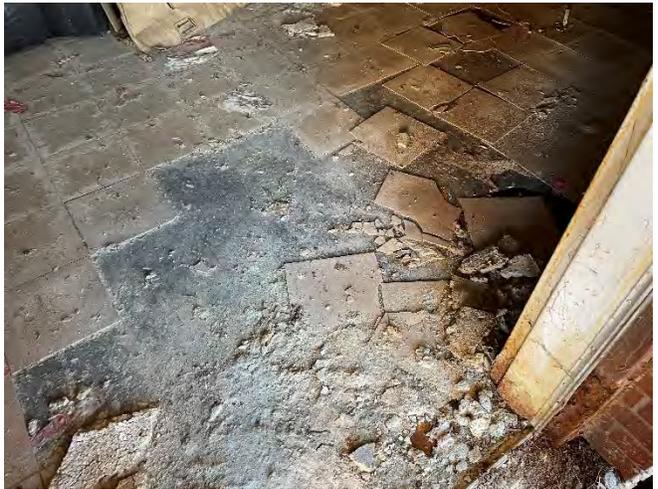
Shop Building Should NOT Be Occupied In Any Capacity

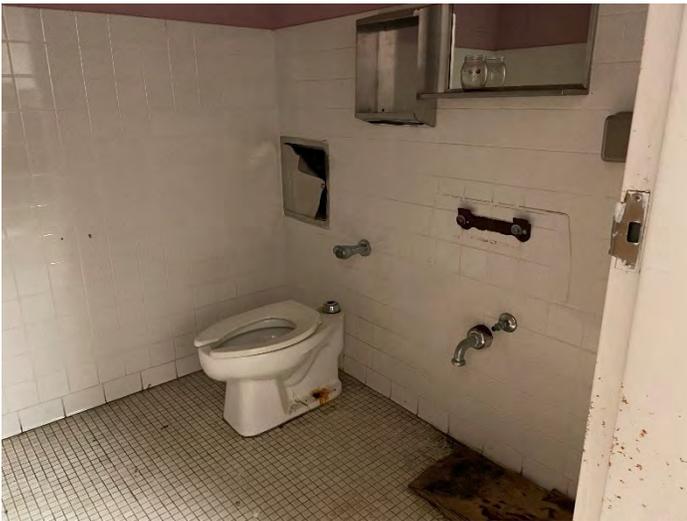
Restroom Out Of Commission

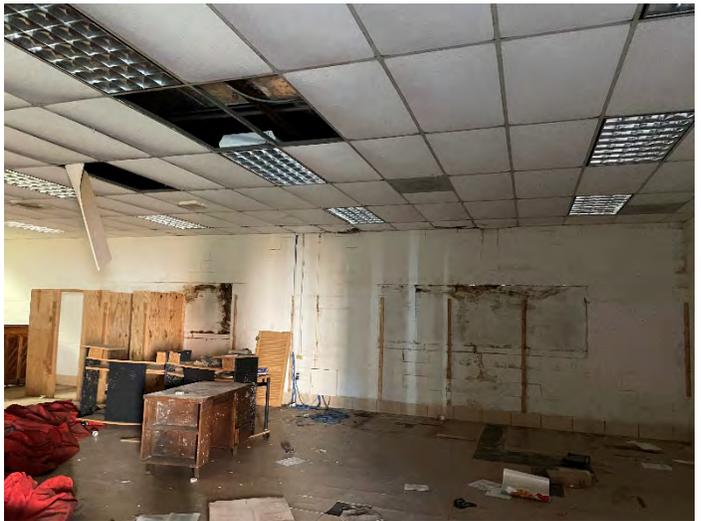
Dilapidated Shop Building – Mold Evident

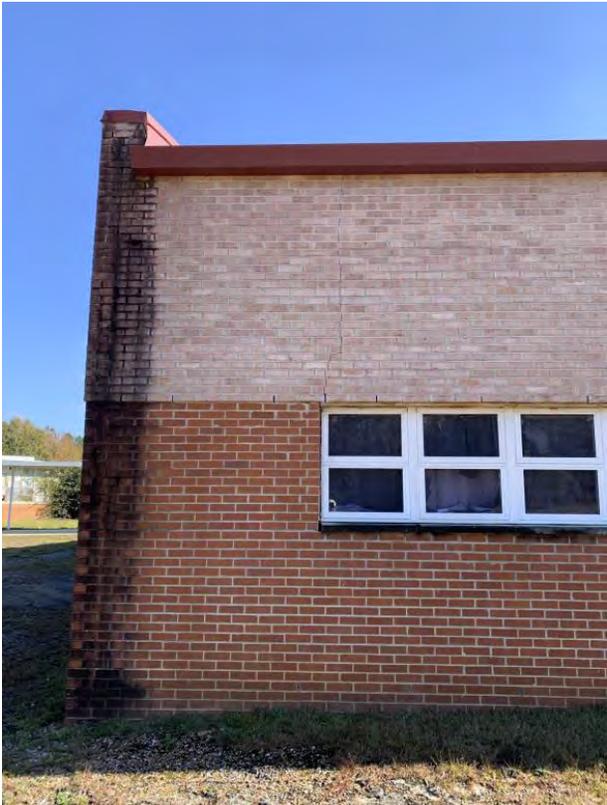
Cracks in Exterior Brick Façade

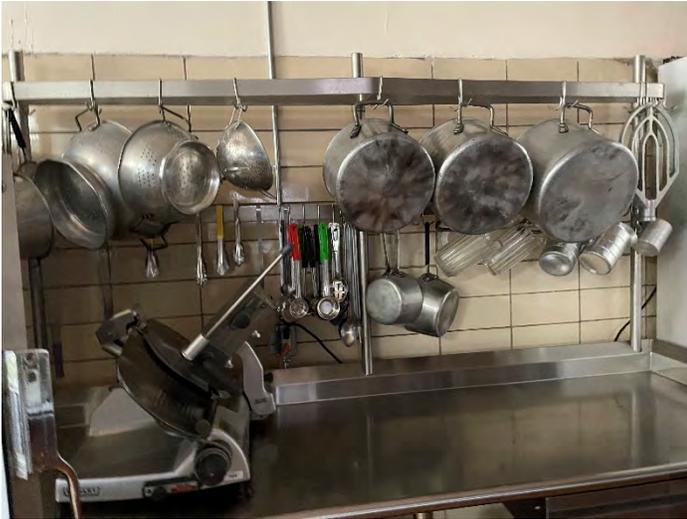
Kitchen Appears To Be Clean & Organized

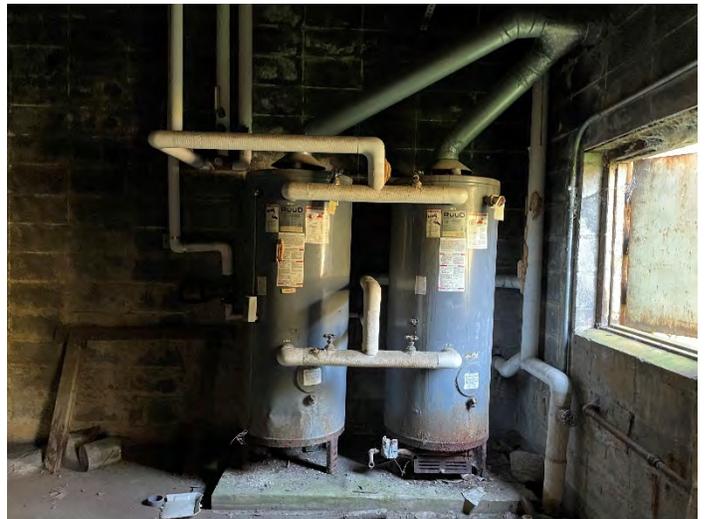
Mechanical Equipment Appears To Need Servicing

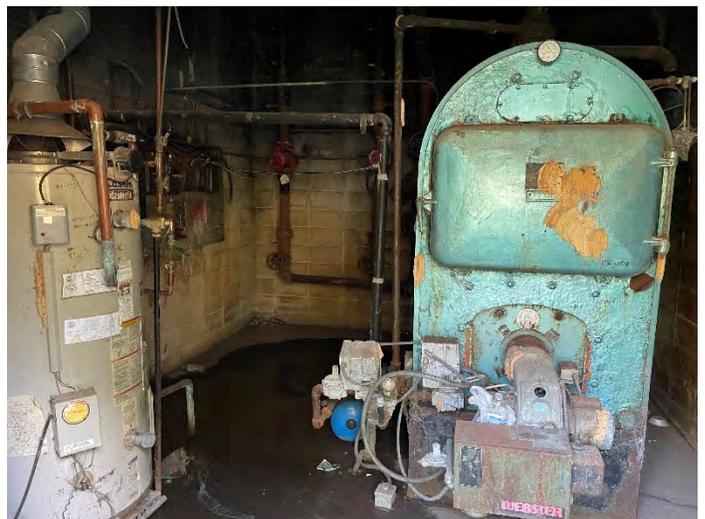
Mechanical Room Is Open & Holding Water

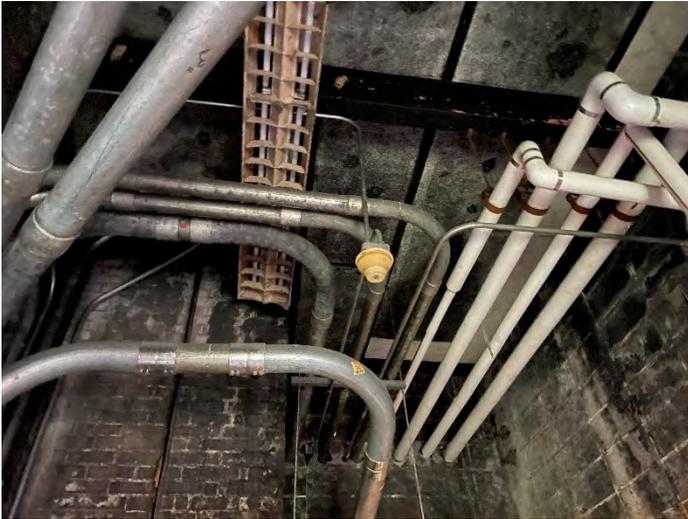
Code Violation – Smoke Detector Is Not Within 12” Of Deck Above

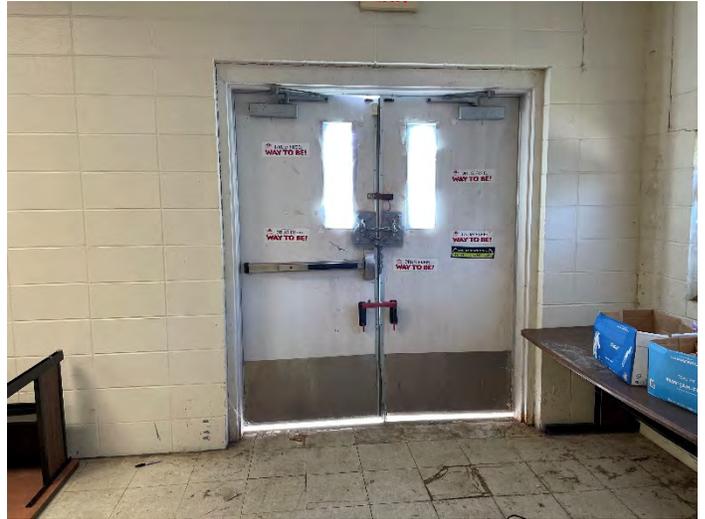
Code Violation – Cannot Lock Egress Doors

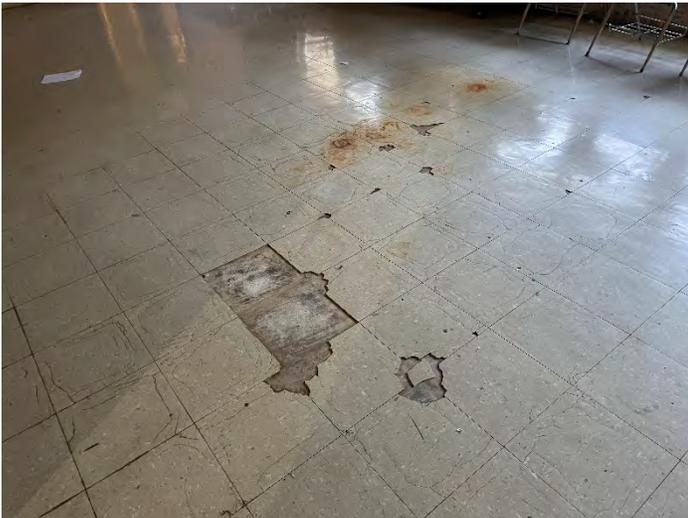
Safety Hazard – Floors Are In Bad Shape

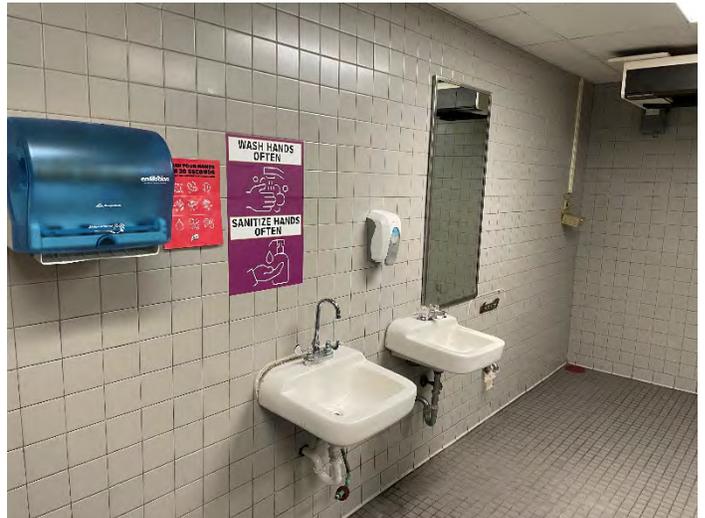
Code Violations – No Mirror Over ADA Sink & Dispenser Above 48”

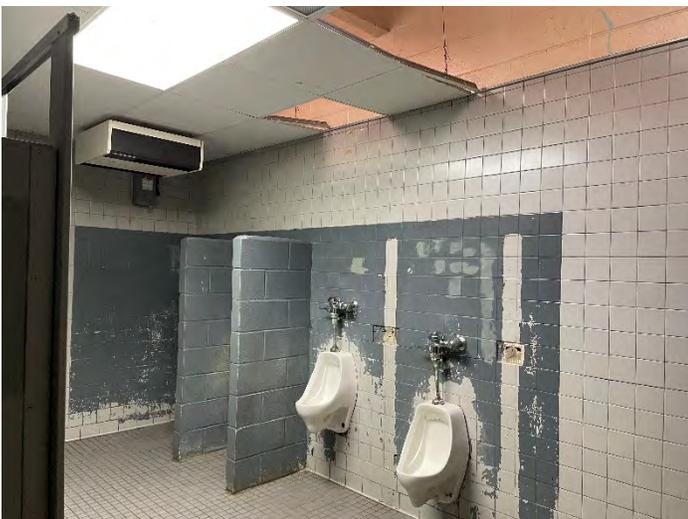
Example of Deteriorating Finishes

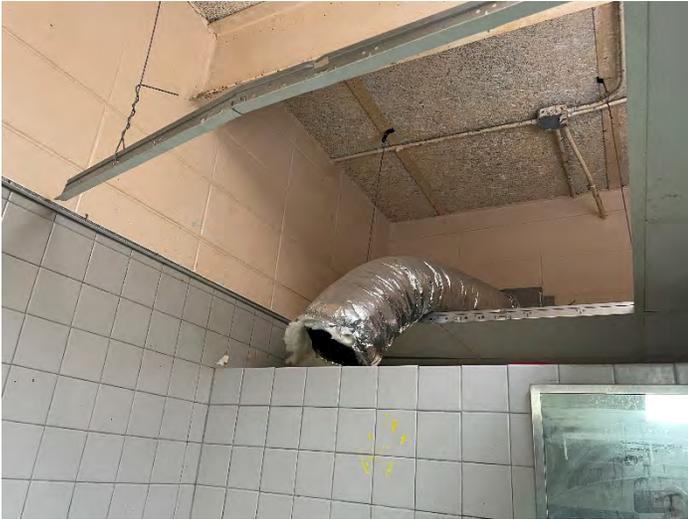
Ceilings / Duct Work Have Been Disassembled

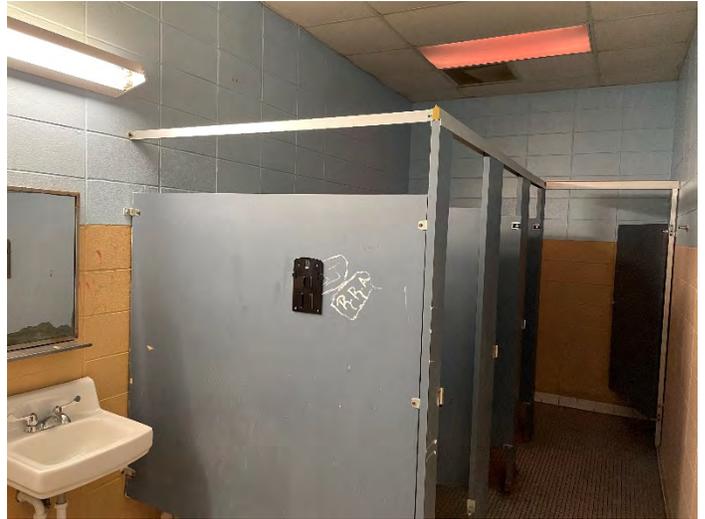
Insufficient Light Over ADA Stall

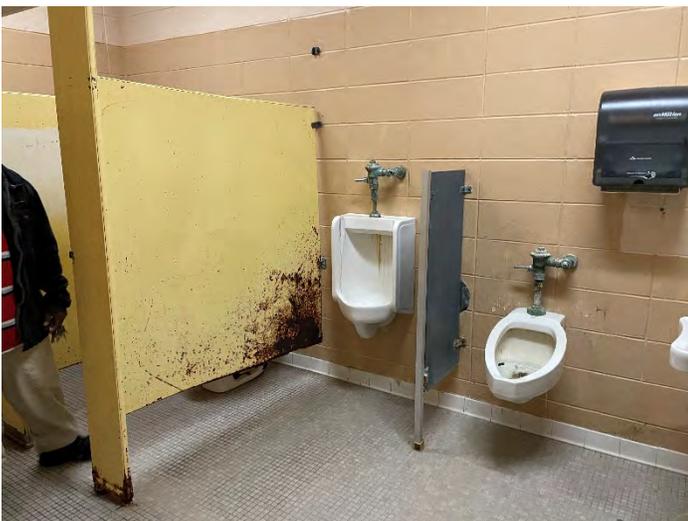
Dated Partitions & Plumbing Need Replacement

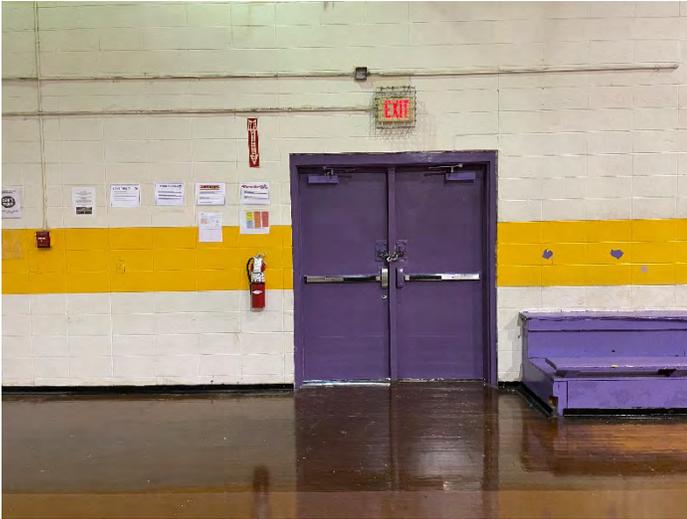
Code Violation – Egress Doors Are Locked

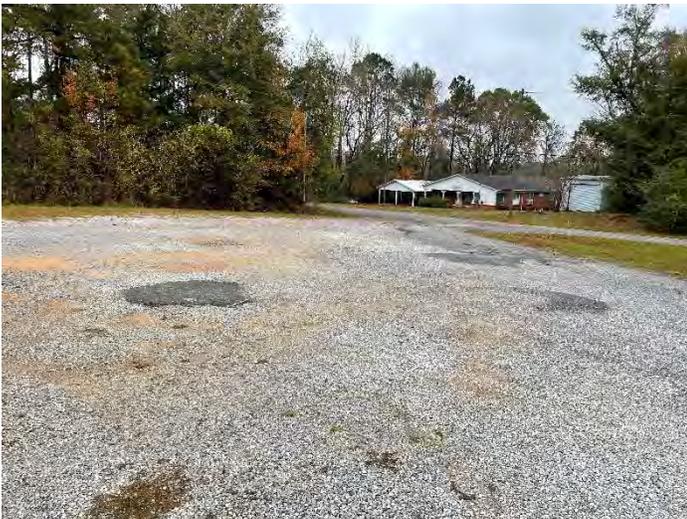
Gravel Drive – No Pavement, Parking Spaces, or ADA Parking (Code Violation)

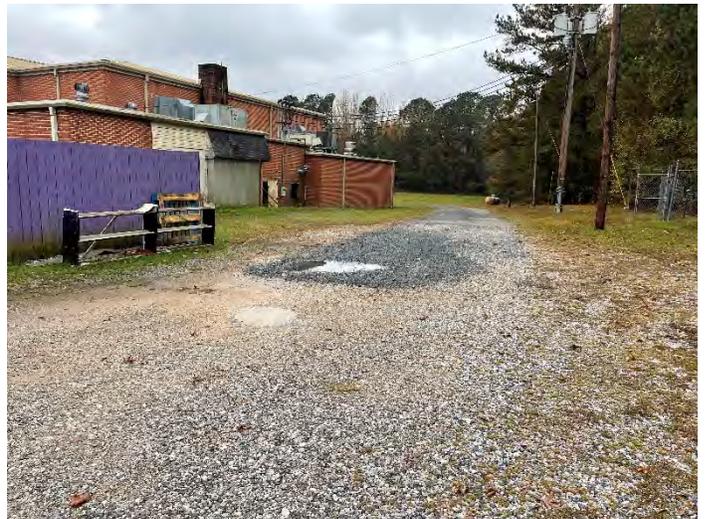
Gravel Drive – No Pavement, Parking Spaces, or ADA Parking (Code Violation)

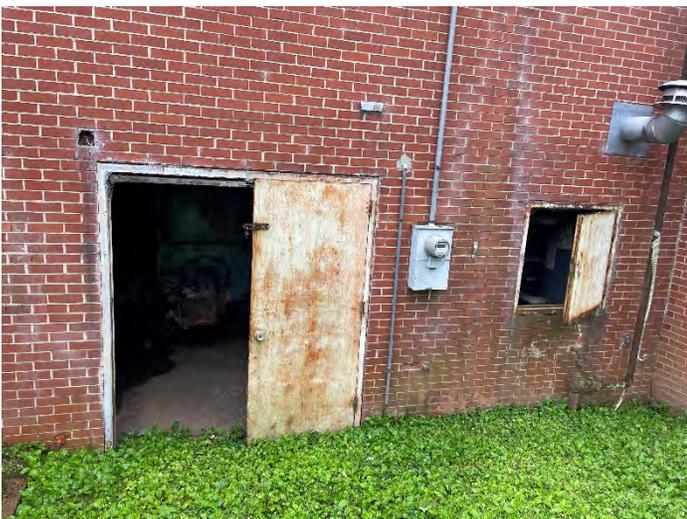
Mechanical Room Is Open & Taking On Water

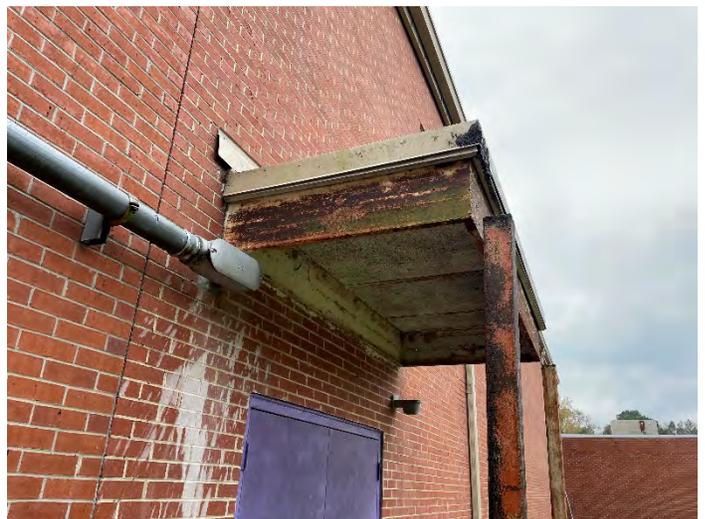
Small Canopy On Back Is Unsupported & Is A Safety Hazard

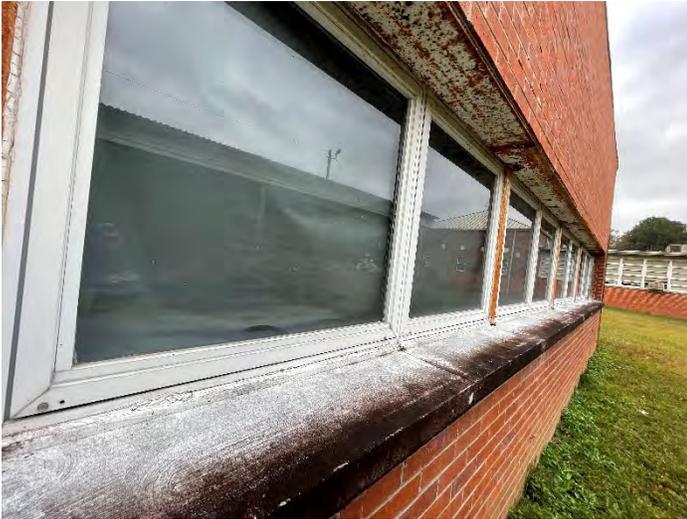
Steel Brick Lintels Are Rusted & Need To Be Repainted

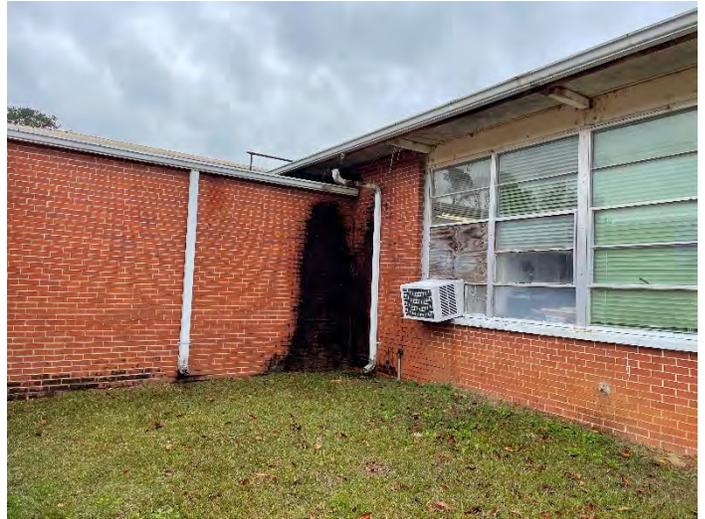
Most Gutters / Downspouts Are In Disrepair
