GENERAL FACILITY ASSESSMENT FOR

2021

Sumter County Schools General Facilities Assessment

York West End Junior High School

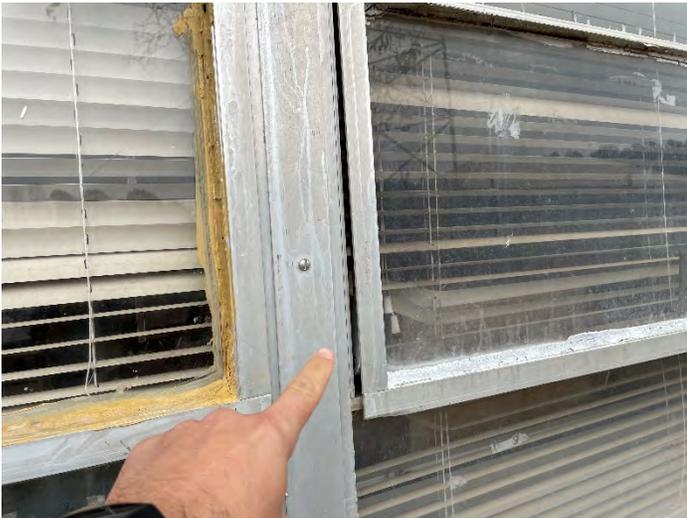
Aluminum Windows Are In Disrepair - Recommend Replacement

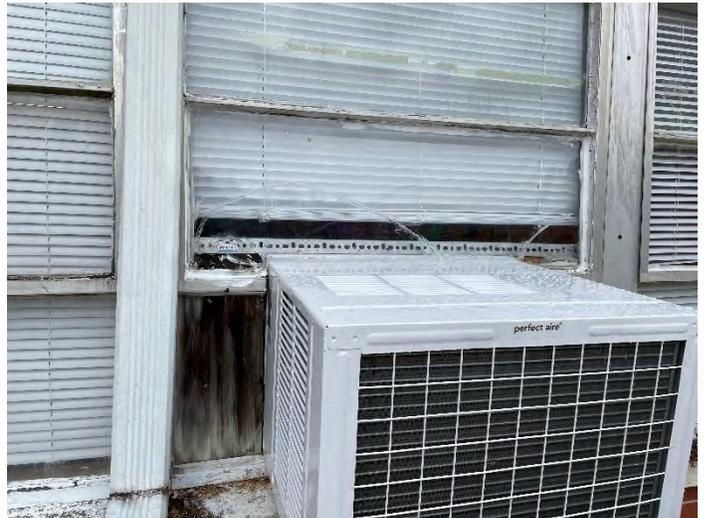
Aluminum Windows Are In Disrepair - Recommend Replacement

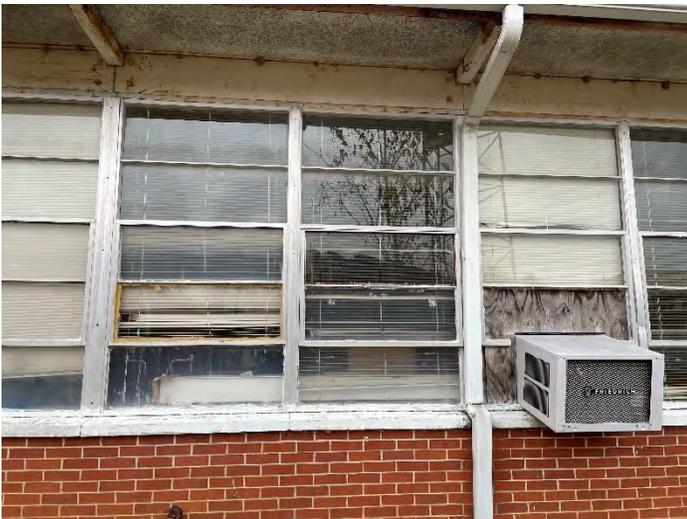
Aluminum Windows Are In Disrepair - Recommend Replacement

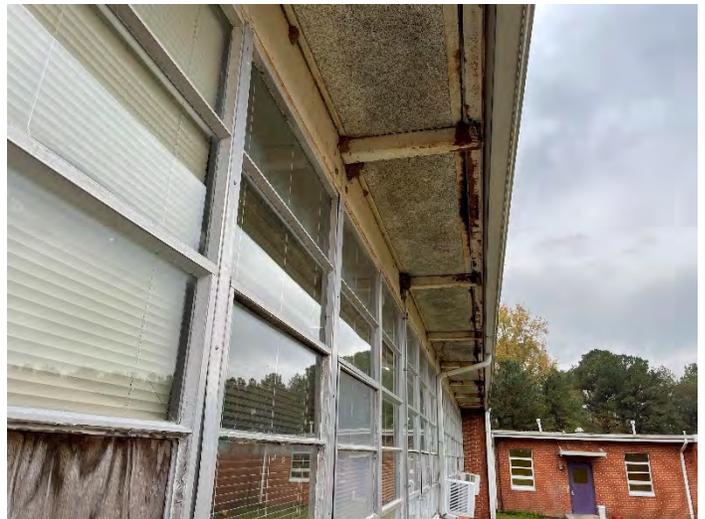
Aluminum Windows Are In Disrepair – Recommend Replacement

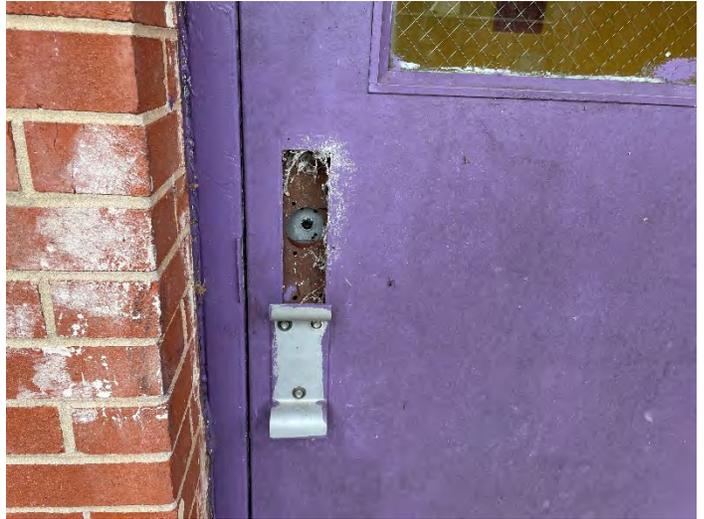
Insufficient Door Hardware At Side Egress

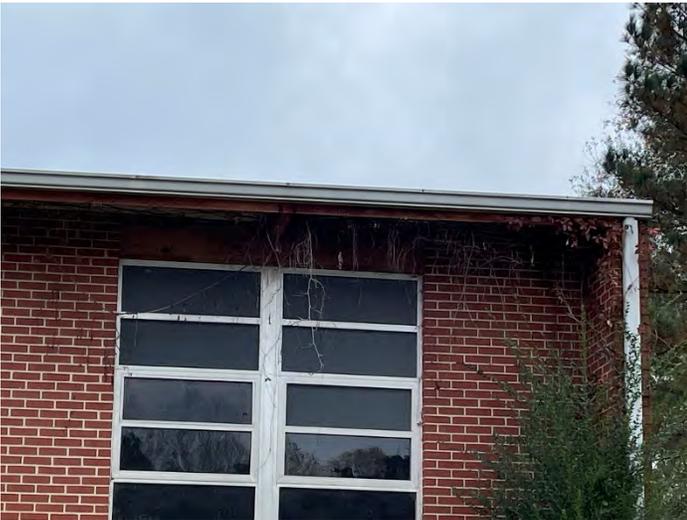
Vegetation Growing On Roof Level

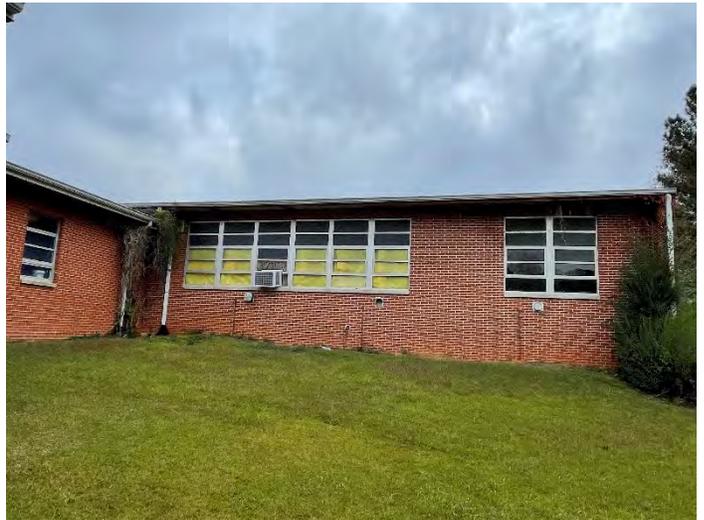
Vegetation Growing On Roof Level

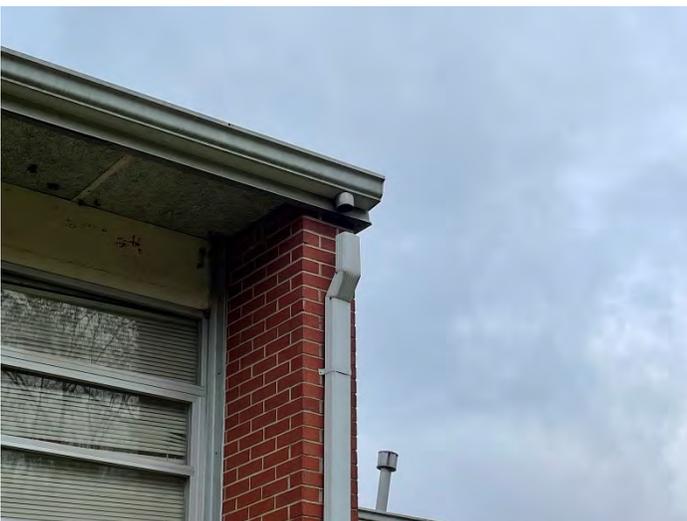
Example of Insufficient Gutters / Downspouts

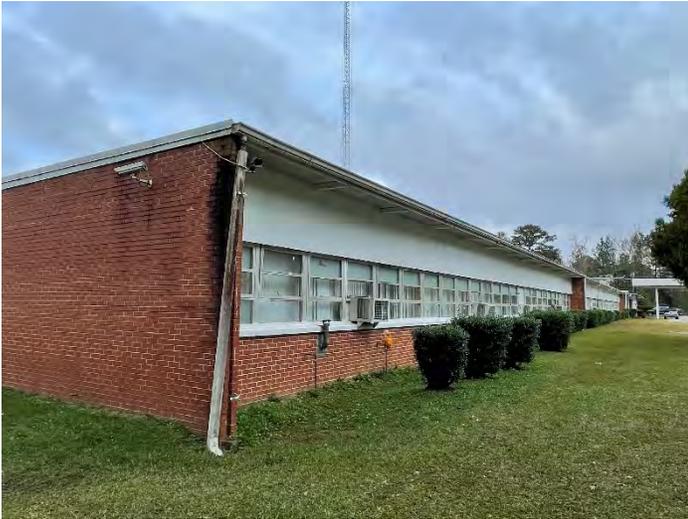
Grade Holds Water Against Building In Some Locations

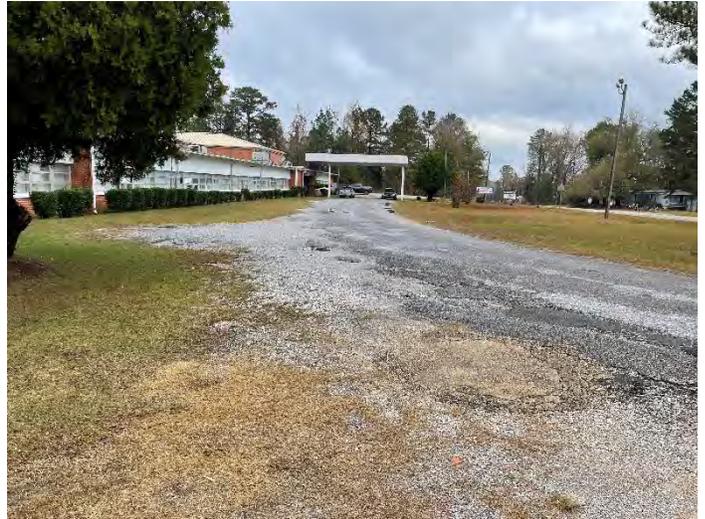
Insufficient Parking – No Parking

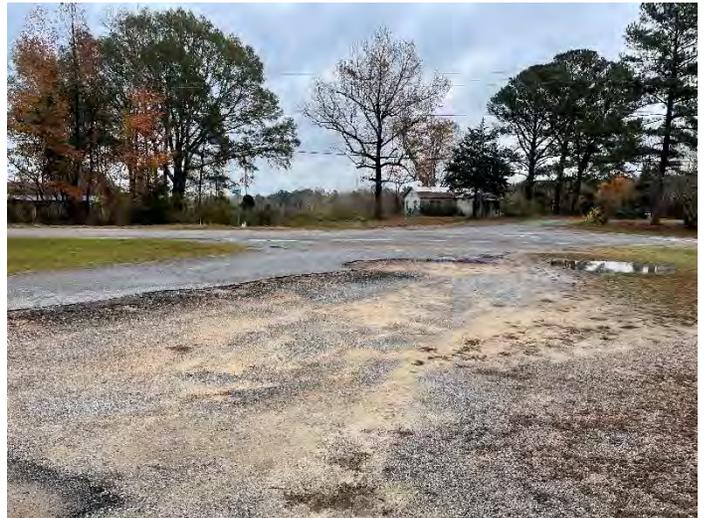
Insufficient Parking – No Parking

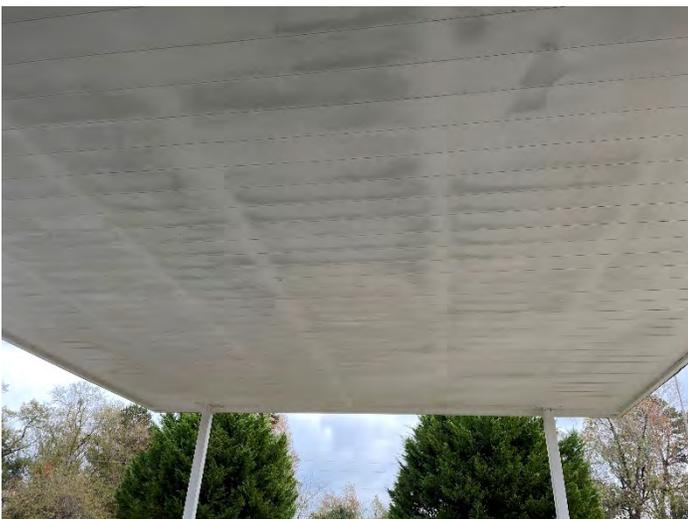
Main Canopy Appears To Be In Decent Shape
Needs Cleaning / Painting

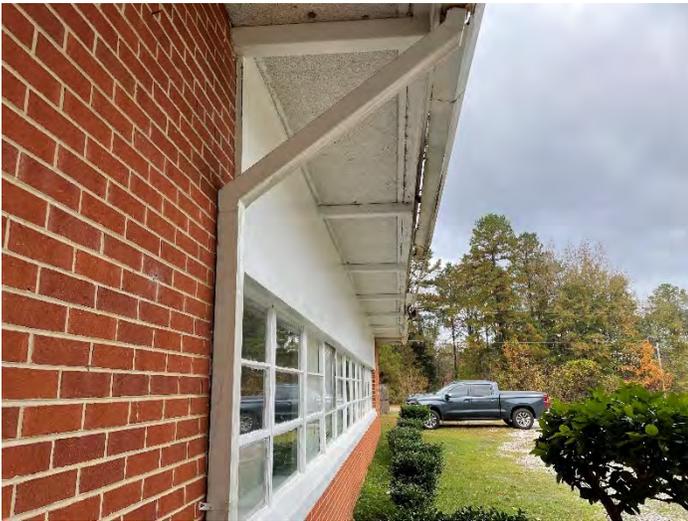
Gutters / Downspouts In Disrepair

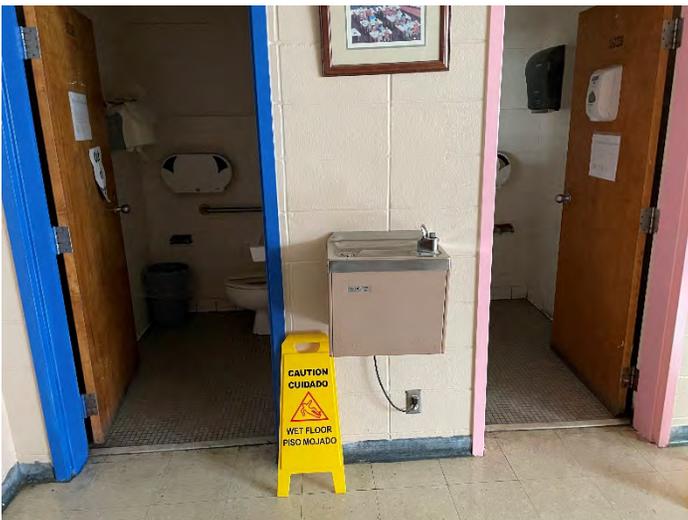
Restrooms Do Not Meet Current ADA

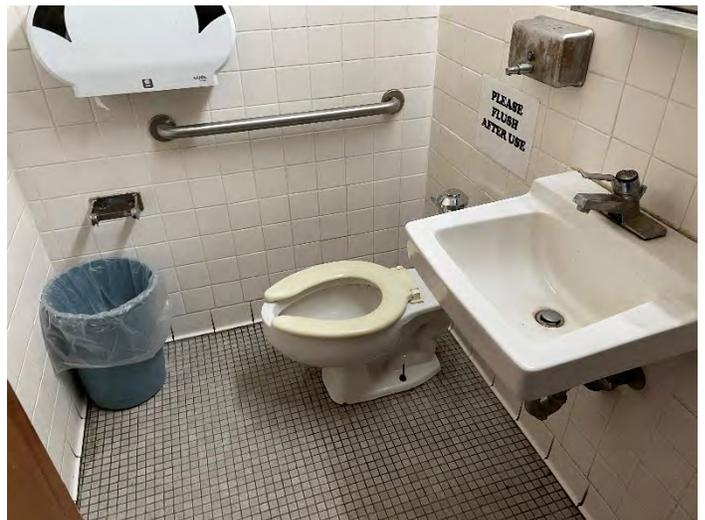
Single Restrooms Do Not Meet ADA

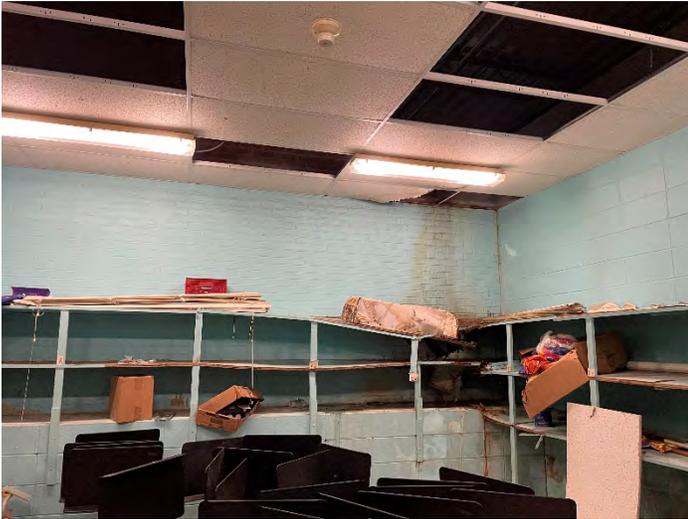
Water Damage From Extreme Roof leak In Band Room – Mold Is Evident – SAFETY HAZARD

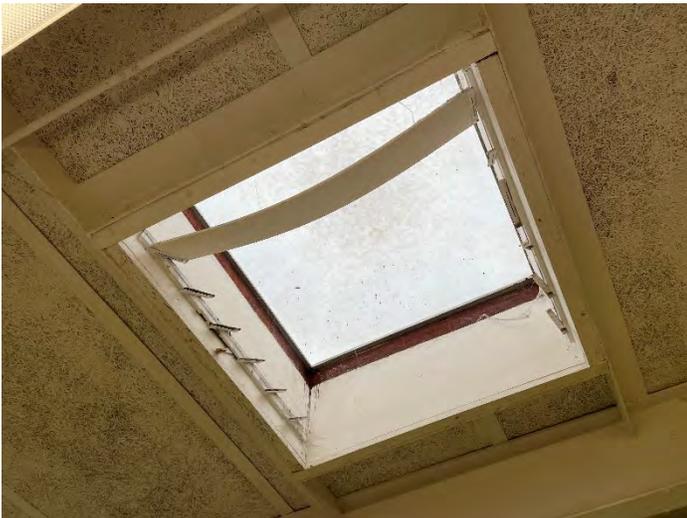
Old Skylights Showing Evidence of Moisture

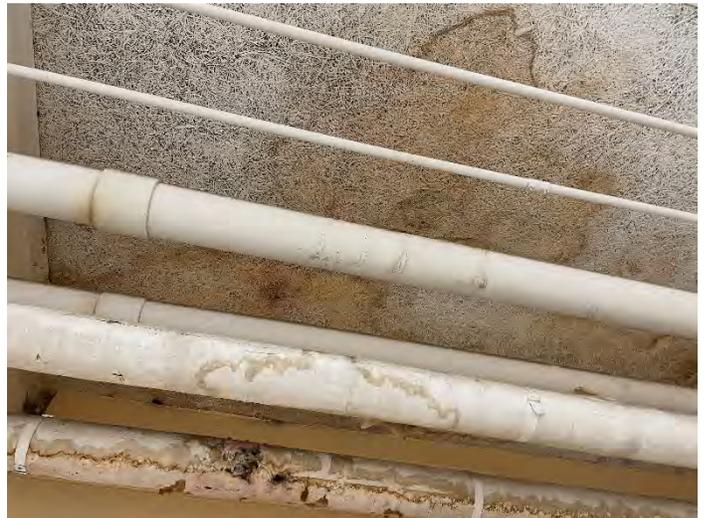
Roof Leak In Hallway

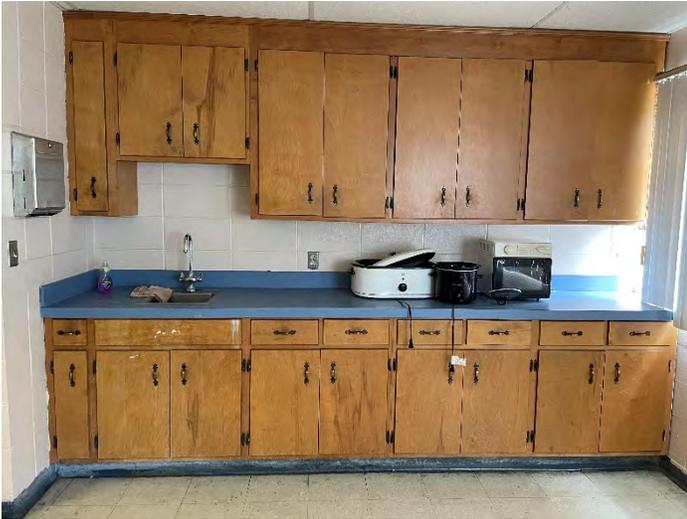
Dated Cabinet In Teachers Lounge

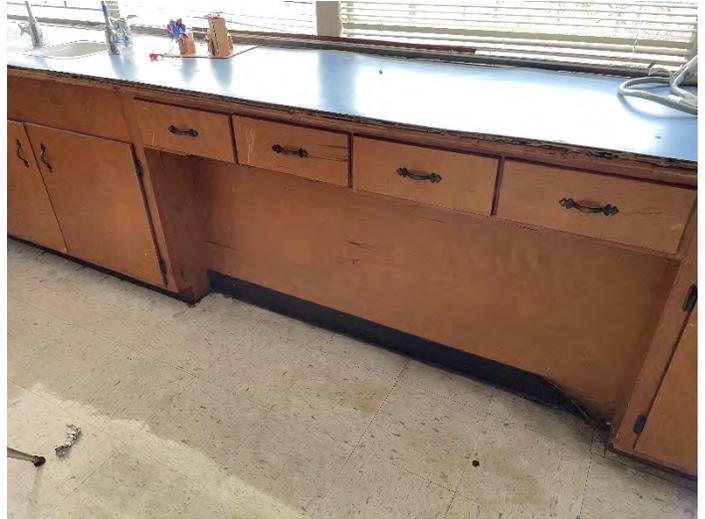
Dated Classroom Cabinets

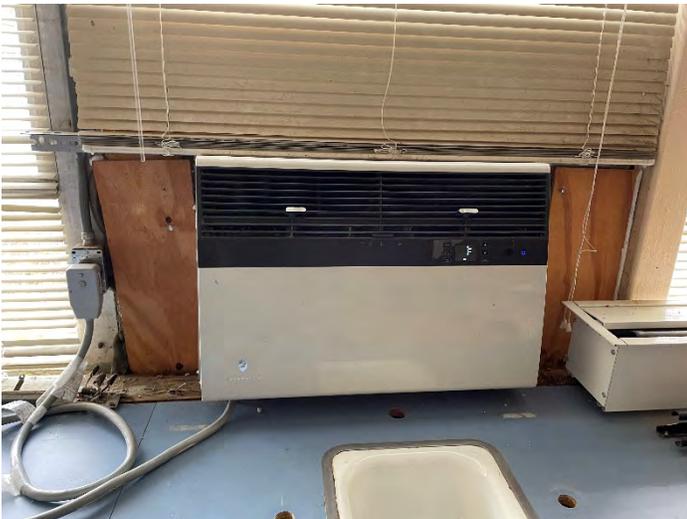
Most All Air Conditioning Comes From Window Units Secured With Plywood

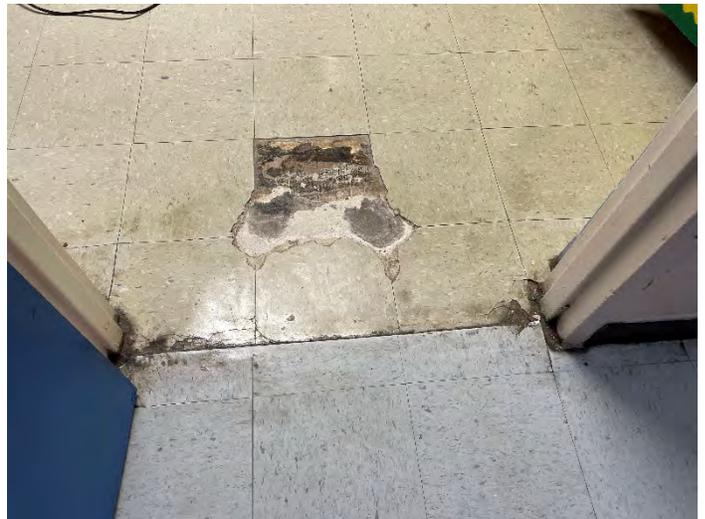
Example of Damaged Flooring – Trip Hazard

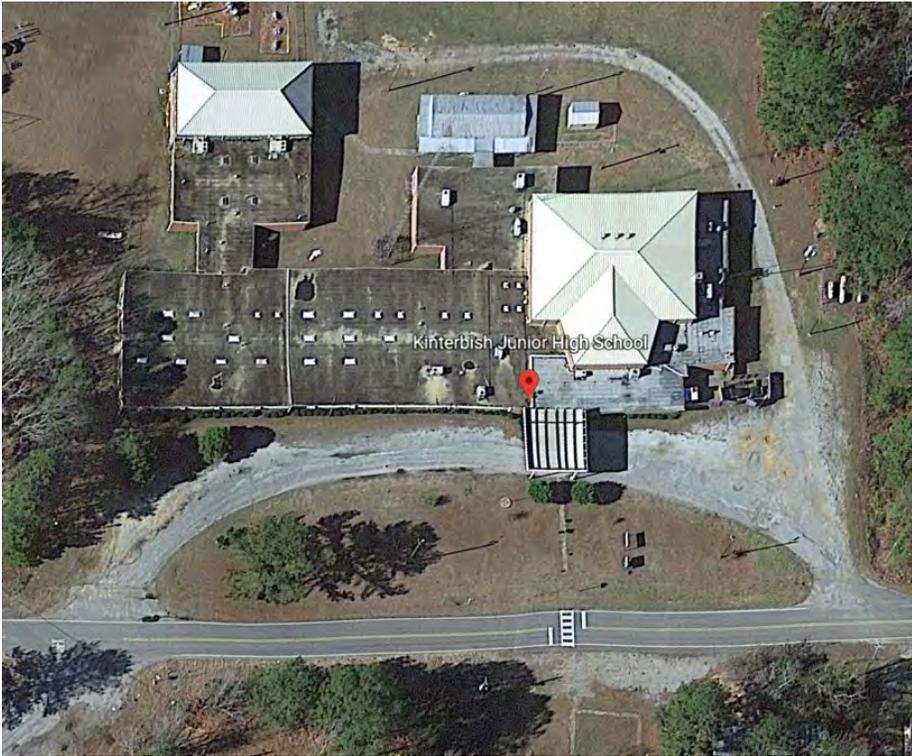
Roof Condition Diagram

Existing Roof Type: Standing Seam Metal Roof
Year Installed: Unknown
Overall Rating: Fair
Life Expectancy: 5 years

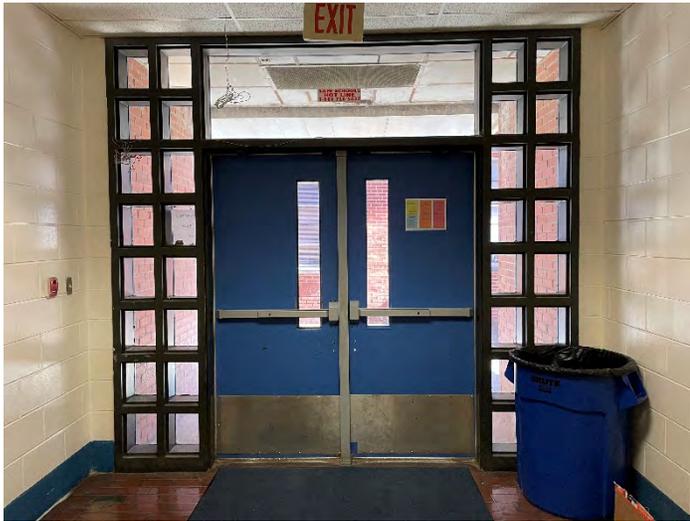
Most Egress Doors Require Adjustment

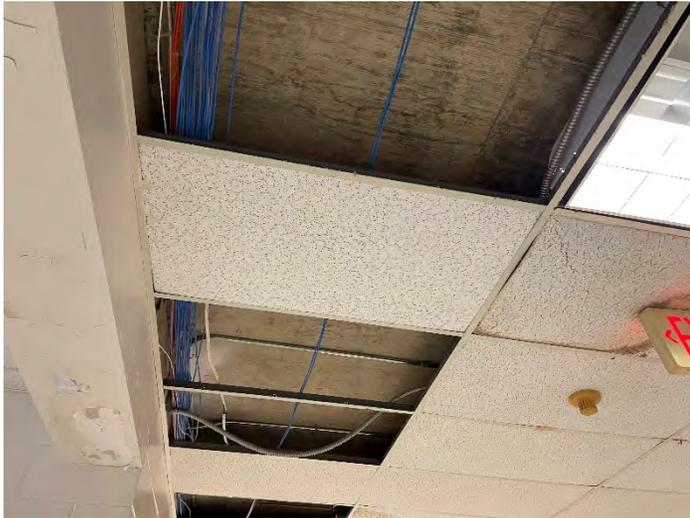
Ceiling Tiles Out – Leaks Reported

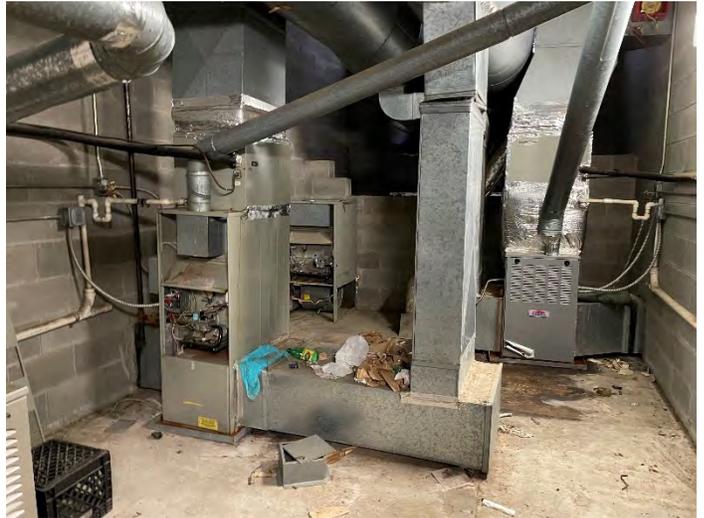
Covers Off HVAC Units on Mechanical Mezzanine Needs Cleaning

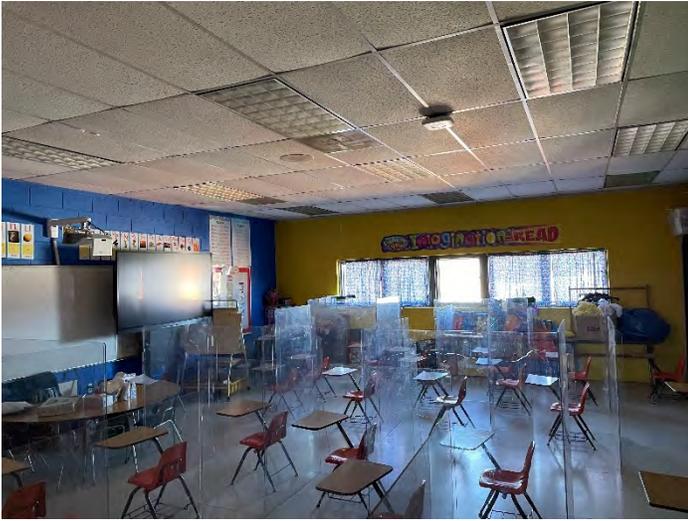
2 x 4 Ceiling Tiles are Starting to Sag

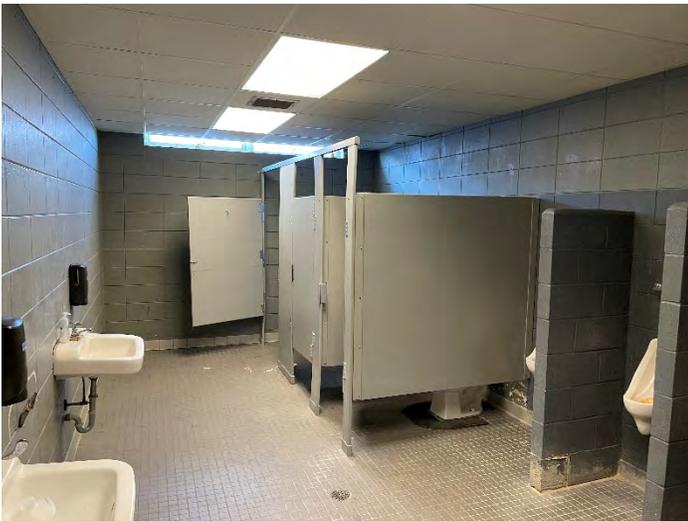
Example of Missing Mirrors & Deteriorating Paint

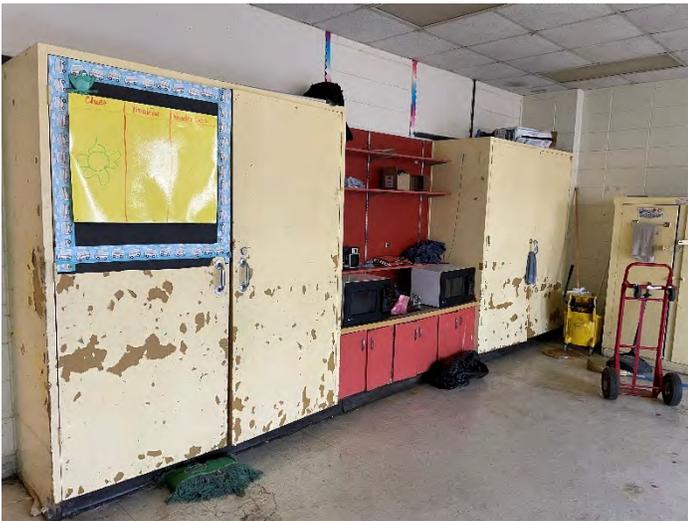
Cabinets in Bad Shape

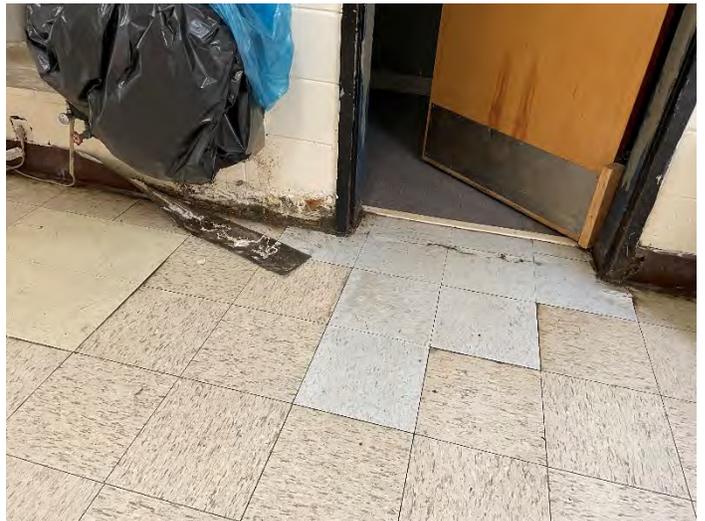
Floor Patching, Base Coming Off

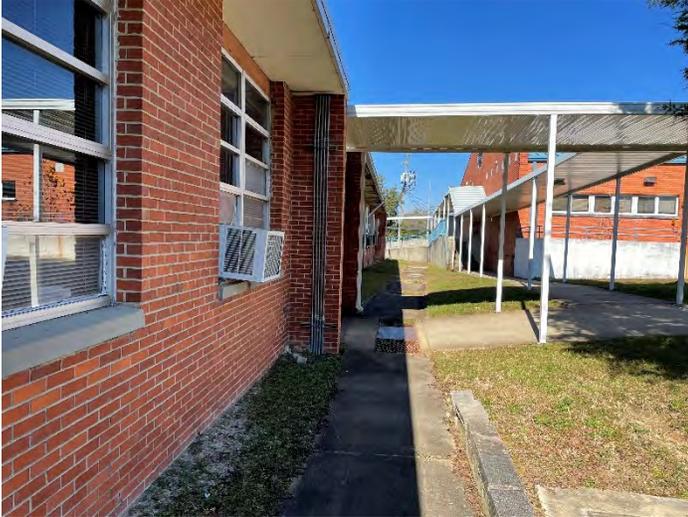
Walkways Appear To have ADA Deficiencies

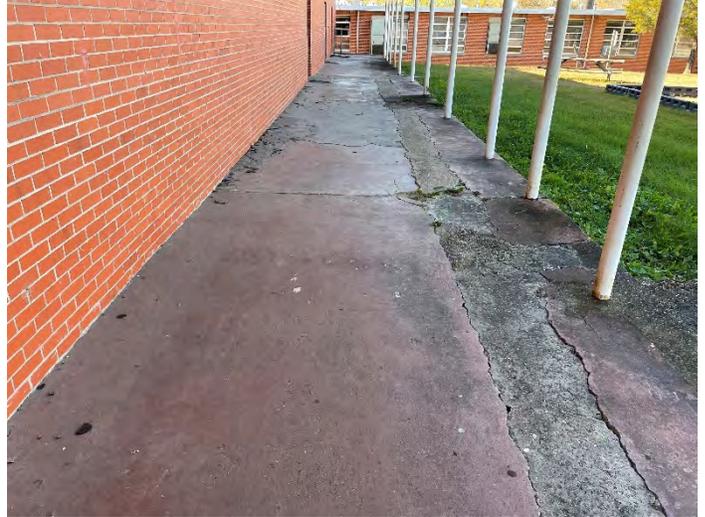
Walkways Are Damaged & Do Not Meet ADA

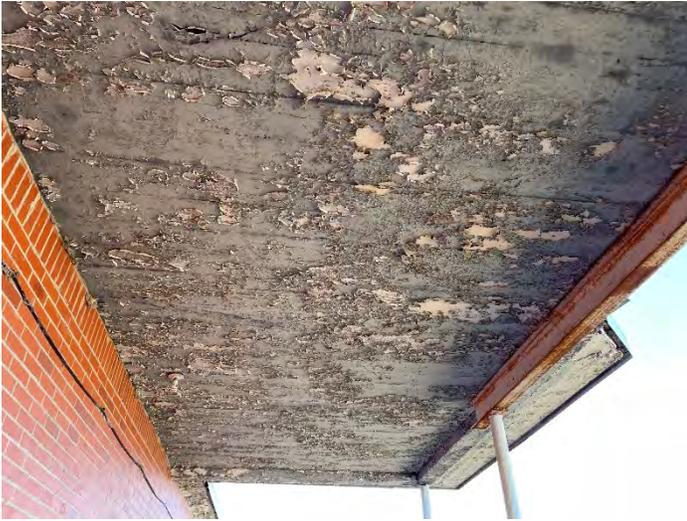
Paint Is Peeling on Concrete Canopy

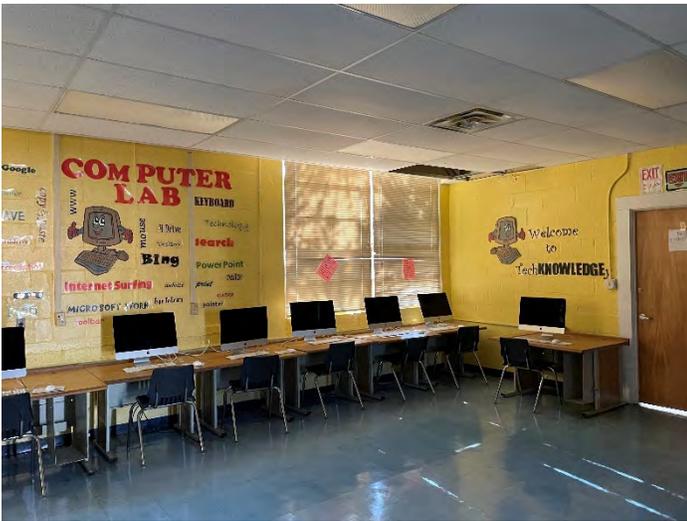
Ceiling Tiles Replaced In Some Classrooms

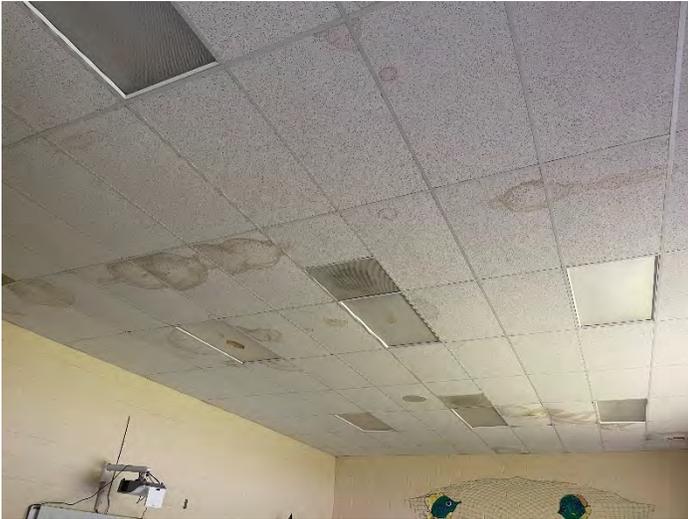
Multiple Leaks In 2001 Library Building

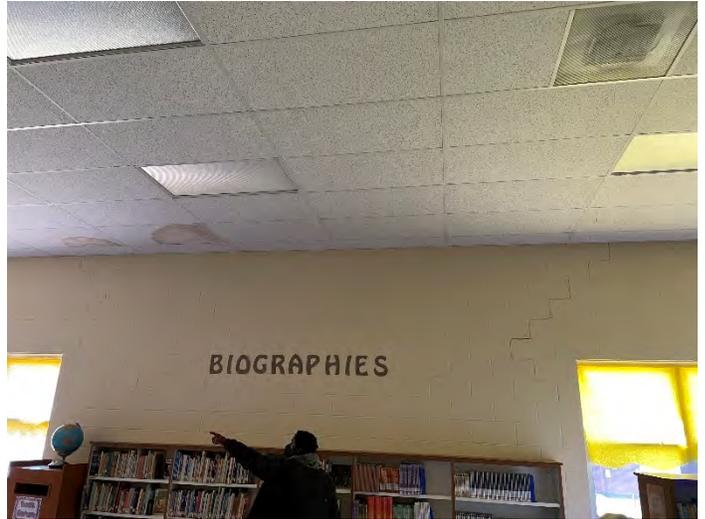
Multiple Leaks In 2001 Library Building

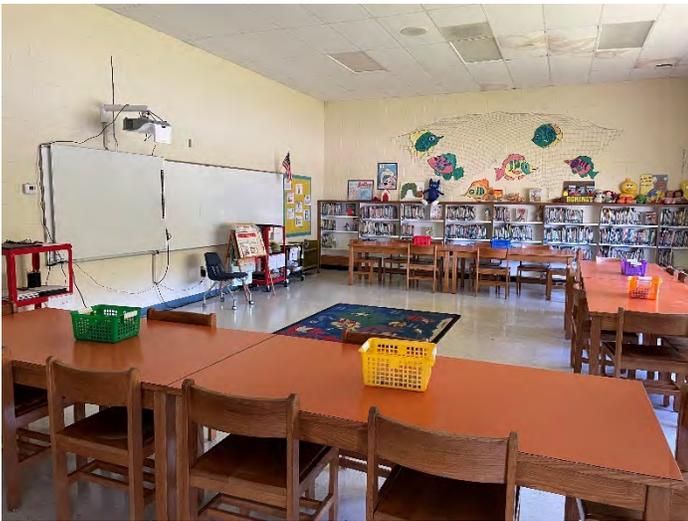
Multiple Leaks In 2001 Library Building

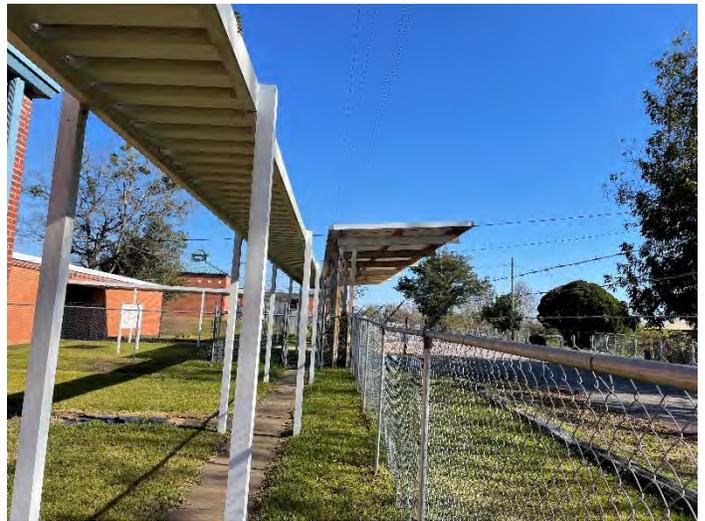
Aluminum Canopies Appear To Be Fine

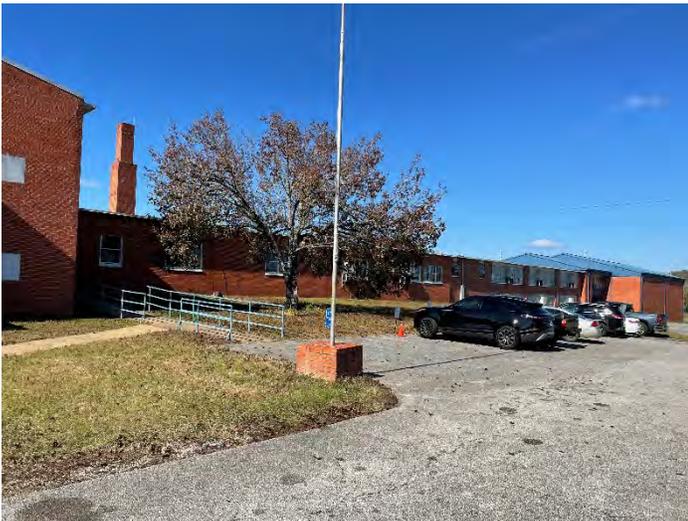
Front Entry – 1 Handicap Space

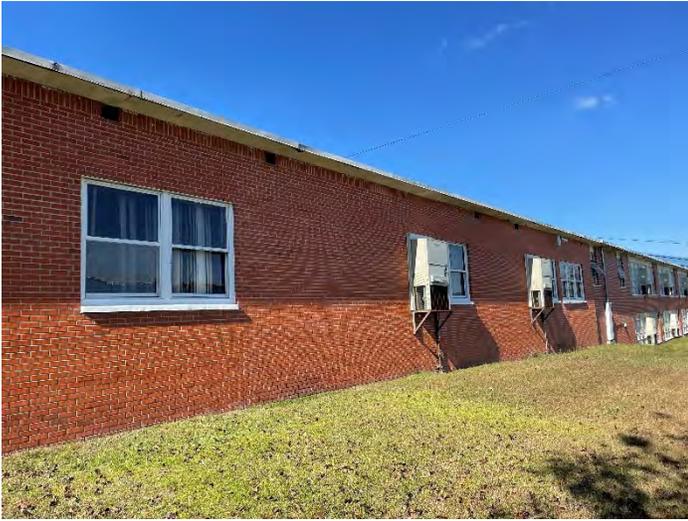
Windows Along This Elevation Appear To Have Been Replaced In Recent Years

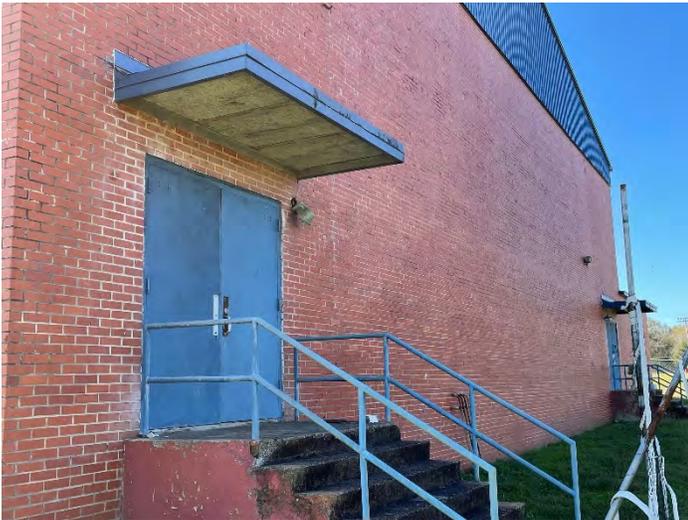
These Doors Need Adjustment

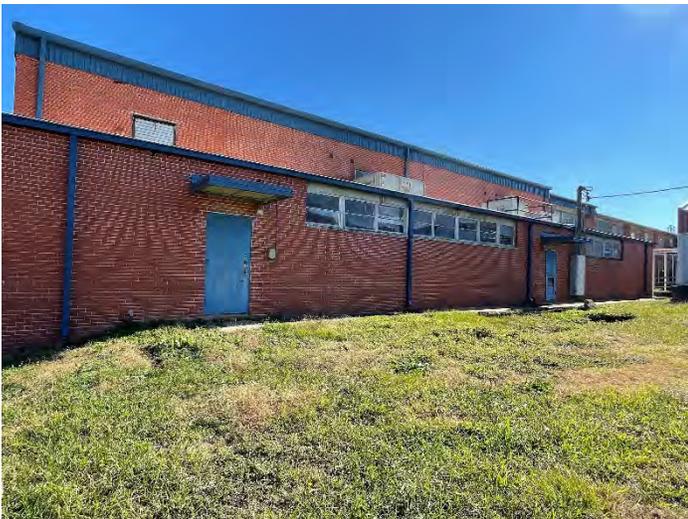
Back Gym Elevation- New Roof On Top

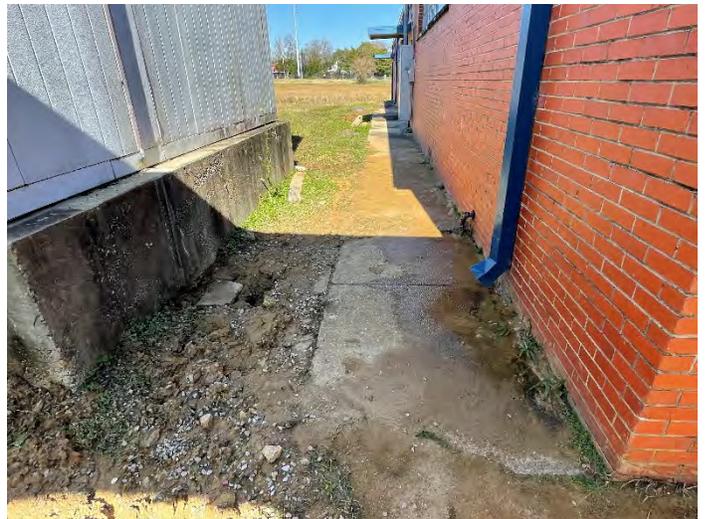
Site Drainage Issue – Muddy Walkway

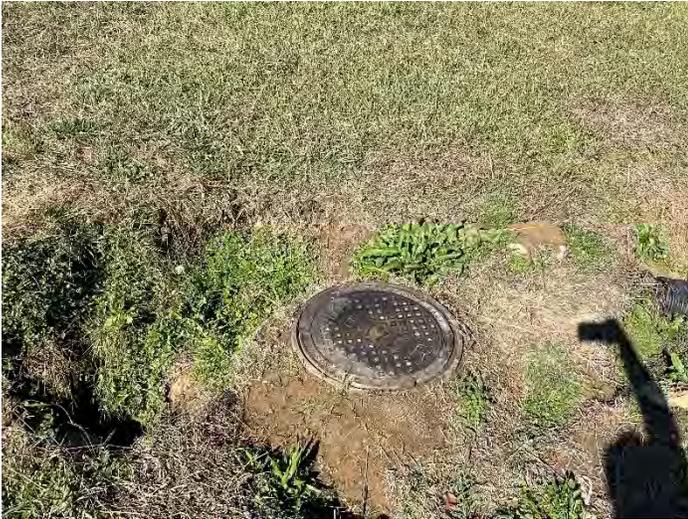
School Reports Deteriorating Sewer Pipe

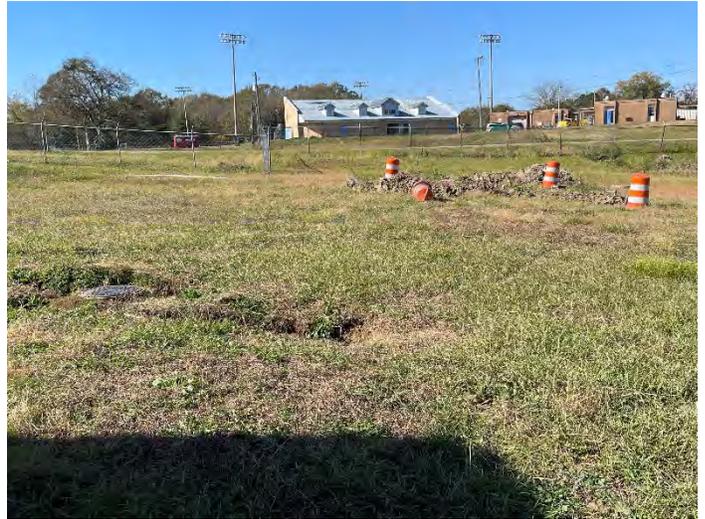
School Reports Deteriorating Sewer Pipe

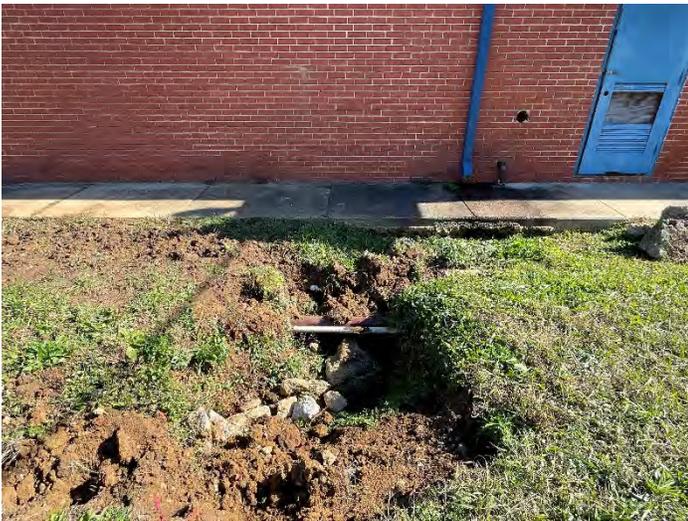
School Reports Deteriorating Sewer Pipe

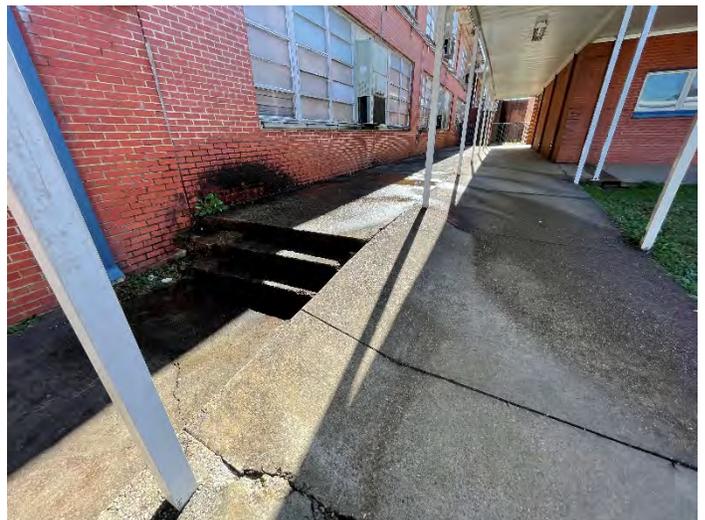
ADA / Trip Hazards at Walkways

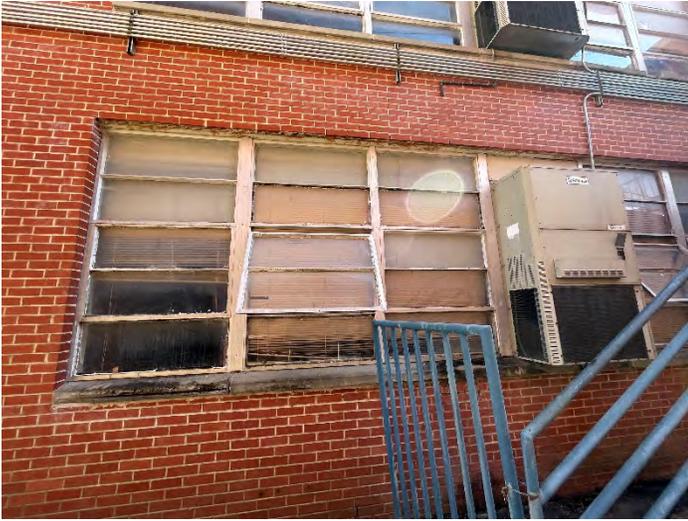
Example of Windows That Need Replacing

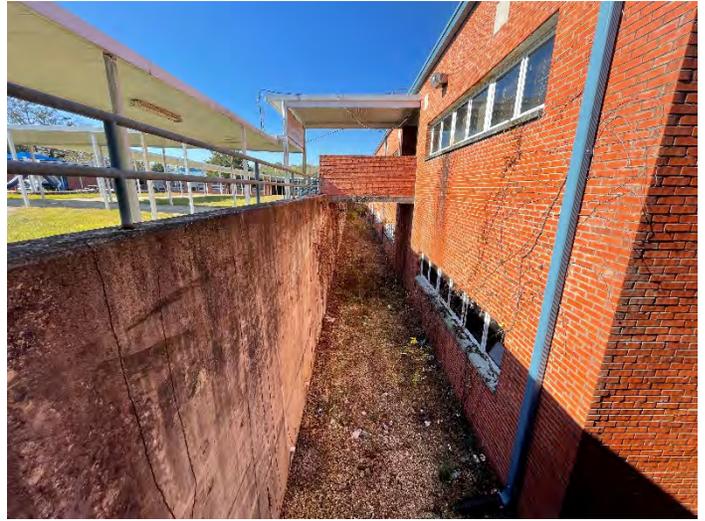
Vegetation Growing On Building

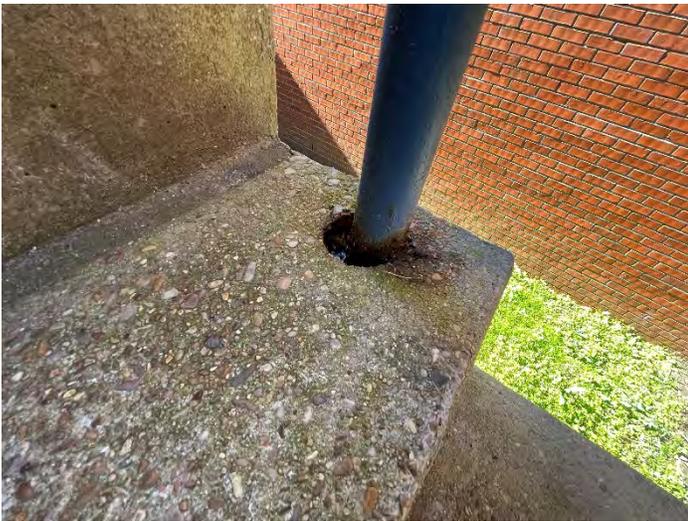
Example of Posts Rusting at Base

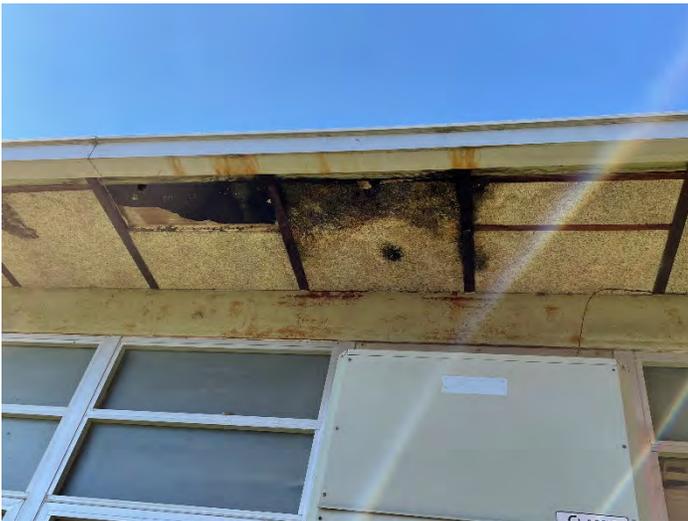
Example of Deteriorating Tecktum Deck

- Repairs of Tectum roof panels and bulb tees that has varying degrees of water damage
- Some tiles and tees will need to be removed and replaced
- Some cracking of the brick veneer and precast windowsills was noted in several areas

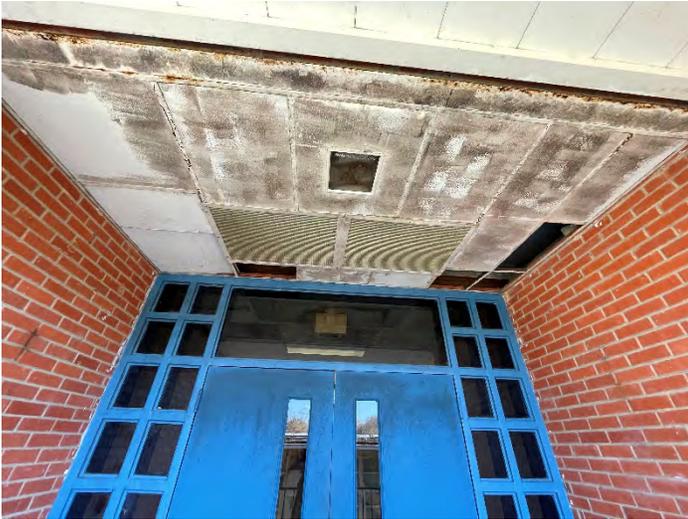
Exterior Soffits Such As This Need New Tiles

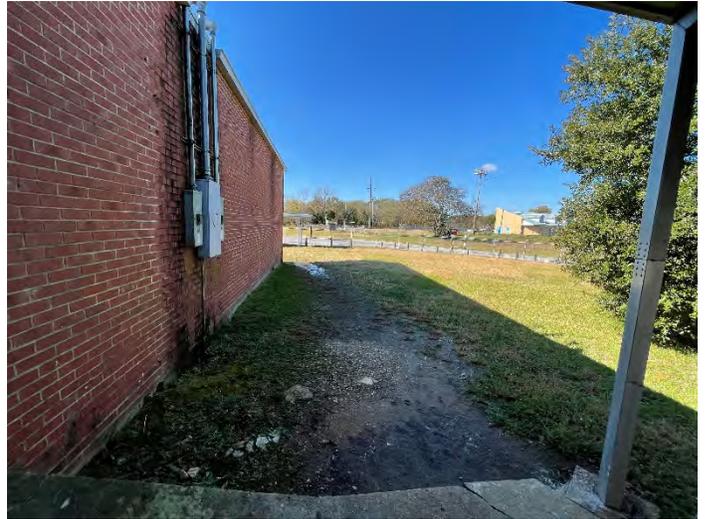
Example of Standing Water On Grade Close To The Structure

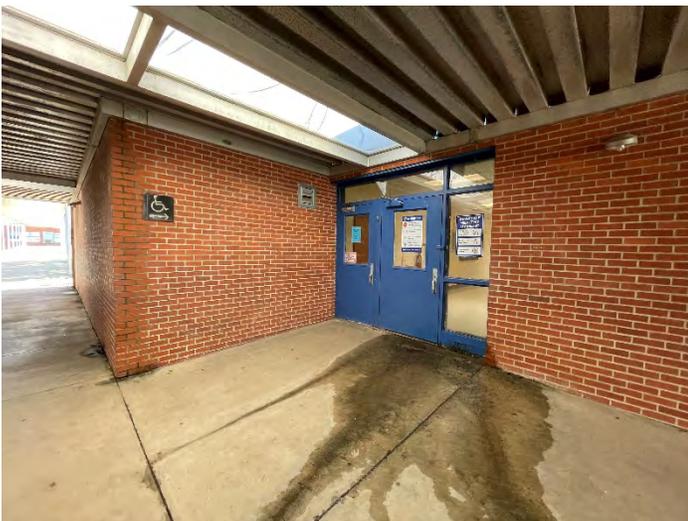
Canopy Leak Close to Egress Door

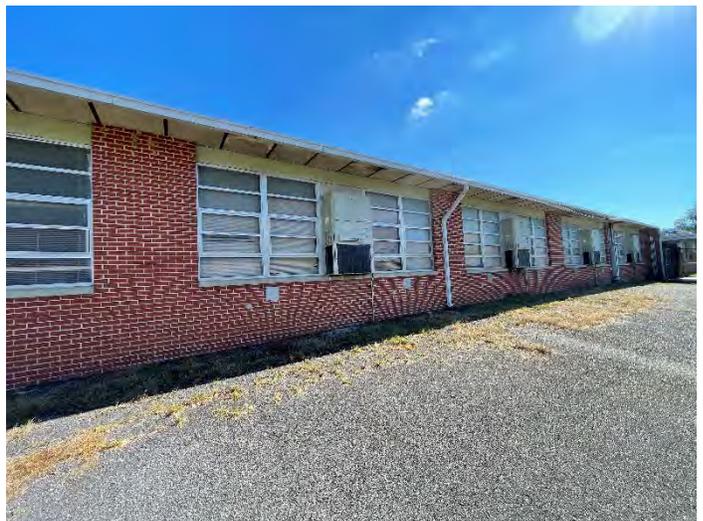
Tecktum / Gutter Deterioration

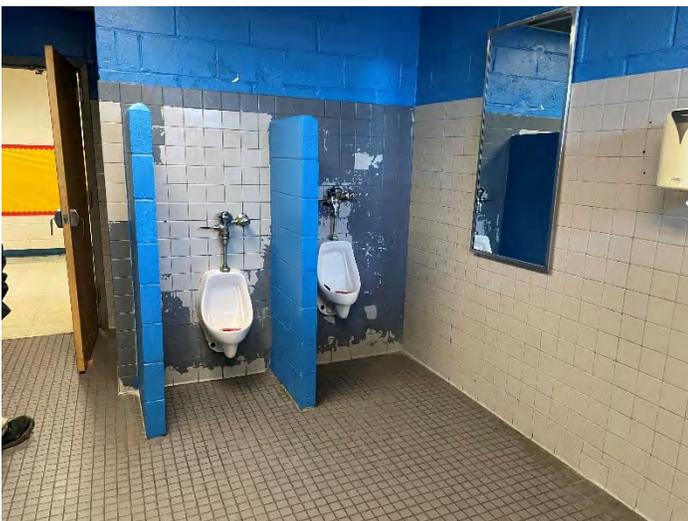
Example of Deteriorating Restroom Finishes

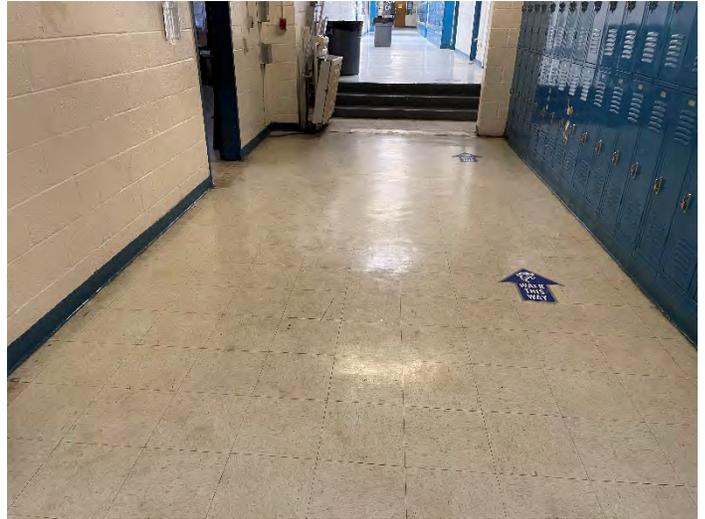
VCT Flooring Appears to Range From "Fair" to "Poor" Condition

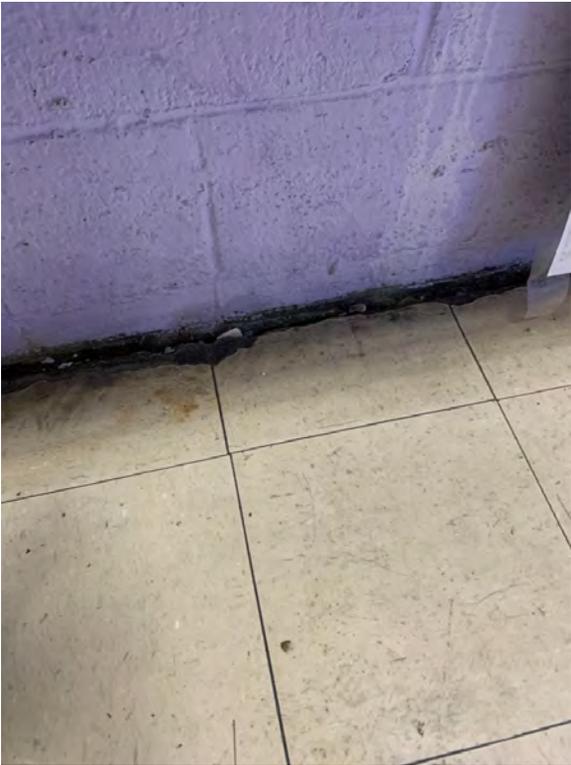
One area of the building was observed to have potential major structural damage. The floor of the bathroom on the east side of the main entry hall has settled several inches. There is a building retaining wall adjacent to this room and the soil under the slab and behind the retaining wall may need to be repaired by removing the interior walls and slab and replacing them in kind.

Large Gap Between Slab and Wall Adjacent to Bathroom
